# Condition Assessment and Maintenance Strategies for South-West NSW Bridges

Muhammad Khattak, Structural Engineer (Bridges), Transport for NSW

In the Southwest region of NSW, which borders Victoria, this paper focuses on two key border bridges which span over the Murray River: Heywood Bridge (B07331) in Wodonga and Mulwala Bridge (B05819) in Mulwala.

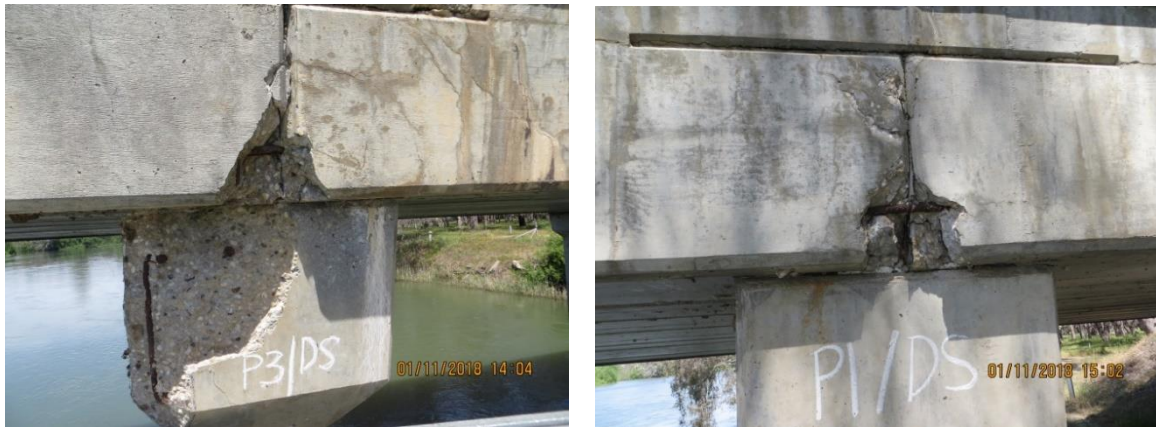
**Figure 4 Spalling in planks and pier's headstock at outer faces**

The 2019 Level 3 inspection of Heywoods Bridge identified significant concrete deterioration, including spalling and exposed reinforcement on the parapets over the headstock in almost all spans (as shown in Figure 4). Additionally, cracks and delamination were observed in the surrounding areas of most pier joints.

- The bridge parapets need to be repaired/rehabilitated.
- The deteriorated headstocks/pier walls need to be repaired/rehabilitated.
- The longitudinal cracks in planks soffit need to be monitored and rehabilitated.

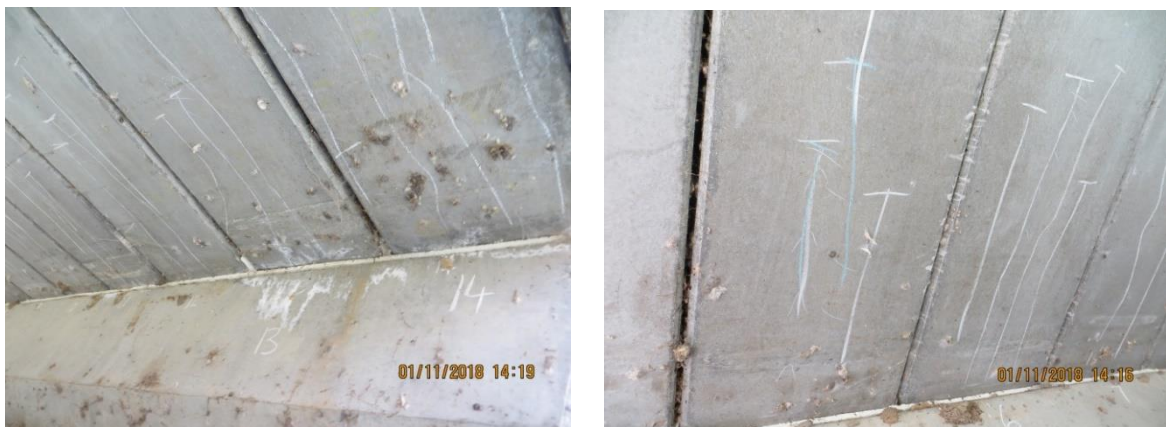
**Figure 5 Longitudinal and transverse cracks observed in the plank's soffit of Heywoods Bridge**

The bridge planks/girders exhibited both longitudinal and transverse cracks (as shown in Figure 5), which were measured and recorded during the inspection, with a maximum crack width of up to 0.6mm. It was noted that certain spans had more extensive cracking than others, particularly Span 3 at Pier 3, Spans 9 and 10 at Pier 9, and Span 11 at Pier 10, where girders (planks) displayed a higher concentration of longitudinal and transverse cracks compared to other spans.

Structural analysis indicates that the observed cracking is due to a combination of temperature-related loading and support restraint effects at all piers. It was also noted that the transverse cracks are located 350 to 500 mm from the face of the respective headstock in each span. This is the region with hardly any prestress due to transmission length and strand de-bonding.

- Initiated the repair/rehabilitation process of prestressed planks affected by longitudinal and transverse cracks.
- Initiated the repair and rehabilitation of deteriorated parapets.
- Planned the installation of a structural monitoring system to remain in place until repair and rehabilitation work is completed.

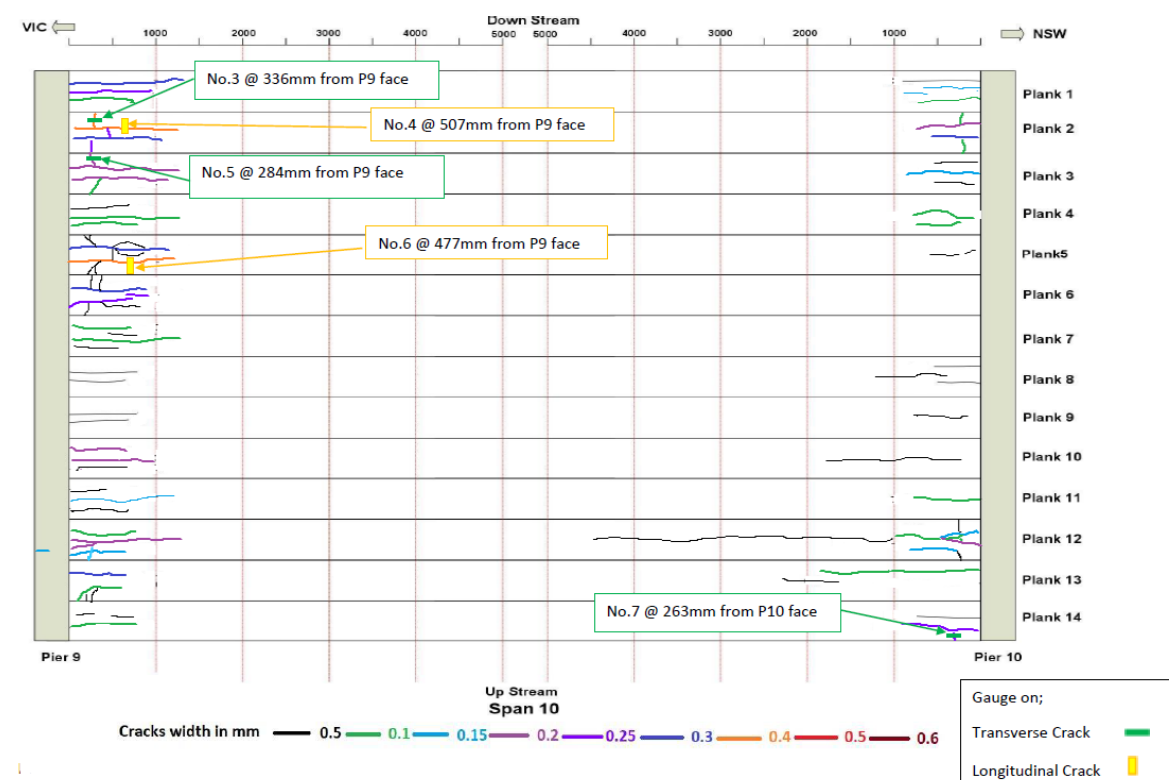
**Figure 6 Crack Gauges (Electronic and Tell-tale) Installation Plan/Layout for Span 10**

TfNSW managed the design and implementation of the bridge monitoring system to ensure effective approach to bridge maintenance. A detailed monitoring plan was developed, including the installation of tell-tale gauges and electronic gauges, with the latter recommended for critical crack locations (As shown in Figures 6 and 7). Readings from these crack gauges were to be monitored monthly, with more frequent Level 2 inspections<sup>\*1</sup> advised to track readings and detect any abrupt changes. The electronic gauges were battery-operated and accessible remotely, though their range was limited to the close vicinity of the bridge.

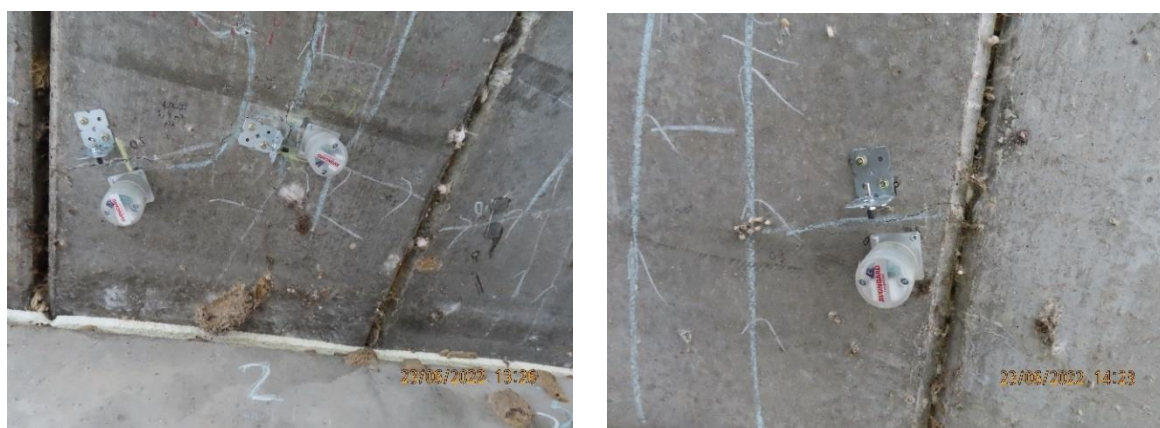
**Figure 7 Electronic Crack Gauges installed at the critical cracks in Heywoods Bridge**

Level 2 inspections were conducted on monthly basis to collect data from crack gauges and monitor the bridge for any further deterioration. These inspections were carried out from ground level. However, it was observed that some electronic sensors were not responding remotely. Consequently, a follow-up Level 3 structural inspection was conducted in 2022 to assess the structural condition of the bridge and identify any further deterioration. This inspection also provided an opportunity to evaluate the functionality of the electronic crack gauges.

The Level 3 inspection found that most bridge cracks remained unchanged. However, in some locations, cracks had elongated. Based on these findings, the follow-up Level 3 inspection recommended the urgent implementation of bridge rehabilitation work.

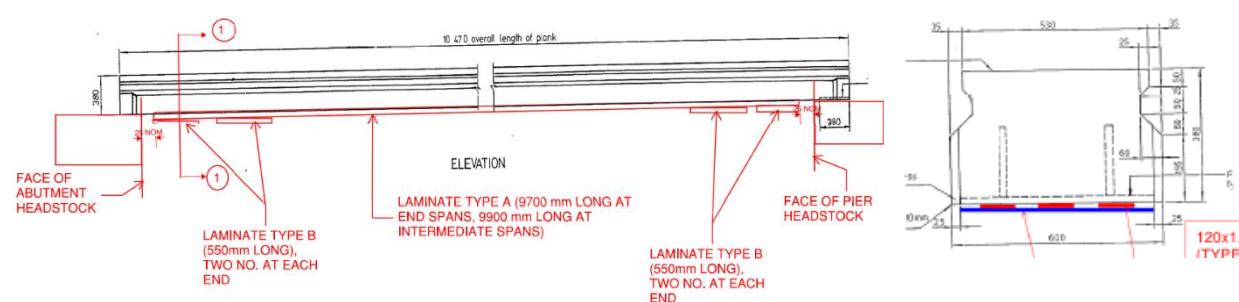
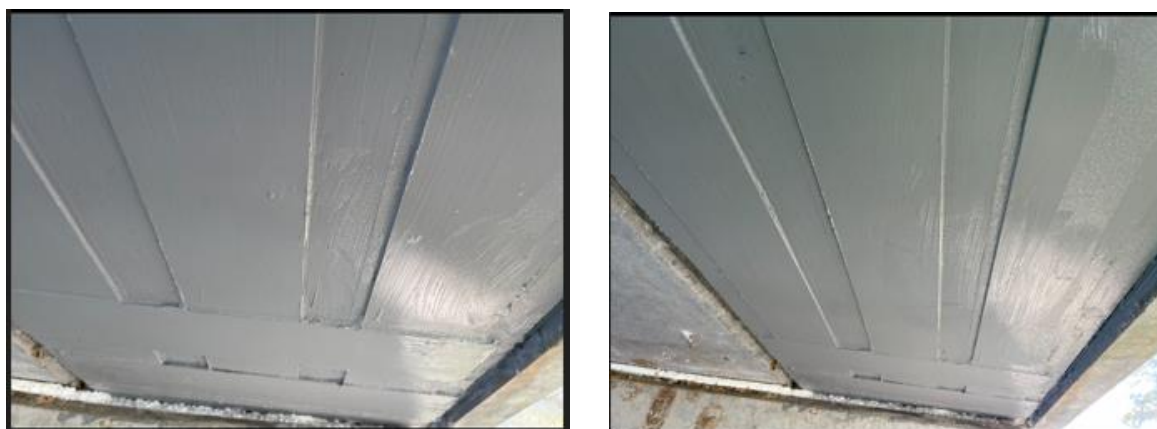
**Figure 8 Details of rehabilitation option CFRP laminates drawings**

**Figure 9 CFRP installed on plank soffit in Heywoods Bridge**

TfNSW considered multiple rehabilitation options for this bridge and determined that Carbon Fiber Reinforced Polymer (CFRP) was determined to be the most suitable option for addressing the longitudinal cracks in the plank (as shown in Figure 8 and 9). Additionally, concrete repair work was carried out at the parapet, at the joint location over the relevant pier. All rehabilitation work was satisfactorily completed in early 2023, ensuring the continued safety and functionality of the structure.

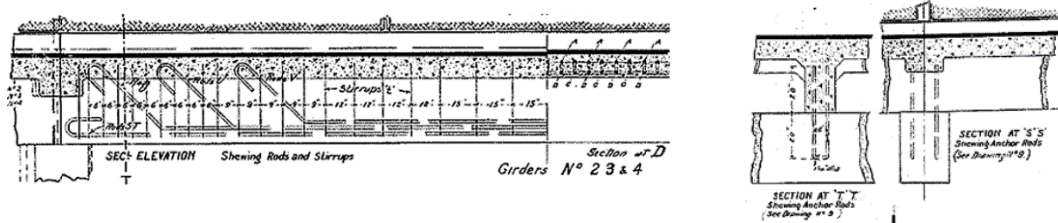
**Figure 13 Concrete Beam at headstock seating and dowel bar arrangement**

In these spans, concrete beams are seated directly on top of piers, with stiff dowels provided between each beam end and the headstock (as shown in Figure 13). Consequently, bridge deck deformations due to thermal effects are restrained, causing cracking, and spalling of the beam ends over the headstocks. In the fully restrained condition, the resultant thermal stresses at the beam ends were found to exceed the concrete's tensile strength. Beam ends are highly stressed regions, with an interaction between thermal restraint and bearing stresses. Inadequate and poorly detailed reinforcement at these locations has further contributed to the deterioration and severity of the cracking (as shown in Figure 14).

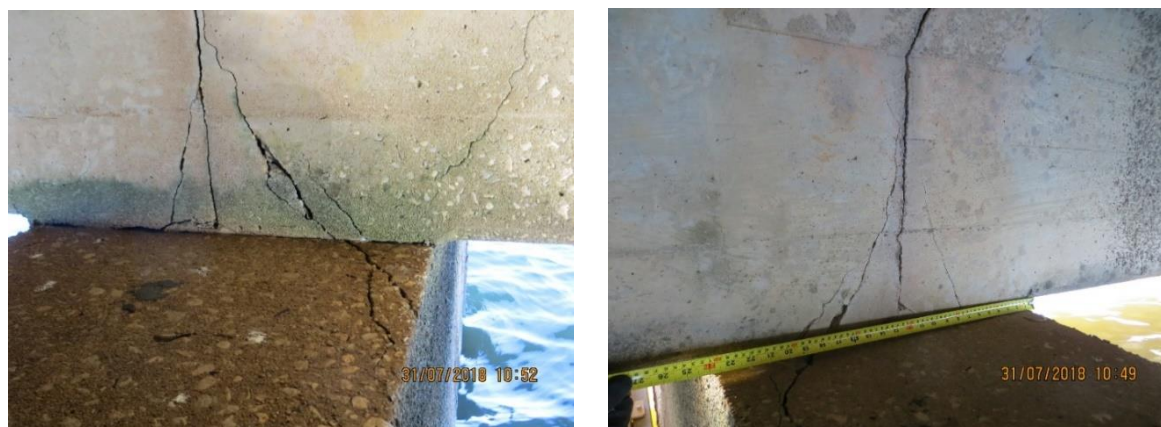
**Figure 14 Photos showing crack at the beam ends at the headstock support locations.**

The Level 3 structural inspection, carried out in 2018, found deterioration at the ends of the beams (Figure 12 shows the beam configuration) in the simply supported concrete beam spans (Spans 1 to 5 and 9 to 31). The deterioration manifested as cracking (up to ~1-2 mm) and spalling on the side faces of the beams over the seated areas (as shown in Figure 13). At the most severely affected locations, cracks extended from the beams into the headstock, accompanied by spalling of the headstock.

Deterioration of the beam ends and headstocks in the simply supported spans was a significant structural issue identified during the inspection. The Level 3 inspection report also categorised each beam end, at the support location, into different condition states to assist in maintenance strategies.

- Restore support areas and rehabilitate beam ends and headstocks in 'poor' or 'very poor' condition. Refer to previous memo for all affected locations identified from the inspection.
- Install interim concrete crack gauges and/or data logger on critical beam ends and headstocks in 'very poor' condition.
- Inspect inaccessible simply supported span beam ends (Spans 21 to 32) – use of a telescopic camera or alternative access arrangements may be necessary.
- Inspect beam ends for any ongoing deterioration during future Level 2 inspections and if further deterioration noticed, urgent Level 3 inspection need to be carried out.

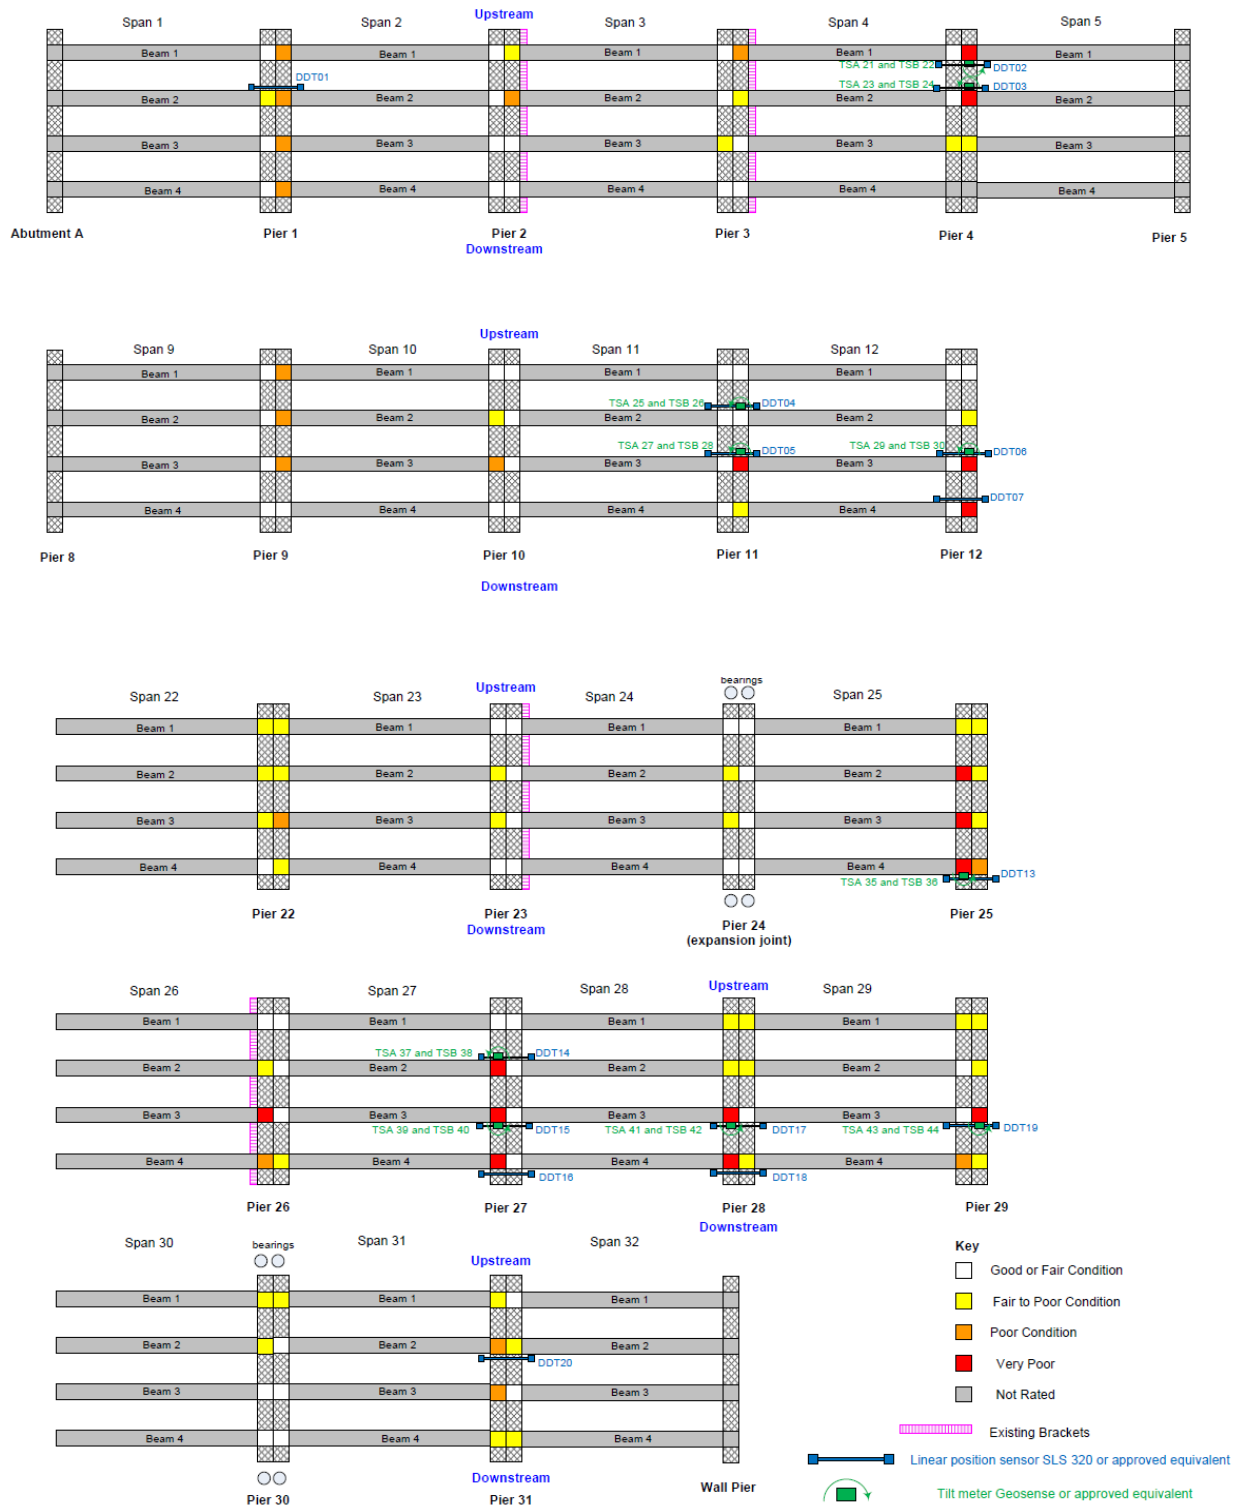
**Figure 17 Schematic showing condition states of the concrete beam ends and proposed monitoring instrumentation layout**

After installing the monitoring sensors as per the layout provided in Figure 17, readings from these sensors were gathered at the end of each month to analyse for any critical events. The sensor data were compared on a monthly basis with previous data to carefully monitor any alarming activity.

During data monitoring, it was noticed that some linear displacement sensors were showing abnormal activity. This raised an alarm to determine whether actual movement had occurred or if it was a sensor malfunction. A special structural inspection was organized to validate the data and investigate the anomaly.

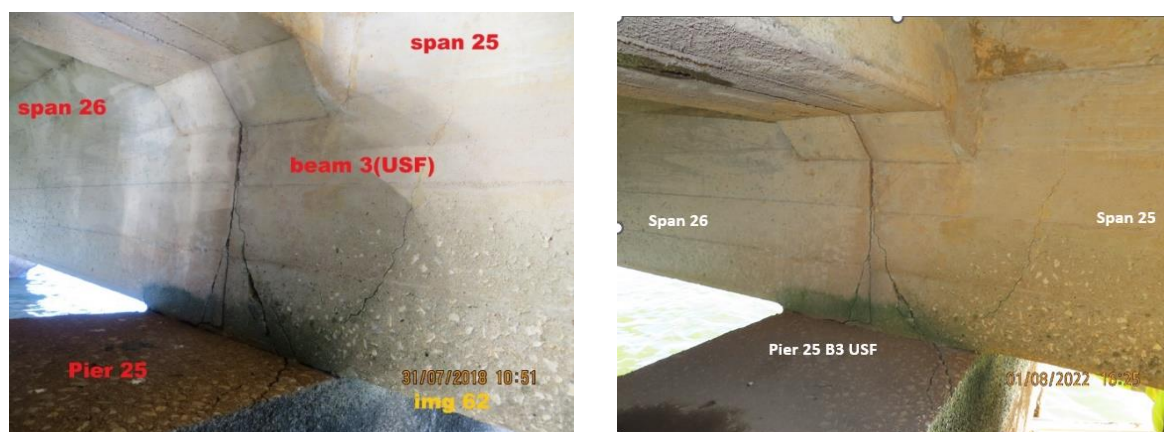
**Figure 18 Comparison between photos of L3 inspection 2018 and 2022**

A Level 2 inspection, along with an urgent follow-up Level 3 inspection, was organised in 2022 to investigate the alarming sensor activity of some linear displacement sensors. Locations with abnormal readings were inspected first. No changes in the condition states of the beam ends at these locations were observed, and it was concluded that the abnormal sensor readings were likely due to the long length of the displacement sensors and other parameters. All beam ends were checked during this inspection. The findings were compared with previous inspections and revealed that most locations remained in a similar condition to those observed during the Level 3 inspection carried out in 2018 (as shown in Figure 18).
