AUSTROADS
BRIDGE
CONFERENCE 2025
Brisbane | 25-27 June 2025

Normanby Overpass, Bridge Strike: Assessment, Management and Rehabilitation

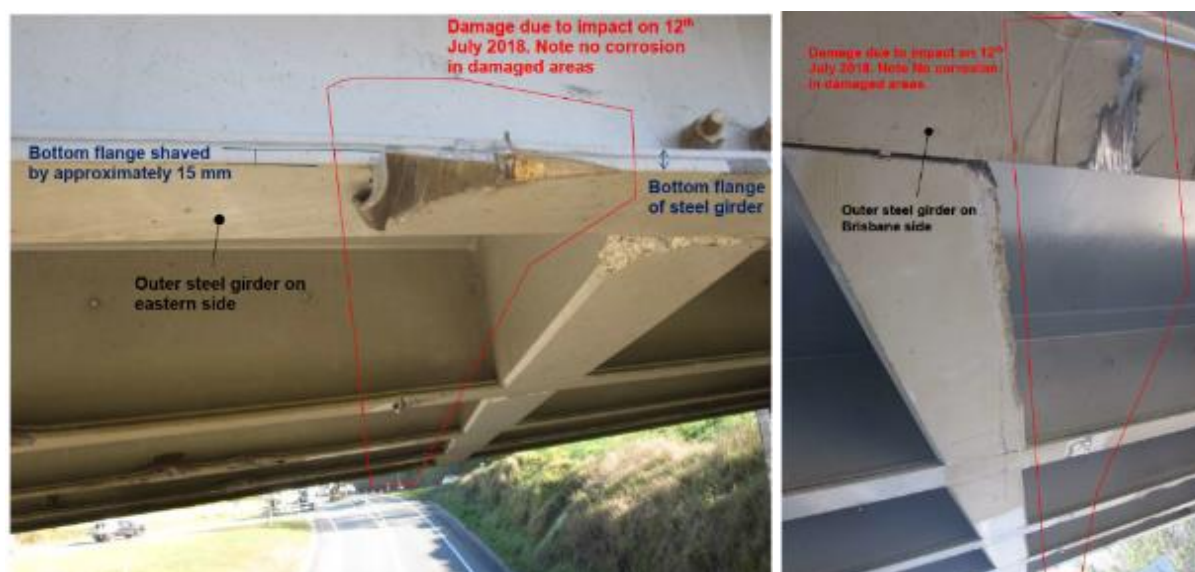
The strike damaged the superstructure's steel girders, intermediate reinforced concrete cross girders and some steel bracings. Figure 3 and 4 show the damage.

a) Damaged steel girders due to strike in 2018

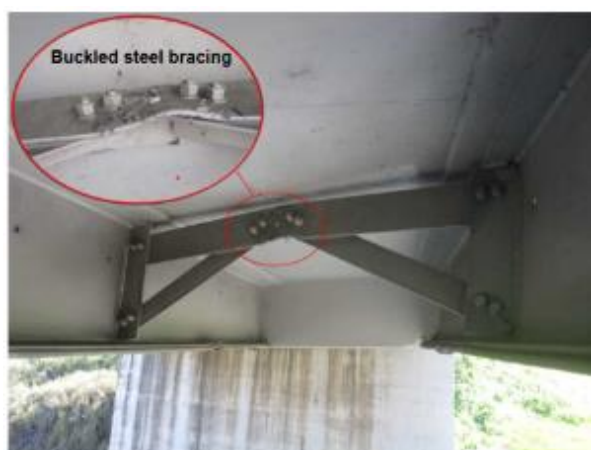
(b) Buckled steel bracing

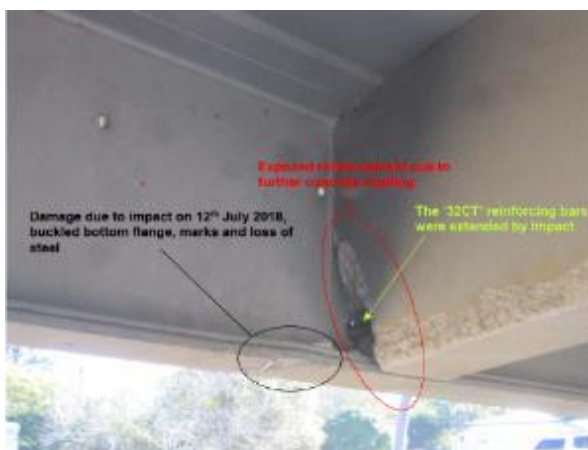
(c) Damaged reinforced concrete cross girder

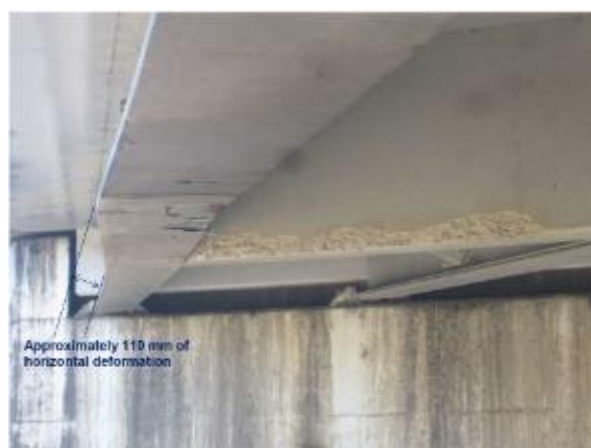
(d) Deformed steel girder

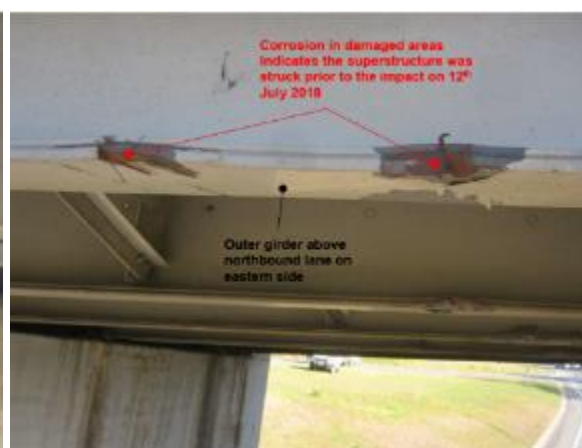
e) Damaged girder due to strike prior to 2018

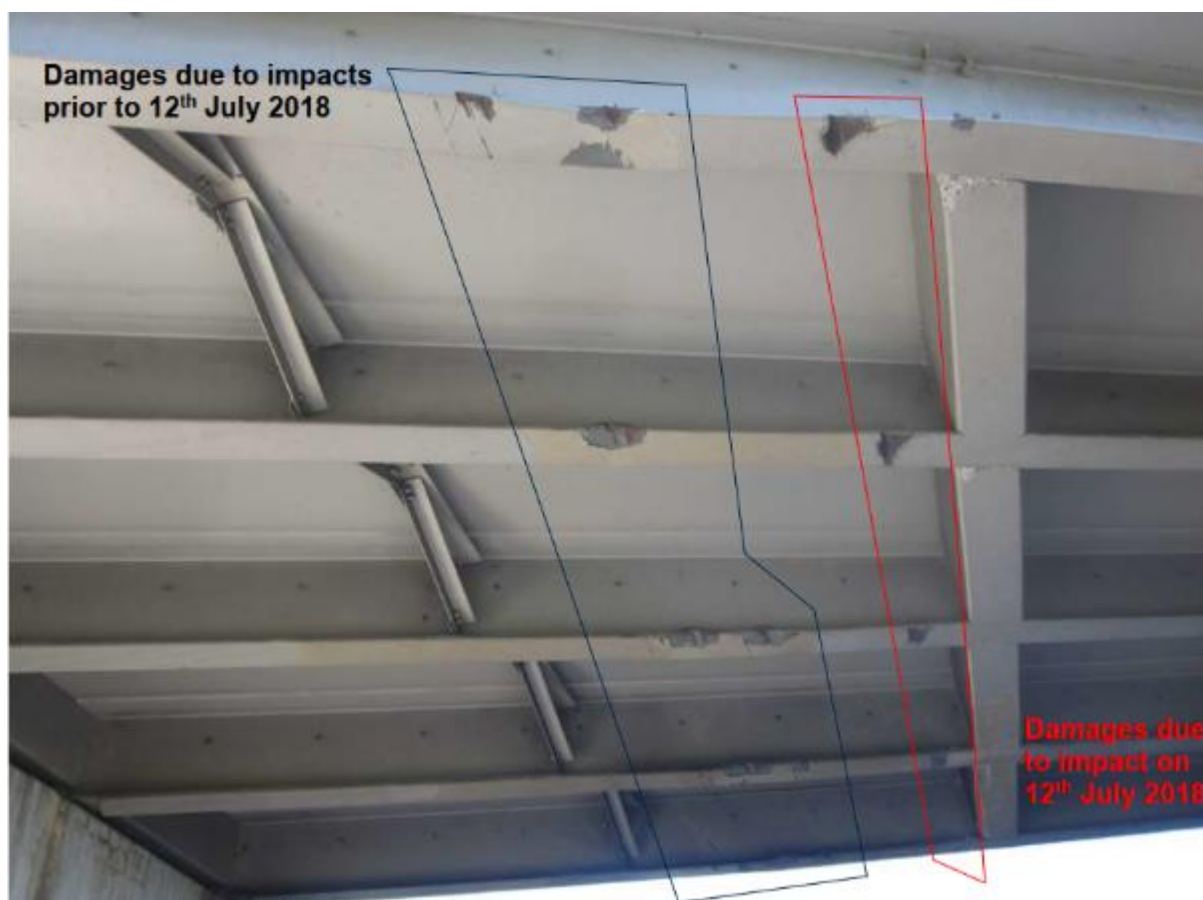
Even though the vertical clearance was increased in 2009, the overpass remained vulnerable to bridge strikes. Based on the records of the Level 1 and 2 Inspections conducted after 2009 and prior to the 2018 strike, the superstructure was damaged by multiple strikes (Hu & Wong¹). The exact number of strikes was unknown as these strikes went unreported to the asset owner, TMR. Almost all of the observed damage was located above the northbound lane of the Bruce Highway. This side of the overpass has less clearance than the southbound side of the Bruce Highway due to the deck/road grade of the overpass. Figure 2 shows the deck/road grade. Corrosion in the damaged areas of the steel girders indicated that the damage was caused by impacts prior to the 2018 strike. Figures 3 and 4 show the damage.

Figure 4: Damage to steel girders above northbound lane – as viewed from the road

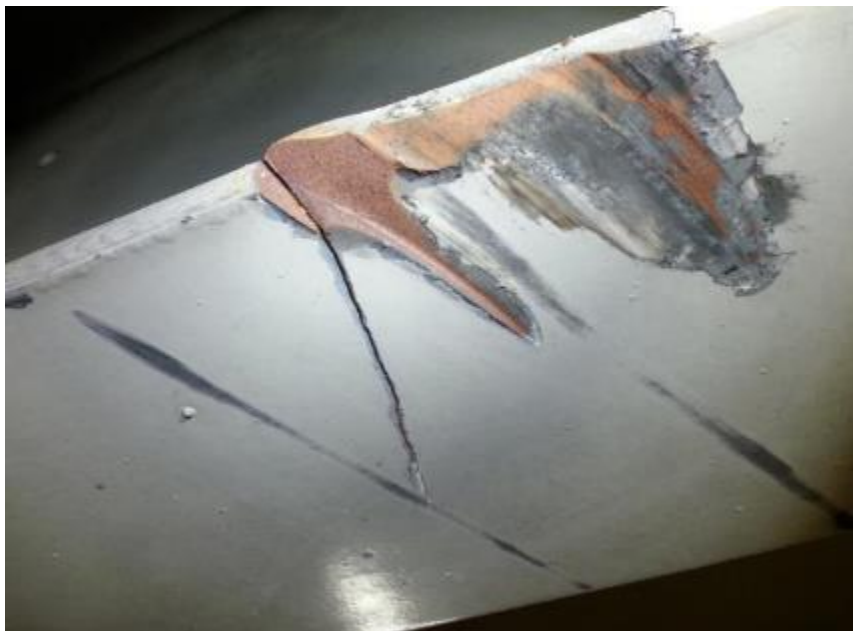
Severe damage was largely to the bottom flange doubler plate of the steel girders, while the girder bottom flanges and webs had undergone twisting and warping (refer to Figures 3, 4 and 6 **Error! Reference source not found.**). A simple grillage analysis that excluded the doubler plates indicated the girders had sufficient capacity to carry BD62.5t, but not HLP400 or SM1600 design traffic loads (Kandadai & Timms⁴). The grillage assessment was deficient in the sense that it ignored the plastic straining of the bottom flange of the steel girders, and the presence of cracks (refer to Figure 5). The presence of cracks sparked concerns that these cracks could spread through the entire width of the bottom tension flange of the girders, leading to catastrophic failure of the superstructure. The high level of plastic straining implied that the bottom flange had reduced ductility, and brittle failure could occur if overstressed. The simplistic grillage analysis could not be relied upon to predict the capacity of the damaged girders or the risk of the cracks spreading to the full width of the flange and causing failure. Nonlinear finite element analysis (NLFEA) of the superstructure was therefore carried out to determine the structural strength and remaining life of the damaged superstructure.

Figure 5: A closer look at the damage to the bottom flange doubler plate of the girders. Cracking and shearing of metal can be seen

While there were visible cracks up to approximately 2 mm wide on the bottom flange doubler plates, inspection revealed no visible cracks on the upper surface of the bottom girder flanges. A key question was whether there was cracking in the hidden bottom surface of the 610UB125 girder flanges. Non-destructive testing (NDT) was adopted to investigate this possibility.

Manual phased array ultrasonic (PAUT) and encoded time of flight diffraction (TOFD) investigations confirmed that the cracking was restricted to the doubler plates (Rostami⁵). This implied that the girders were not in immediate danger of failing, as there were no cracks in the bottom flange of the 610UB125 girders, which had previously been assessed to have sufficient capacity to carry the Regulation Mass Vehicles.

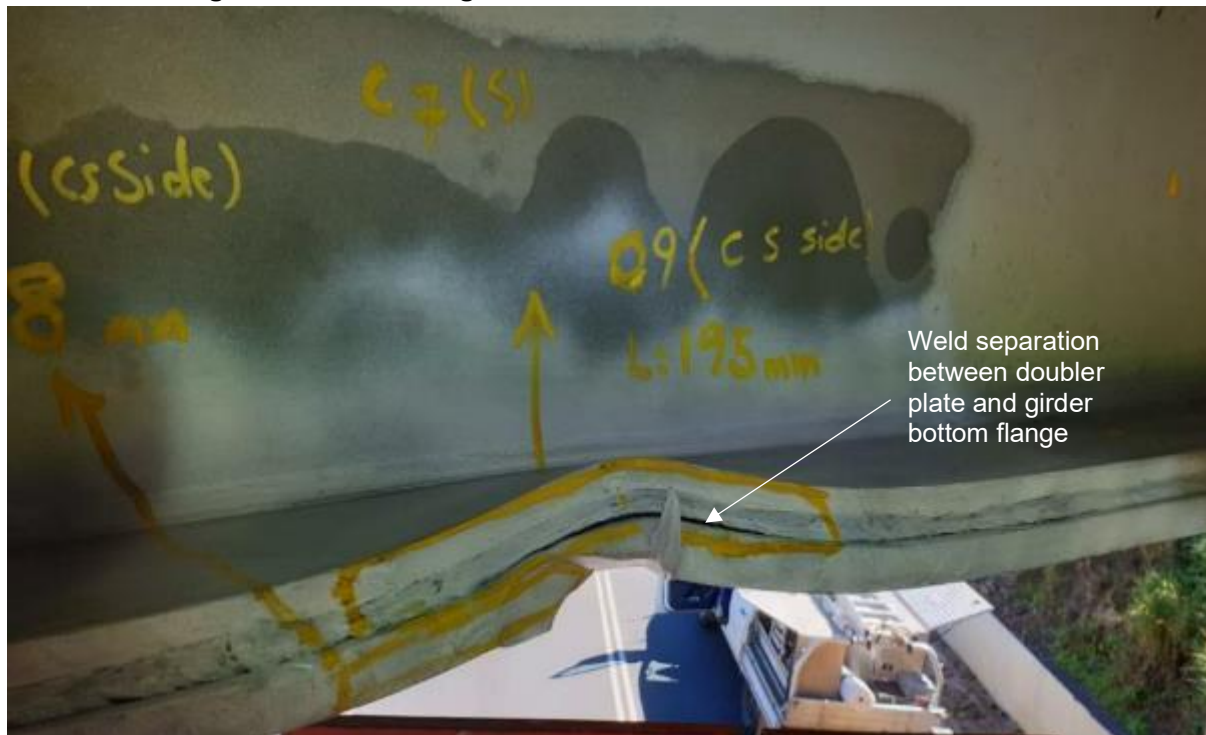
Magnetic particle investigation (MPI) performed on the exposed surfaces of the girders revealed poor fusion and widespread separation of the fillet welds between the girder bottom flange and the doubler plate (Rostami⁵) (refer to Figure 6). Poor quality weld, intermittent weld regions, and pre-existing cracks in the bottom tension flange increased the risk of continued crack propagation and subsequent failure.

Figure 6 MPI showing weld separation at fillet weld to doubler plate, but no cracks in the 610UB125 girder bottom flanges

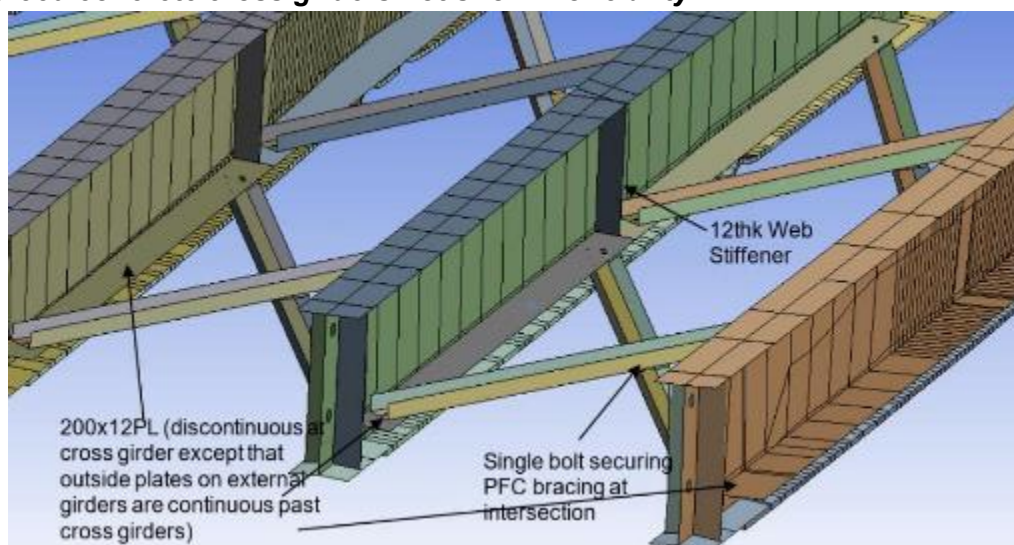
Figure 9 Option 1: additional 'bottom flange' plates welded to web and bracing. Reinforced concrete cross girders not shown for clarity

- 1) Option 1: Install steel bracings with flange plates welded to the webs

- additional 'bottom flange' plates welded to the web 90 mm above the existing damaged flange
- additional 125PFC horizontal bracings added between girder flanges
- additional 12 mm thick web stiffeners, and
- no repair of cracks or rectification of deformed girders.

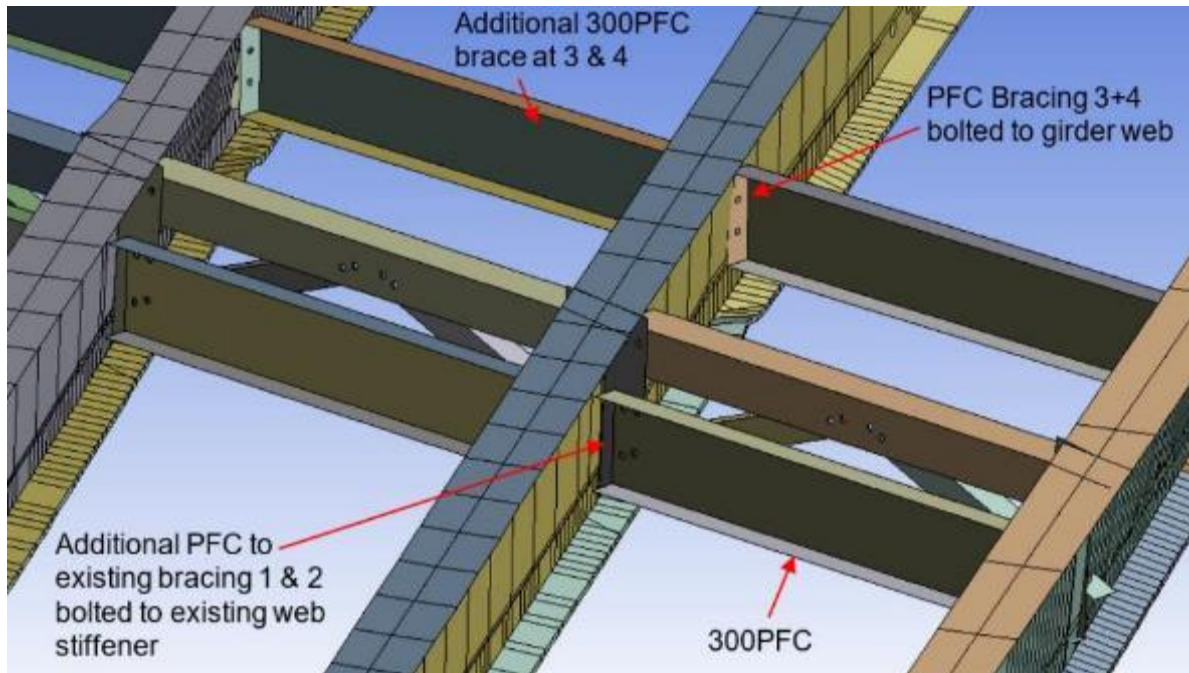
Figure 10 Option 2 – additional channels bolted to webs adjacent to existing cross-girders

2) Option 2: Install steel bracings bolted to the webs

- additional channel section bracings between girders both in the vertical and in the horizontal plane, and
- no repair of cracks or rectification of deformed girders.

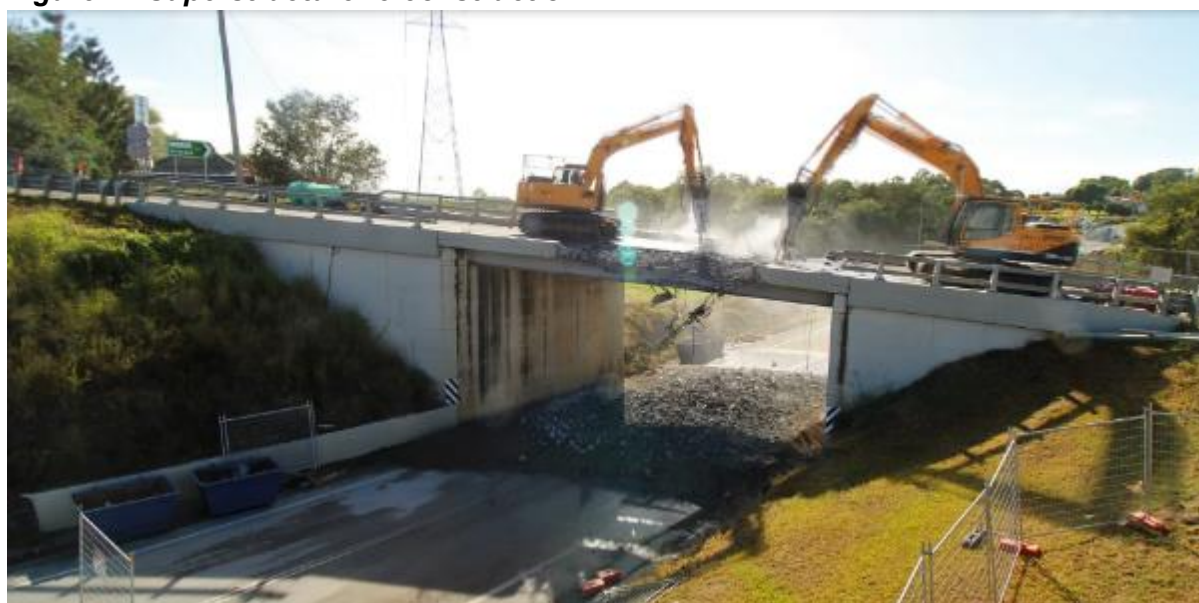
(a) Bridge concrete deck/slab demolition

The superstructure re-construction proceeded effectively, and was completed in just over 2 months, from February 2021 to April 2021. There were minimal changes to the design details during the construction. Figure 11 shows the demolition of the damaged superstructure.

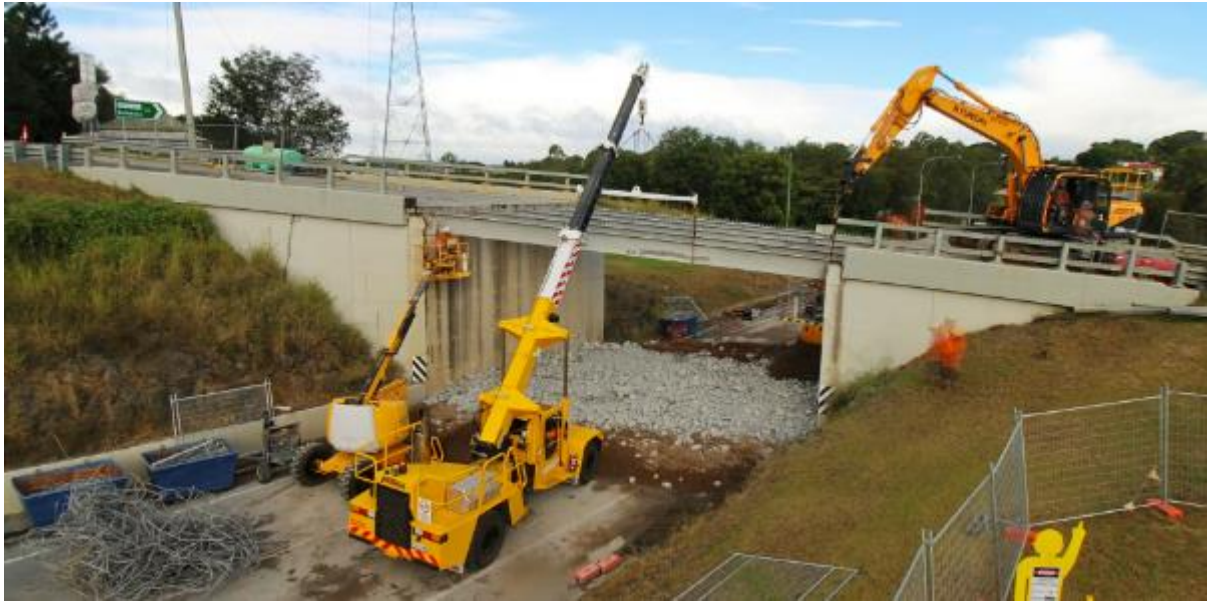
(b) Damaged steel girder removal
