# SA Water OCUs Performance Assessments

**Presenters: Paul Sproules<sup>1</sup>, Heath Georgeff<sup>2</sup>**

## OCUs Performance Assessments

Prepare report with collated data, observations and finding with recommendations for improvements ensuring optimal performance

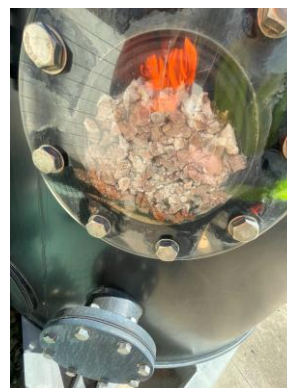
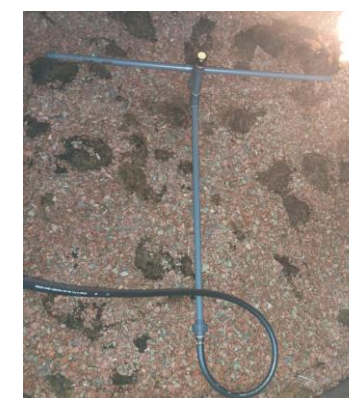
# WWPS184 OCU, Reliance Road, Hallett Cove

| Condition | Performance |
| GOOD | GOOD |

- H<sub>2</sub>S inlet: 6 ppm.
- Inlet volatile organic compounds (VOC): 1.5 ppm.
- H<sub>2</sub>S after biofilters: 0.48 ppm (92% removal) via spot sample measurements.
- H<sub>2</sub>S after carbon: 385 ppb

- Consideration of network ventilation and possible rectification of restricted airflow through collecting pump station manhole
- Renewal of blocked drains

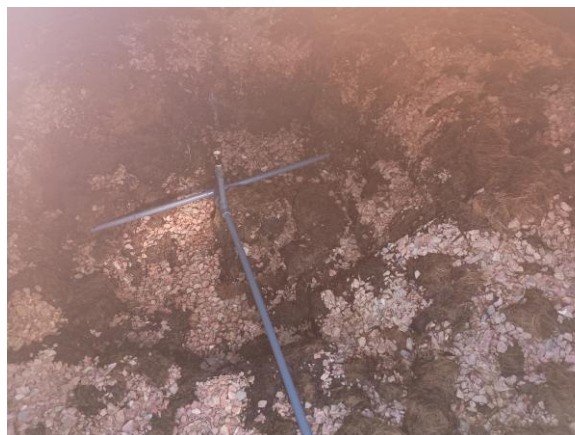
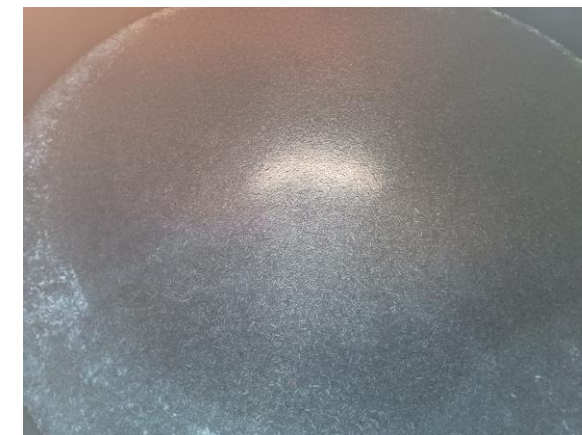
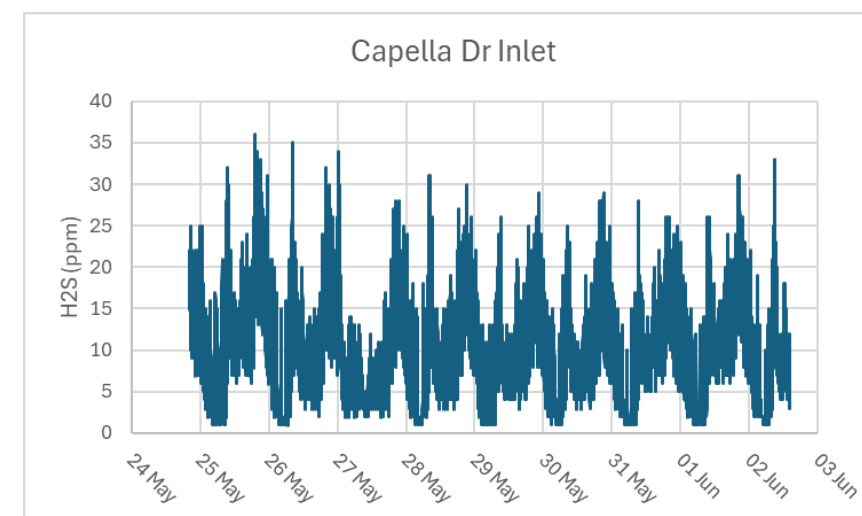
# WWPS282 OCU, Capella Avenue, Hallett Cove

- Inlet H<sub>2</sub>S: 9.7 ppm
- Inlet VOCs: 1.5 ppm
- Outlet H<sub>2</sub>S (post biofilter): 0.3 ppm (97% removal)
- Outlet H<sub>2</sub>S (post carbon): 570 ppb

| Condition | Performance |
| FAIR | GOOD |

- Investigate sump pump performance issue leading to flooding of sump.
- Fix blocked duct drain after the biofilter.
- Monitor carbon bed odour breakthrough and replace when required.

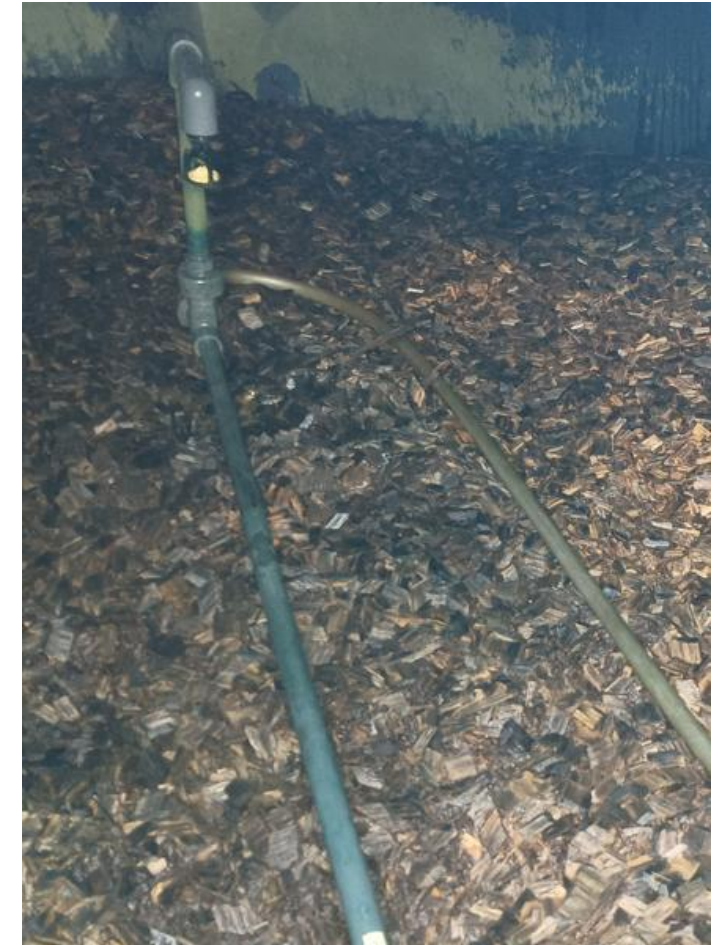
# WWPS021 OCU, Capelli Road, Wingfield

| Condition | Performance |
| FAIR | FAIR |

- Consideration of the restriction of foul air extraction from the sewer.
- Other items:
  - Replacement of the ductwork with FRP ductwork
  - Remedy of various leakage points
  - Renewal of the humidity sensors
  - Renewal of the H<sub>2</sub>S sample pump
  - Renewal of the irrigation rotameters

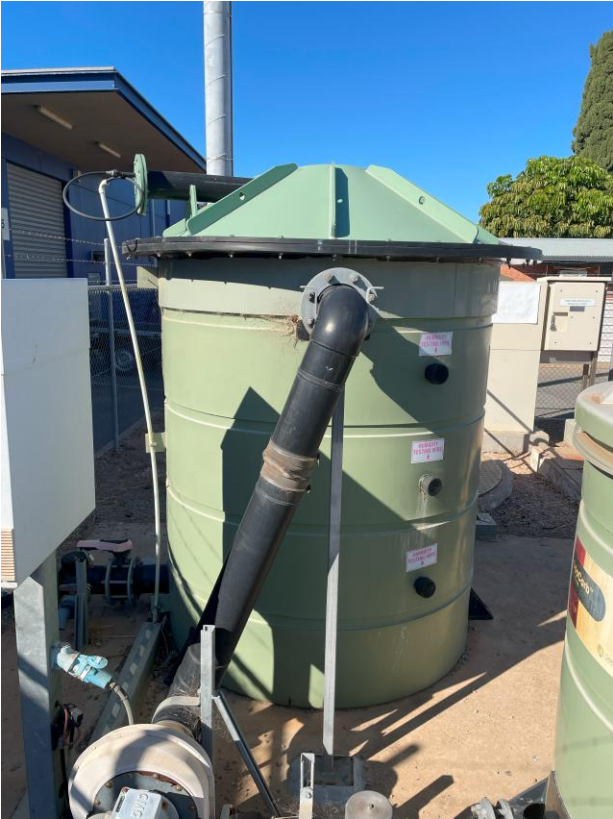
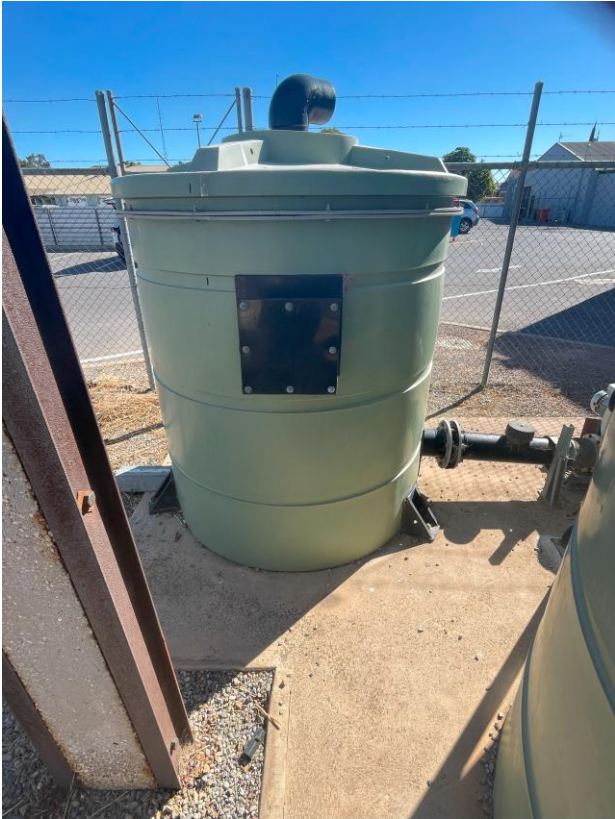
# WWPS17 OCU, Gertrude Road, Port Pirie

| Condition | Performance |
| POOR | POOR |

- Replacement of the biofilter media and checking of the irrigation rate and cycle.
- Replacement of the carbon media
- Repair of the hole in the site perimeter fence
- Replacement of the fan mounting
- Renewal of ductwork and expansion joints
- Rectification of the biofilter drain

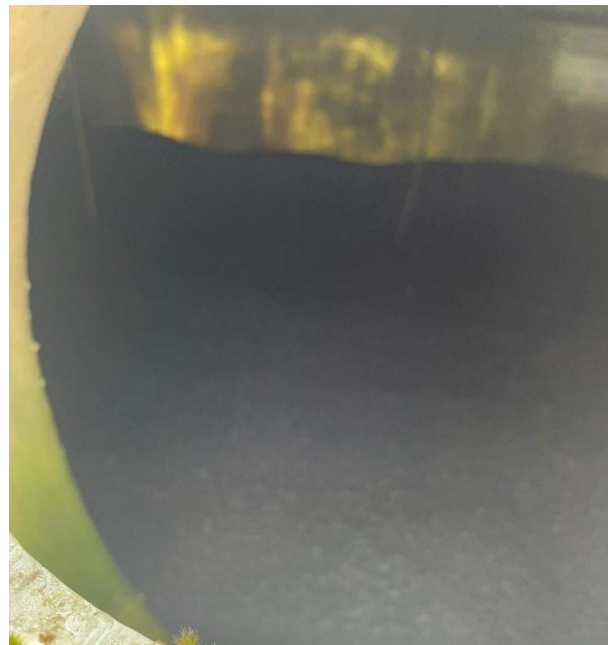
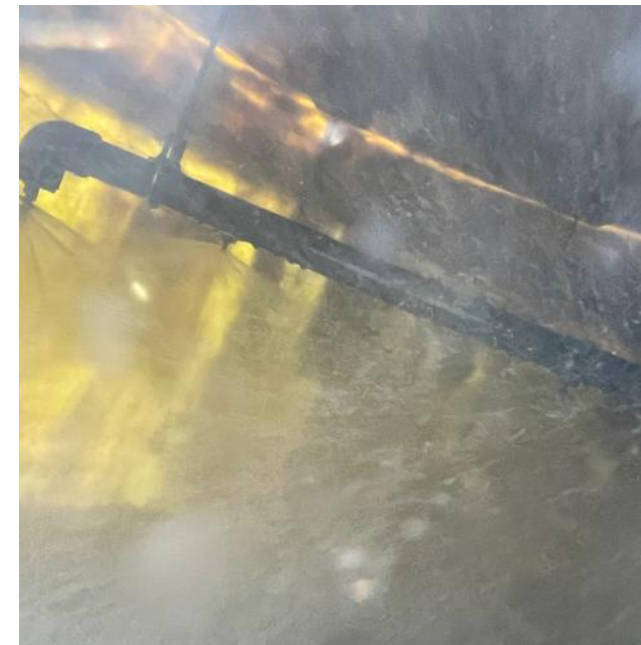
# OCU1, Teasdale Crescent, Parafield Gardens

| Condition | Performance |
| FAIR | FAIR |

- Renewal of:
  - leaking sampling ports
  - pressure indicators
  - dosing pump mounting and corroded cable tray
- Removal of an intrusive tree branch at top platform.
- Calibration of the Dräger Polytrons
- Consideration of sewer corrosion. High septicity is recommended to be addressed to prolong sewer life
- Although H<sub>2</sub>S removal is good, further assessment of possible BTF media compaction will determine if DP continues to rise leading to potential biomass degradation putting performance pressures on the system

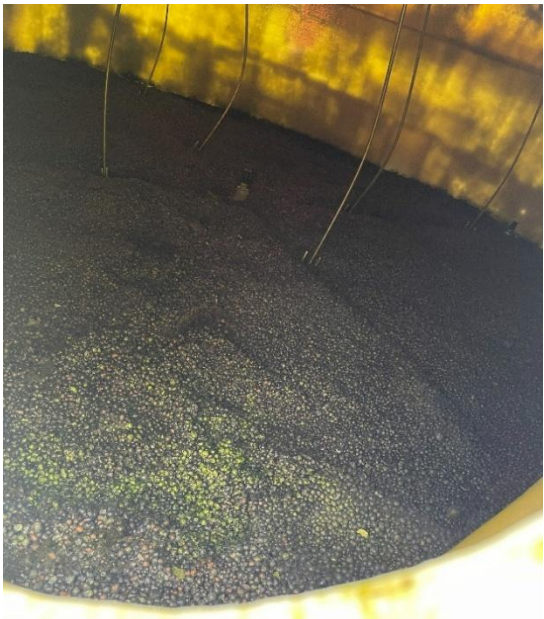
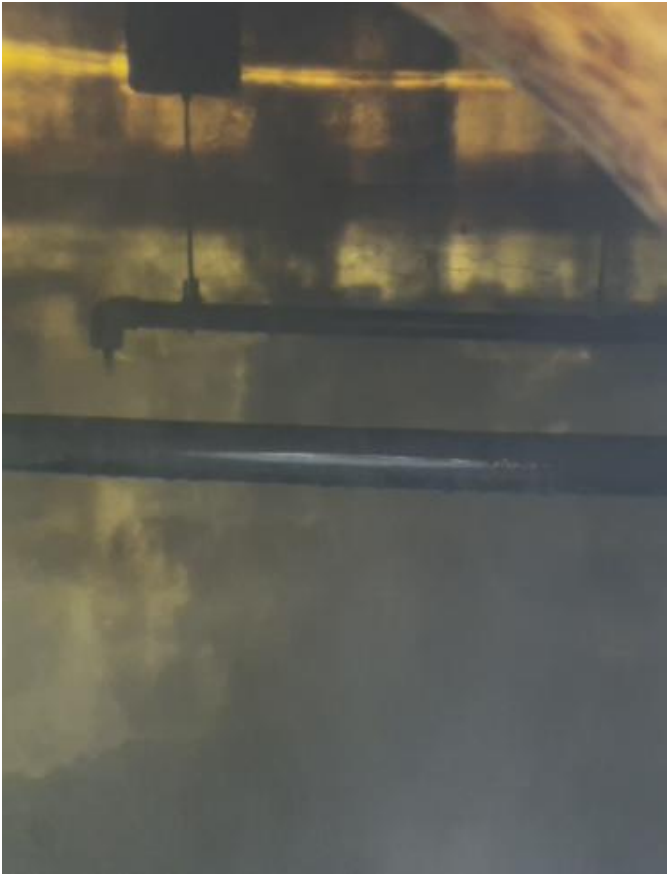
# OCU2, Shepherdson Road, Parafield Gardens

| Condition | Performance |
| FAIR | POOR |

***No complaints received from this site***  
***Issues related to undraw of air from the sewer***

- High sewer septicity to be addressed to prolong sewer life
- Calibration of the Dräger Polytron units
- Renewal of:
  - leaking sampling ports, pressure indicators
  - bypass duct condensate accumulation
  - repair delaminating vessel rib at rear of biofilter
- Immediate attention to compacted BTF media preventing full airflow through BTF
- Signs indicate biomass degradation and increased activated carbon media usage
