CABLE DUCT EXCAVATION USING A MECHANISED SHIELD AT KOLÍN RAILWAY STATION – AUTONOMOUS GEOTECHNICAL MONITORING OF THE TRACK SYSTEM

The project "Ensuring barrier-free access to the platform at Kolín railway station" aimed to rebuild the existing underpass beneath the platform in Kolín and to transfer the utility networks to a newly constructed cable duct in the immediate vicinity of the railway station. The 88-metre-long cable duct was constructed at the end of 2024 using a HERRENKNECHT mechanised bentonite shield with a diameter of 3 meters. The cable duct runs perpendicular to 16 transport tracks in a geological environment of fluvial sediments of the Elbe River. The fillings and weathered orthogneiss have a cover thickness of approximately 5 meters and the entire length of the excavation is below the groundwater level. The excavation was carried out during full operation, which is why the proposed geotechnical monitoring activities were particularly important for ensuring the safe progress of construction and monitoring the impact on its immediate surroundings. Construction monitoring was carried out using automatic IOTIN tilt sensors from INSET s.r.o. and levelling measurements

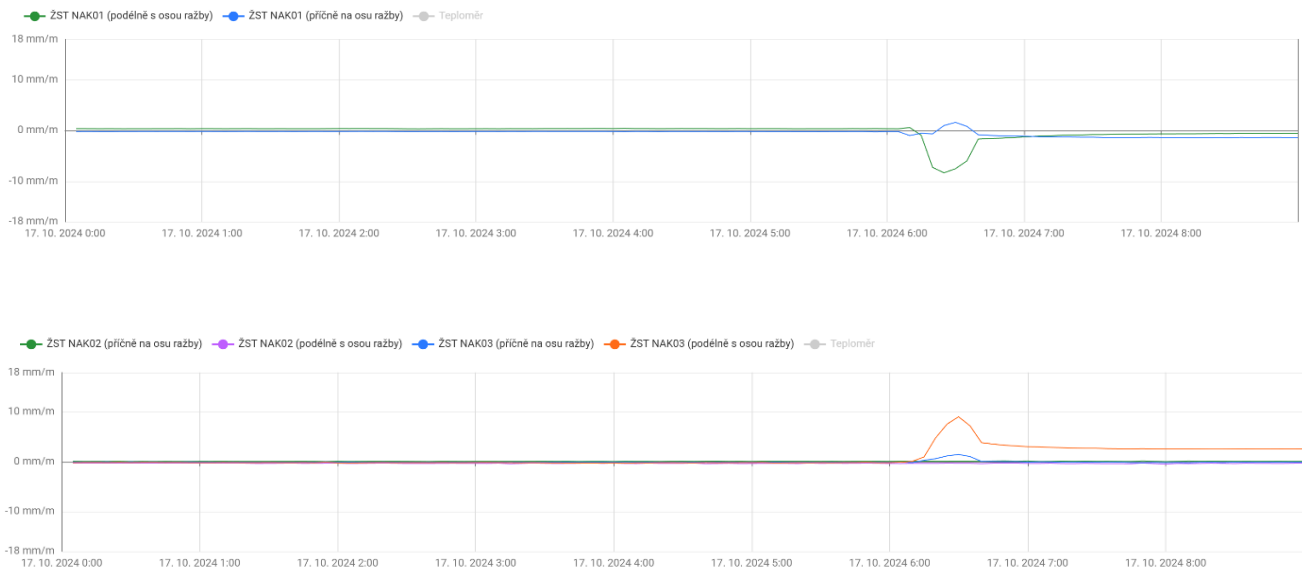
Even before the actual excavation with a mechanized shield, the first round of grouting on October 17, 2024, caused deformation of the overburden due to jet grouting in the vicinity of the launch shaft. The first warning level was exceeded on the adjacent mast marked 268A and the signal marked Lc116c, which was well documented in relation to the zero measurement, as can be seen in the graph in Figure 4. The leveling measurement even showed a rise of +27.42 mm (3rd warning level = ± 15.00 mm).

Figure 4: Graphical output from measurements taken by the tilt sensor on mast 268A.

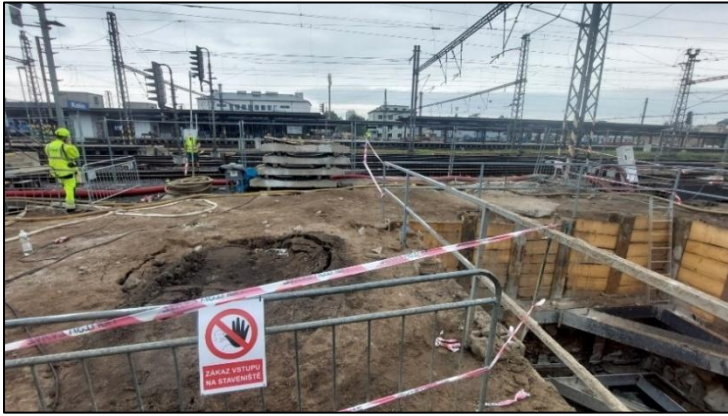
During the excavation of the launch shaft itself, despite all the special foundation work, on November 25, 2025 (depth of the clean excavation of the shaft approx. 9.2 m below ground level), large volumes of fine-grained material (fluvial sandy sediments and clayey soils) washed through the shoring and bottom of the construction shaft. This occurred to such an extent that the surface outside the retaining wall collapsed (Fig. 5). It was then necessary to flood the construction shaft to approximately two-thirds of its depth (Fig. 6) to prevent its bottom from breaking through. This was followed by a second round of jet grouting, which successfully sealed the sources of the leaks. As these were locations outside the operational track, it was not necessary to take any measures related to train operations.

Figure 5: Surface subsidence at the launch shaft.

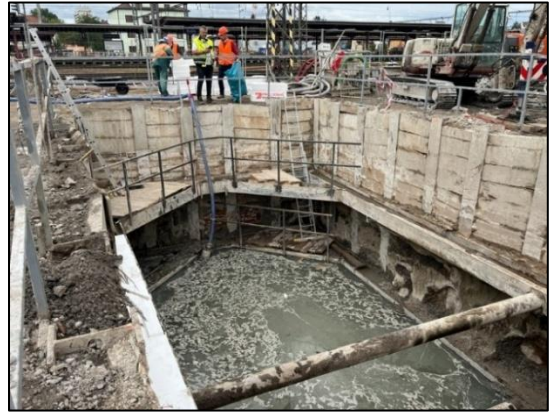
Figure 6: Flooding the shaft to prevent bottom break through.

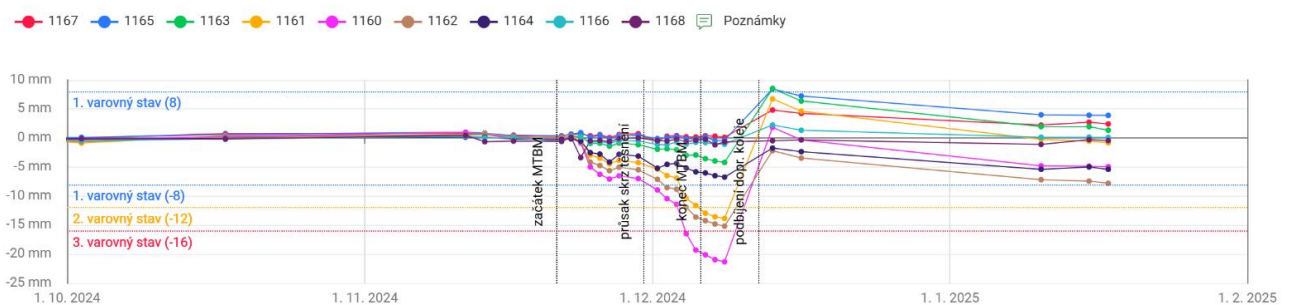
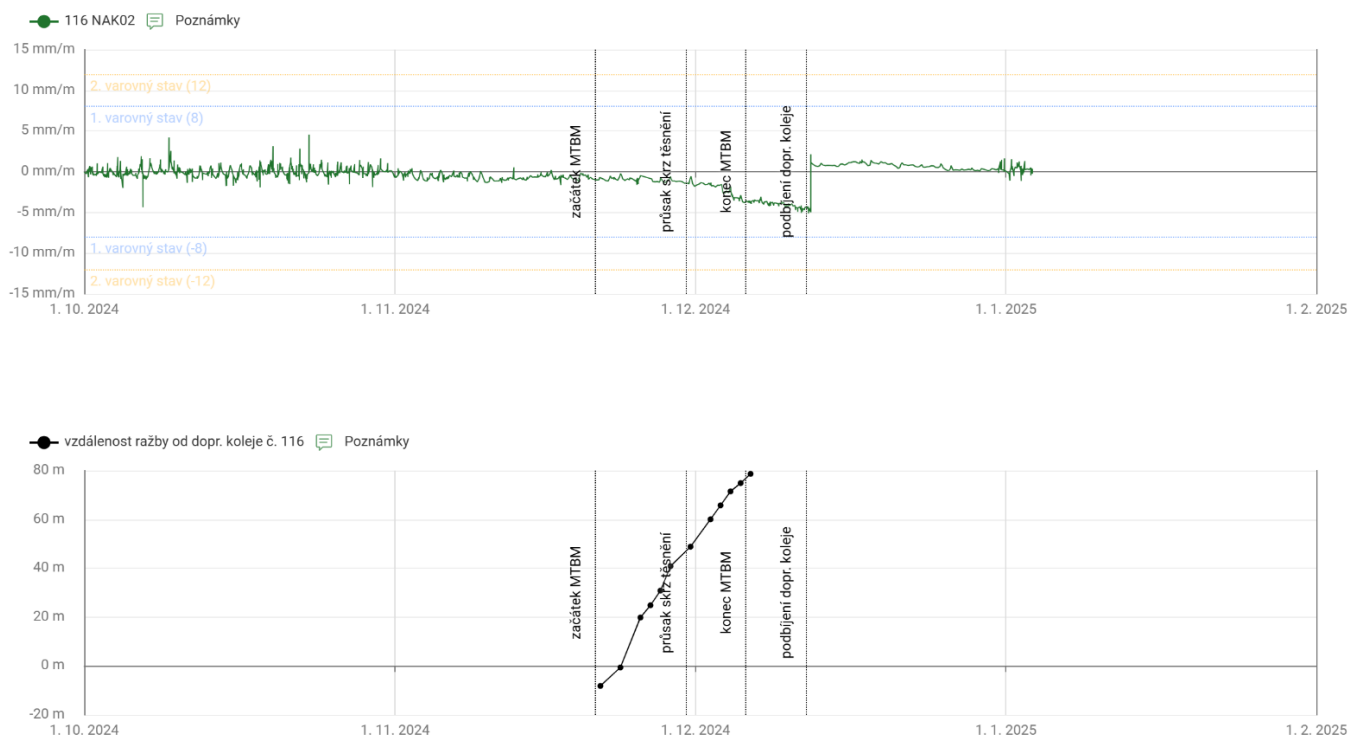
In the first 40 meters from the starting shaft, the mechanized excavation itself did not have a significant impact on the subsidence of the transport tracks. One of the largest subsidence events in this section was recorded on track No. 116 at a stationing of 8.1 m from the starting shaft in connection with massive groundwater seepage through the seal between a pair of segments. The seepage was probably caused by poor contact between the concrete section and the seal. The total change in the measured tilt values in the X direction was ± 4.80 mm/m (1st var. state = ± 8.00 mm/m), while the tilt measurements in the Y direction reached maximum values of ± 1.80 mm/m (1st var. state = ± 2.00 mm/m) (shown in Fig. 6).

As part of the levelling measurement, the leakage between the two segments manifested itself in a drop in the measured track, when on December 1, 2024, the first warning level (= -8.00 mm) was exceeded with a measured value of -8.95 mm in the excavation axis. Three days later, the third warning level (= -16.00 mm) was exceeded with a measured value of -16.47 mm. The overall drop was also influenced by the subsequent pushing through of the remaining segments, with a value of -21.31 mm measured on December 8, 2024 (Fig. 6). Subsequently, the transport track was underpinned and its safety assessed in terms of GPK (geometric position of the track). The measured values in the excavation axis gradually stabilized at around -5.00 mm.

Figure 6: Graphical output of the levelling measurement of track No. 116 and measured values on the 116 NAK02 tilt sensor in the X direction.
