RECONSTRUCTION OF THE DOLNOLUČANY TUNNEL, FROM INITIAL IDEAS FOR SOLVING LEAKS TO THE CONSTRUCTION OF A NEW TUNNEL

L. Mařík

SAGASTA s.r.o., Prague, Czech Republic

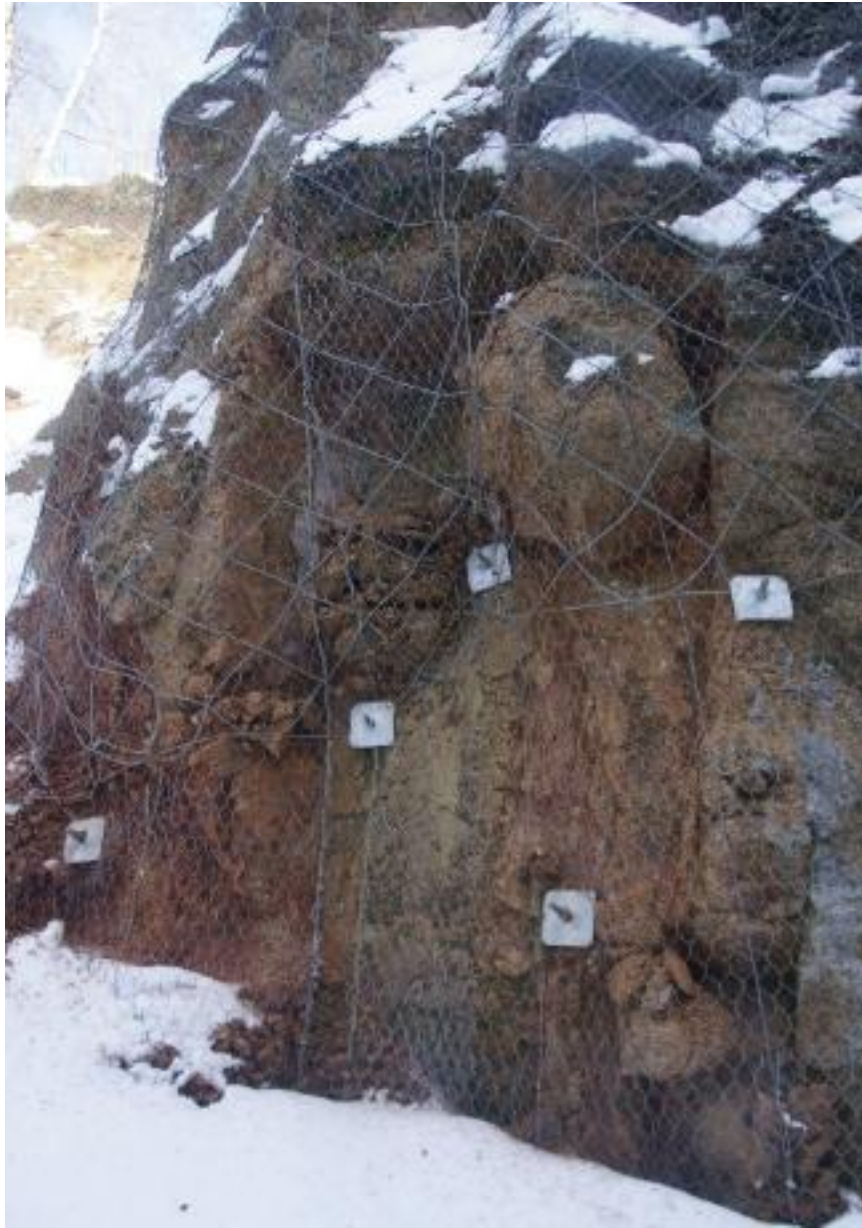
by weathered and wind-eroded rock, and there are also sections with completely decomposed rock over the entire height of the walls. Blocks of rock are still being released from the steep walls of the rock cut, which, without securing, threaten the safety of traffic. Figure 2 shows a loose block of rock from the side of the rock cut caught in a high-strength net.

Figure 2 Rock block caught in a high-strength net on the side of the rock cut

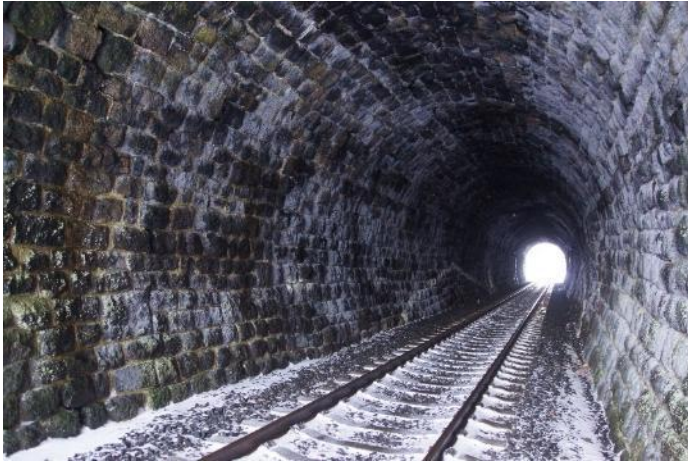
The entire length of the tunnel tube is secured with granite block lining. The masonry is heavily saturated, and the tunnel's waterproofing and drainage systems are non-functional. Fissure water infiltrates the tunnel and the rock cuts at both portals, manifesting as significant leaks and the leaching of mortar from the joints. Locally, this process compromises the stability of individual lining blocks. In certain sections, rock pressure causes slight bulging of the masonry on the sidewalls. However, the tunnel remains stable as a whole, and the structural integrity of the lining is not compromised, as shown in Figure 3. In portal sections P1 and P2, significant transverse cracks (up to 30 mm wide) are present in the vault, as illustrated in Figure 4. In these sections, the joint mortar has deteriorated, and the surface of the masonry blocks is weathered.

Figure 3 Condition of the brickwork during the dry season

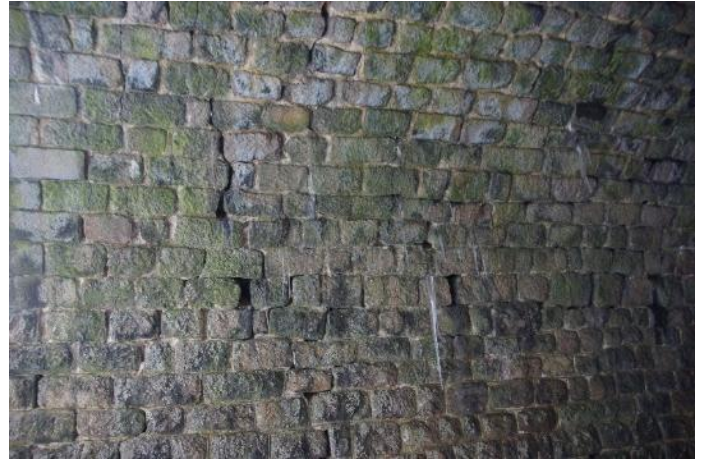
Figure 4 Vertical cracks in the lining

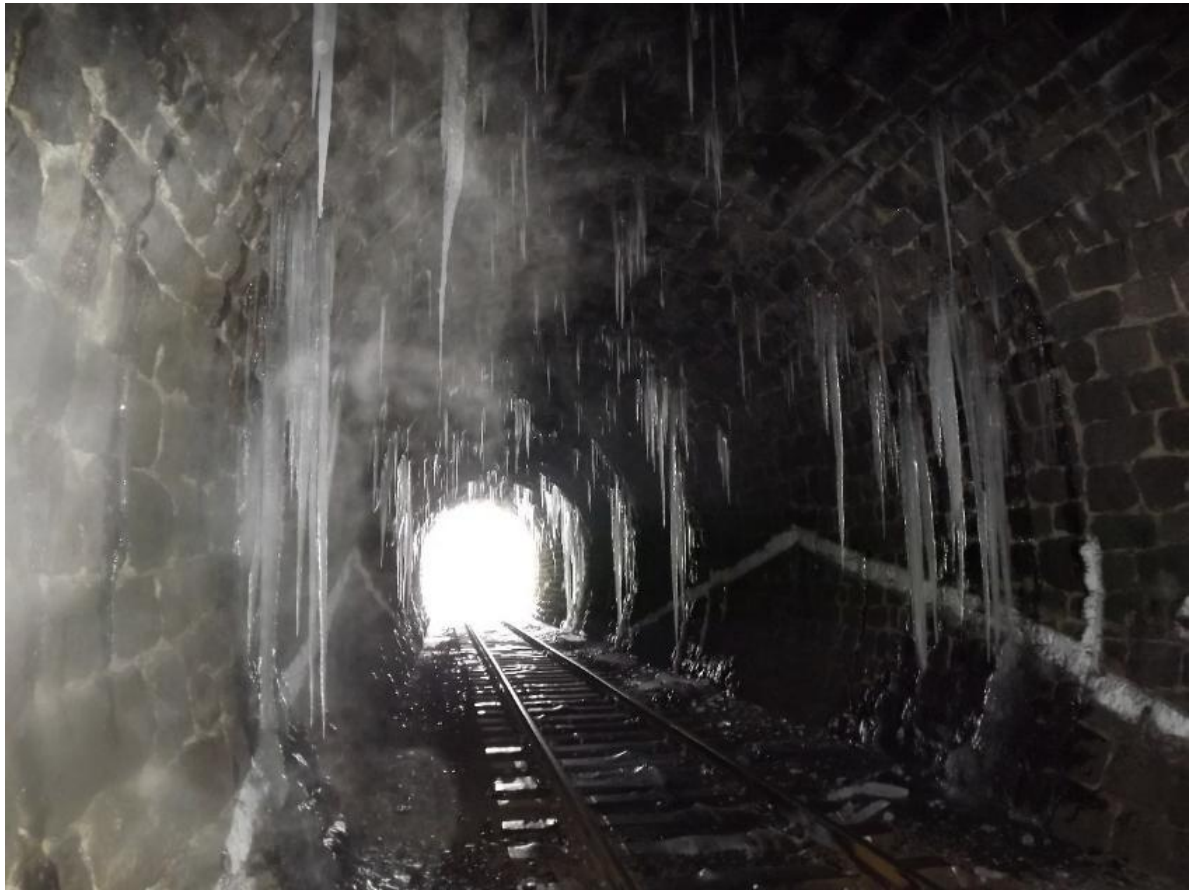
Due to the shallow overburden and the nature of the rock mass fracturing, the entire tunnel is significantly affected by climatic conditions. Surface rainwater appears within the tunnel with a minimal time lag. During the spring thaw, when the rock mass in this mountainous area is continuously saturated, the issue becomes more persistent. The formation of icicles and icefalls, which can reach as far as the track, necessitates daily maintenance. The condition of the tunnel during the winter season is illustrated in Figure 5.

Figure 5 Massive icing of the tunnel due to groundwater seepage

This situation negatively impacts the operating costs associated with ensuring operational safety. Detailed inspections indicate that the lining in the vault is saturated, with water infiltration occasionally manifesting as heavy dripping or "raining." Given the tunnel's length and the environmental conditions at the portals, the entire interior of the tunnel freezes during winter. Consequently, the lining throughout the tunnel exhibits defects similar to those in the portal areas, specifically loose masonry joints and surface-wide seepage. The technical condition reflects the tunnel's age and the fact that neither the supporting structure nor the waterproofing and drainage systems have been renovated during its service life.

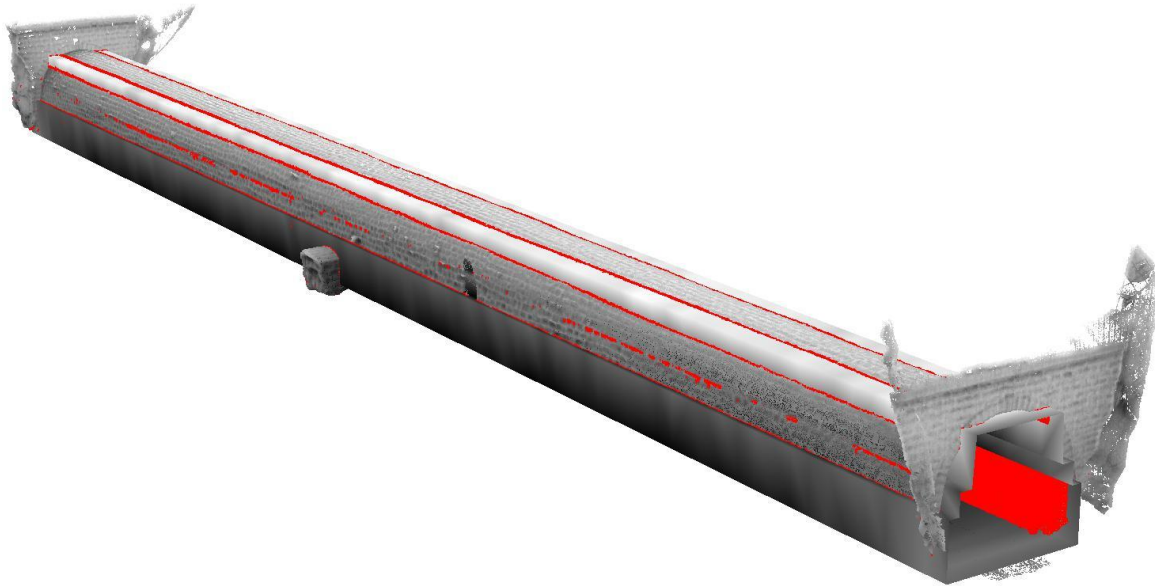
The CloudCompare software was utilized to analyze the geometric relationship between the clearance envelopes and the lining face. The program performs a numerical evaluation of the entire lining surface, allowing for visual inspection on a 3D model. An example of clash detection (collision points) between the lining face and the clearance envelope is shown in Figure 6..

Figure 6 Evaluation of collisions between the clearance gauge and the 3D point cloud model of the lining face

This process ensures that all interferences between the clearance gauge and the tunnel are reliably detected. Due to the confined space within the tunnel, the clearance gauge was modeled with zero tolerance, even though a 50 mm tolerance is typically standard. Nevertheless, the 3D model evaluations demonstrated that without altering the geometric alignment of the track, spatial clearance cannot be guaranteed for any of the tested gauges. Since the adjacent track sections preclude any change in the track's position, it was evident that no measures could be implemented under the existing vault that would further encroach upon the clearance envelope.

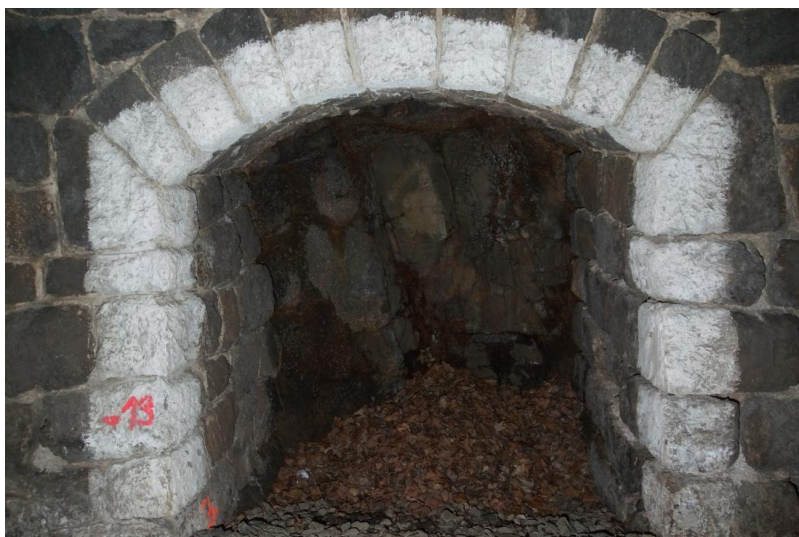
The assessment of the rock mass behind the tunnel lining was conducted via ventilation openings situated within the lining. Out of the 81 investigated openings, the nature of the rock could be determined in 48 of them. In the remaining 33 locations, backfill or packing was found filling the void between the lining and the excavation face. The only locations where the exposed rock mass is visible within the tunnel are the rear walls of two rescue refuges, as shown in Figure 7.

Figure 7 Rock in a rescue niche

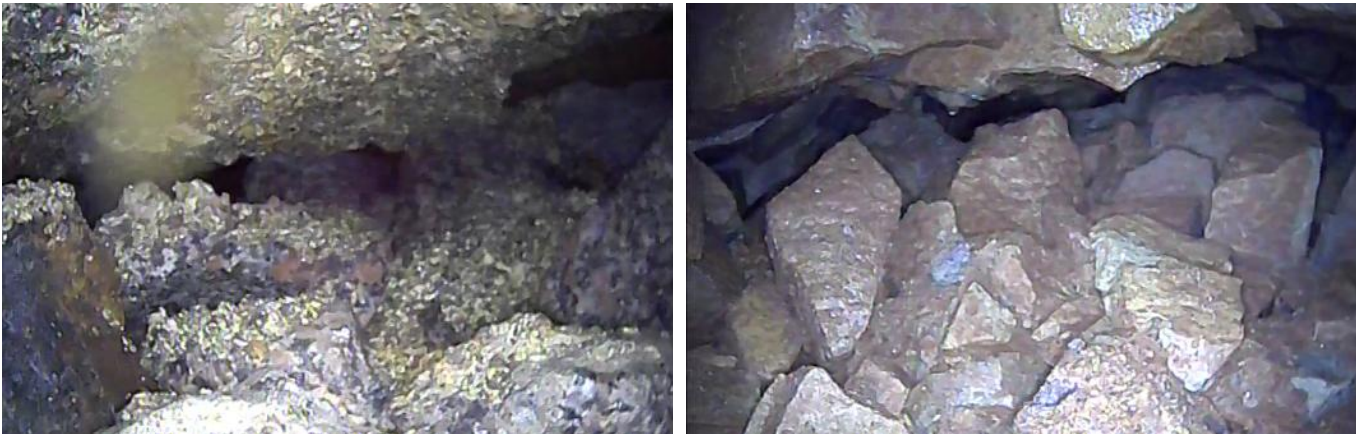
In all boreholes, a void was identified between the back of the existing lining and the excavation face. This indicated that the lining had not been "activated" at the crown; the excavation had remained stable for 125 years even without direct support from the lining in that area. The camera survey revealed rock fragments within the cavity, some originating from the original packing (backfill) and others apparently resulting from spalling off the unsecured excavation face. Figure 14 presents two of the twelve images from the camera survey behind the tunnel lining. Core samples taken from the boreholes were used to determine the geomechanical strength characteristics of the rock mass, which served as the basis for the final stability design of the enlarged excavation.

Fig. 14 Cavities captured by the camera behind the original tunnel lining

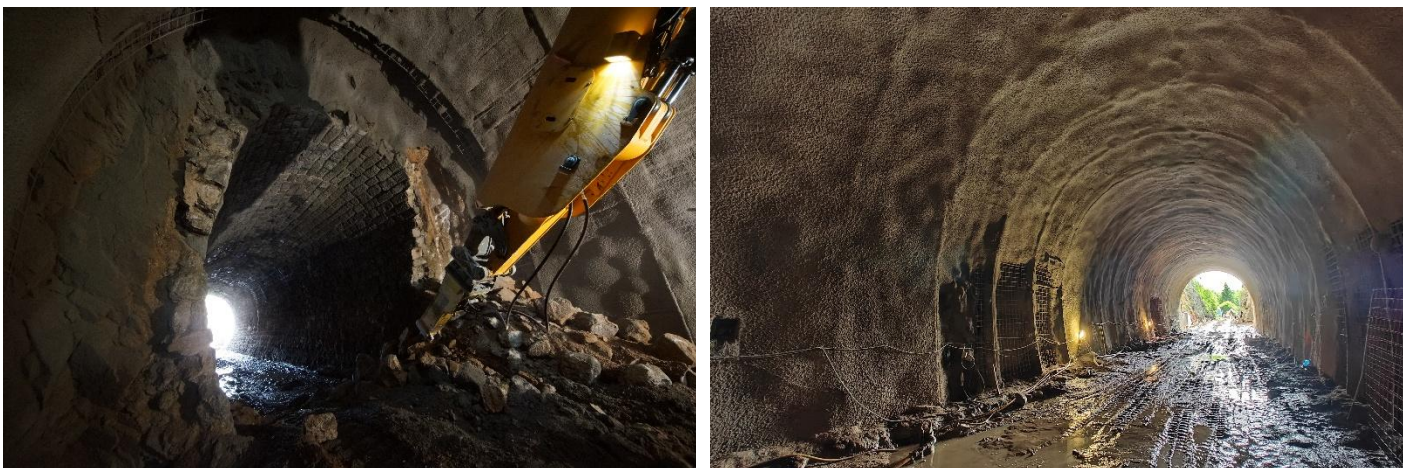
Fig. 17 Demolition of the existing tunnel lining and securing the enlarged excavation with primary lining

All operations had to be conducted with access to only one portal, meaning the opposite portal could only be reached through the tunnel itself. The excavated ballast and track panels removed from the railway superstructure had to be transported to landfills outside the construction site. The exposed formation level (after the removal of the superstructure) served as parking for construction machinery and as the primary access road to the portal. During the widening of the rock cuts, the predicted presence of fractured and weathered granodiorite was confirmed; nevertheless, it was possible to maintain the excavation geometry as envisioned in the design. The enlargement of the rock mass to the projected excavation profile was initially performed using a tunnel excavator. However, as the distance from the portal increased and the rock quality improved, drill-and-blast methods had to be employed. Works progressed from the Tanvald portal. The use of lattice girders (truss frames) and steel wire mesh ensured the structural integrity and geometry of the primary lining (see Figure 17).

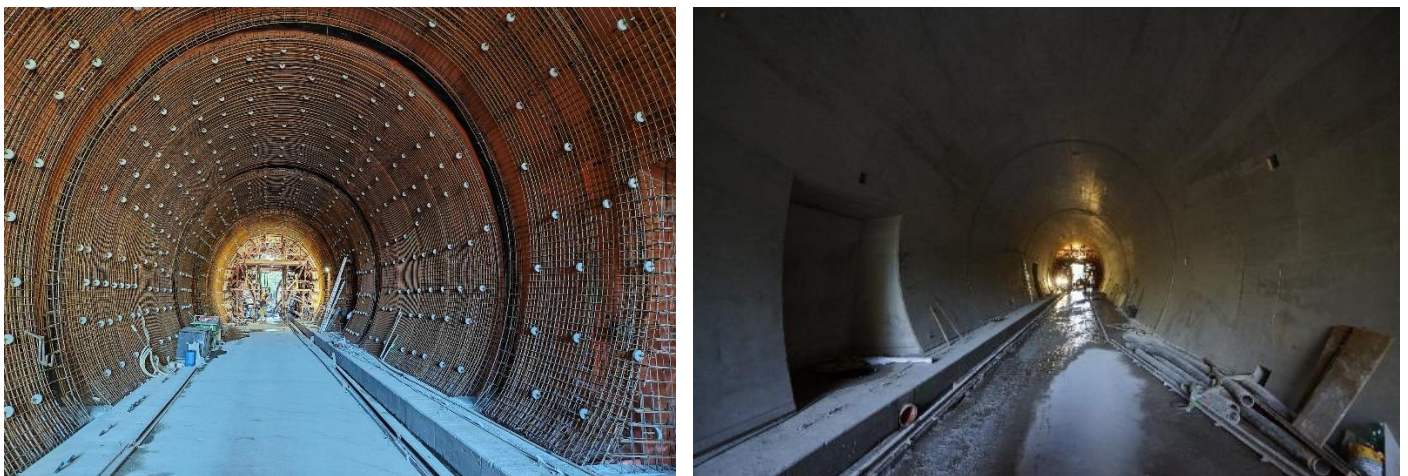
Fig. 18 Reinforcement and concreting of the secondary lining

A total of nine concrete blocks, each with a length of 10 m, were cast. The secondary lining, with a thickness of 300 mm, was reinforced along the entire length of the tunnel and constructed using C 25/30 XC1 XF1 concrete. The portal collars (P1 and P2) were designed using C 25/30 XC2 XF3 XA1 watertight concrete.
