GEOTECHNICAL MONITORING DURING THE CONSTRUCTION OF BARRIER-FREE ACCESS TO THE JIŘÍHO Z PODEBRAD METRO STATION

M. Čermák, B. Pavelková, R. Morávek
INSET s.r.o., Prague, Czech Republic

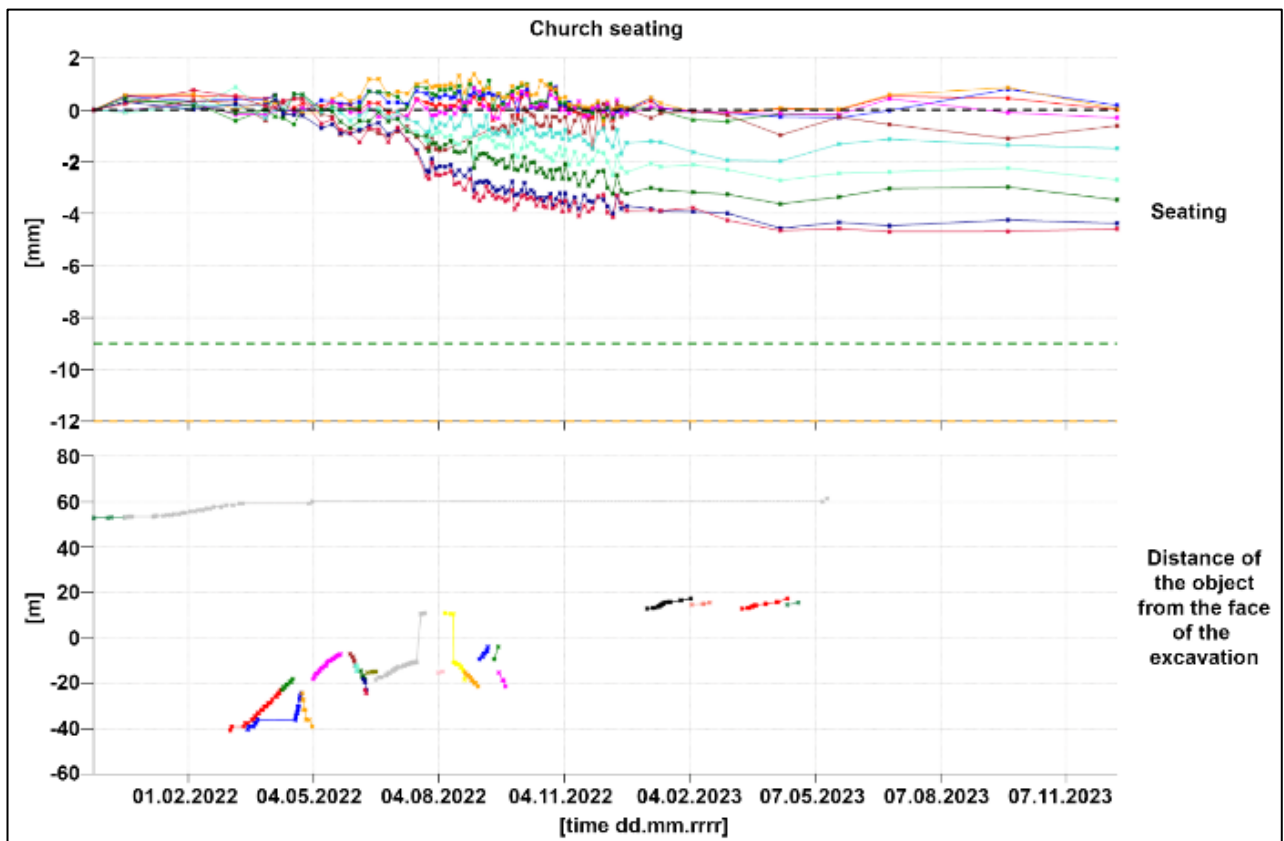
From the measurements taken and their development (Figure 3), it is clear that even the first warning level was not exceeded by a sufficiently large margin (see Table 1). The highest settlement value was near the excavations, i.e., the southeast corner of the church, which was in line with expectations. For this reason, a higher number of monitoring elements was proposed for this area. Figure 4 shows the settlement isolines at the end of the measurement. The measuring points, together with the data transmission equipment, were also selected with regard to the operation of the church itself and to avoid significant interference, such as from visitors walking around. An example of the installation is shown in Figure 5 and the measurement results in Figure 6.

Figure 3: Settlement of the church depending on the execution of excavation and tunneling

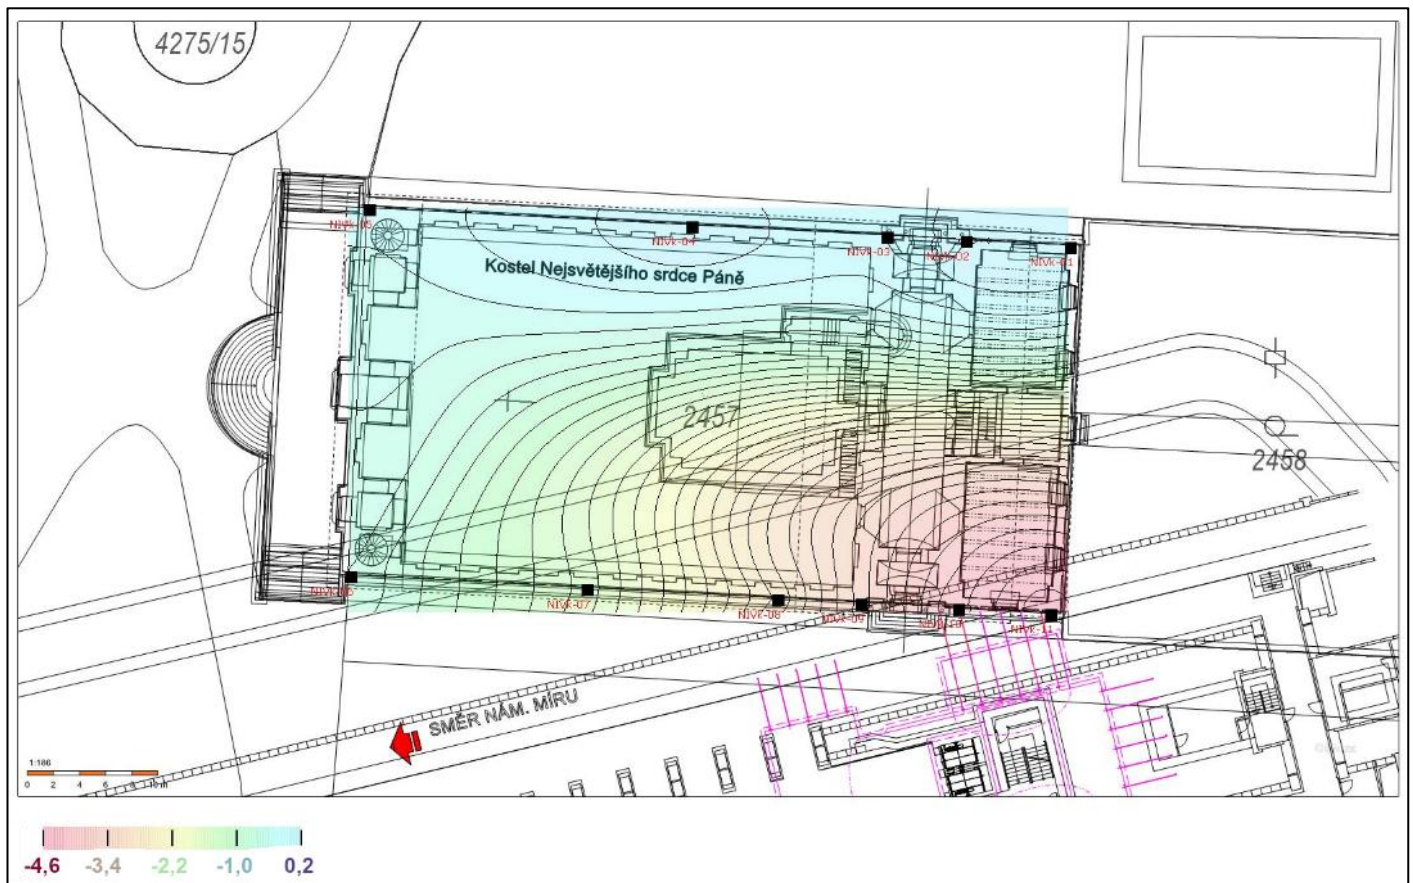
Figure 4: Contour lines showing the settlement of the church at the end of the measurement (on December 14, 2023)

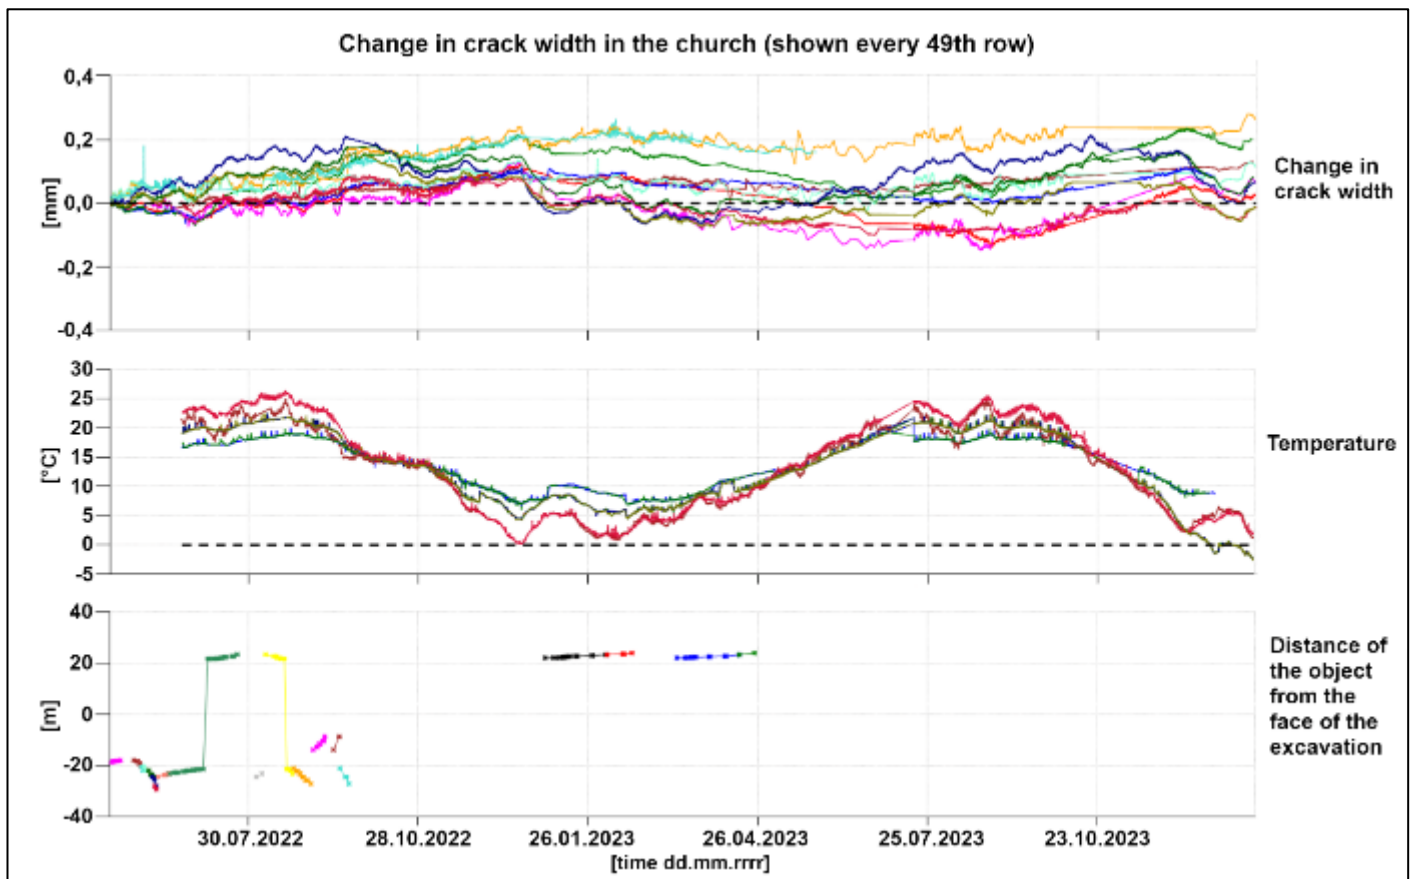
The measured changes in crack widths from automatic measuring devices in the church were not significantly affected by temperature. At the same time, no significant correlation with construction activity was measured. The measured values were well below warning levels – see Figure 6 and Table 1. Simultaneously with the measurement of crack width changes, the temperatures of the measured structure were also measured at these locations. Figure 6 shows how the church tower is significantly affected by temperature changes, and the maximum and minimum temperatures were measured at the same time at a point in the tower (shown in red in the graph).

Figure 6: Measured changes in crack widths in automatic mode, measured temperatures for individual gauges, and construction progress

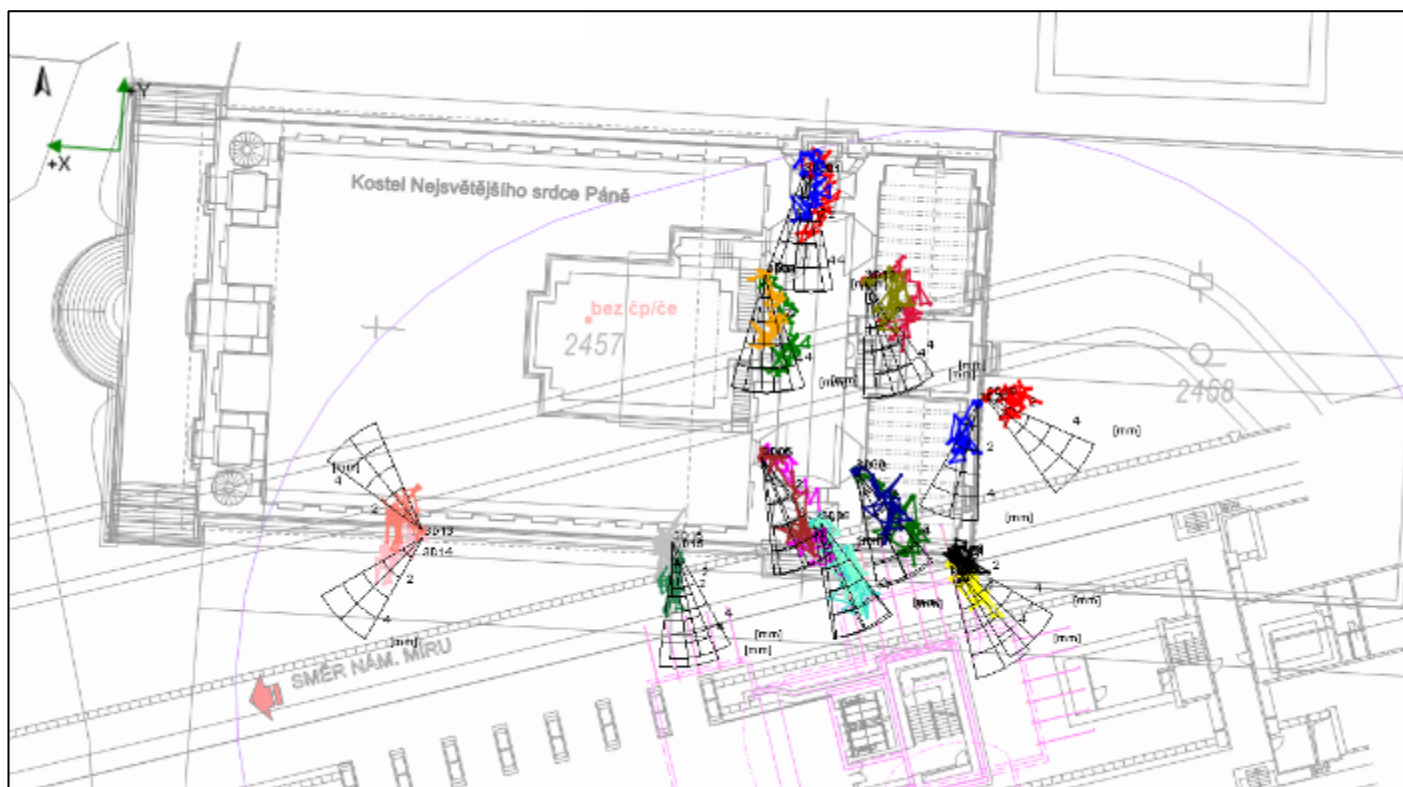
An article in *Tunel* magazine (ČERMÁK, M., PAVELKOVÁ, B., MORÁVEK, R., 2014) presented a cross-section showing the deformations of the church towards the building structure, based on measurements of positional points on the facade of the building. In Figure 7, we supplement this with deformations in the floor plan, which correspond to the settlement of the building in Figure 4 and show deformations towards the station's transfer corridor, i.e., there was uneven settlement and tilting of the church towards the excavations.

By measuring the positional points on the church facade and measuring the automatic inclinations (after compensating for the influence of temperature on the measured values), similar inclination curves towards the building were found. The inclination of the church was presented both in relation to the terrain and as the difference in deformation values from points above each other, which eliminated some measurement errors and made the graphs significantly "smoother" and the reported deformations smaller. The maximum measured and calculated values with warning conditions are listed in Table 1.

Figure 7: Fans showing the direction of deformation at positional points on the church facade (always two points above each other, inclination relative to the terrain)

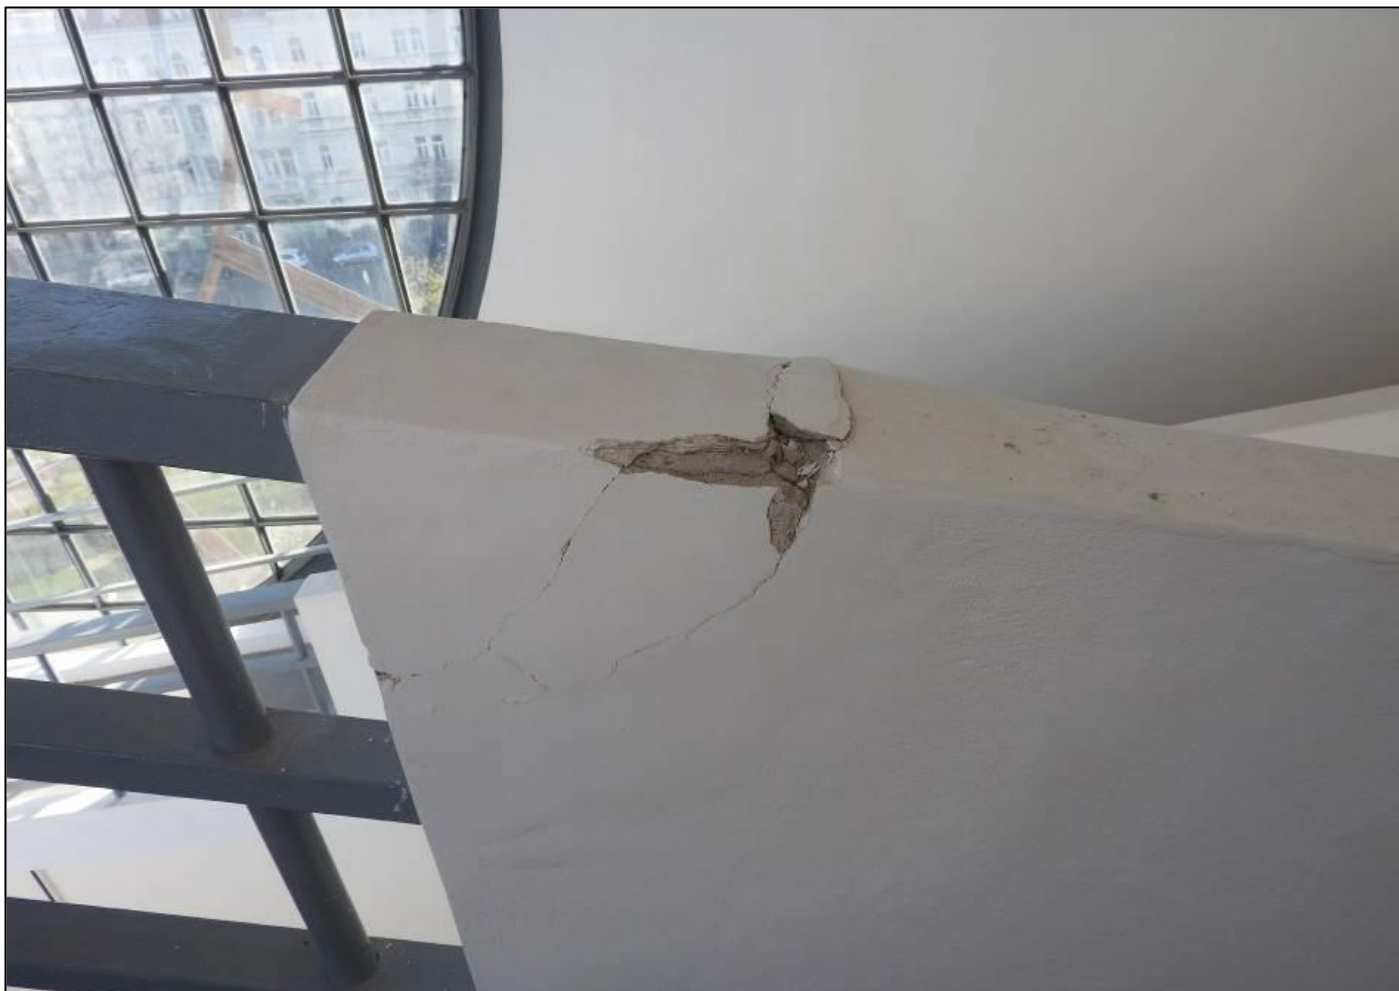
During the inspections carried out in the church, new cracks were documented, but these were more likely cracks that commonly occur in connection with annual temperature fluctuations and the drawing of older cracks, which were only painted over or were in places where they could not be associated with the construction work being carried out. The temperature fluctuations themselves are significant in the church – see the temperature measurements taken by automatic deformometers, which show differences of up to 30 °C or even higher (measured over less than two annual cycles). Due to the temperature, the most significant damage occurred in the area where the ramp railings are anchored, which are located in

the tower at the level of the glass clock – similar damage gradually began to appear to a lesser or greater extent in other parts of the ramps (Figure 8).

Figure 8: Damage at the point of attachment of the ramp railing due to temperature

After the measurements were completed, all areas where the structure had been altered due to the installation of measuring points were repaired by a specialist company that had already carried out repairs on the church. This involved the use of materials and colors approved by the Department of Monument Preservation and the parish – this mainly concerned the holes left by the points in the mortar between the bricks on the facade. This restoration work was first carried out by an employee of an external company from a platform and then, after instruction by our employees, by climbers on the tower.

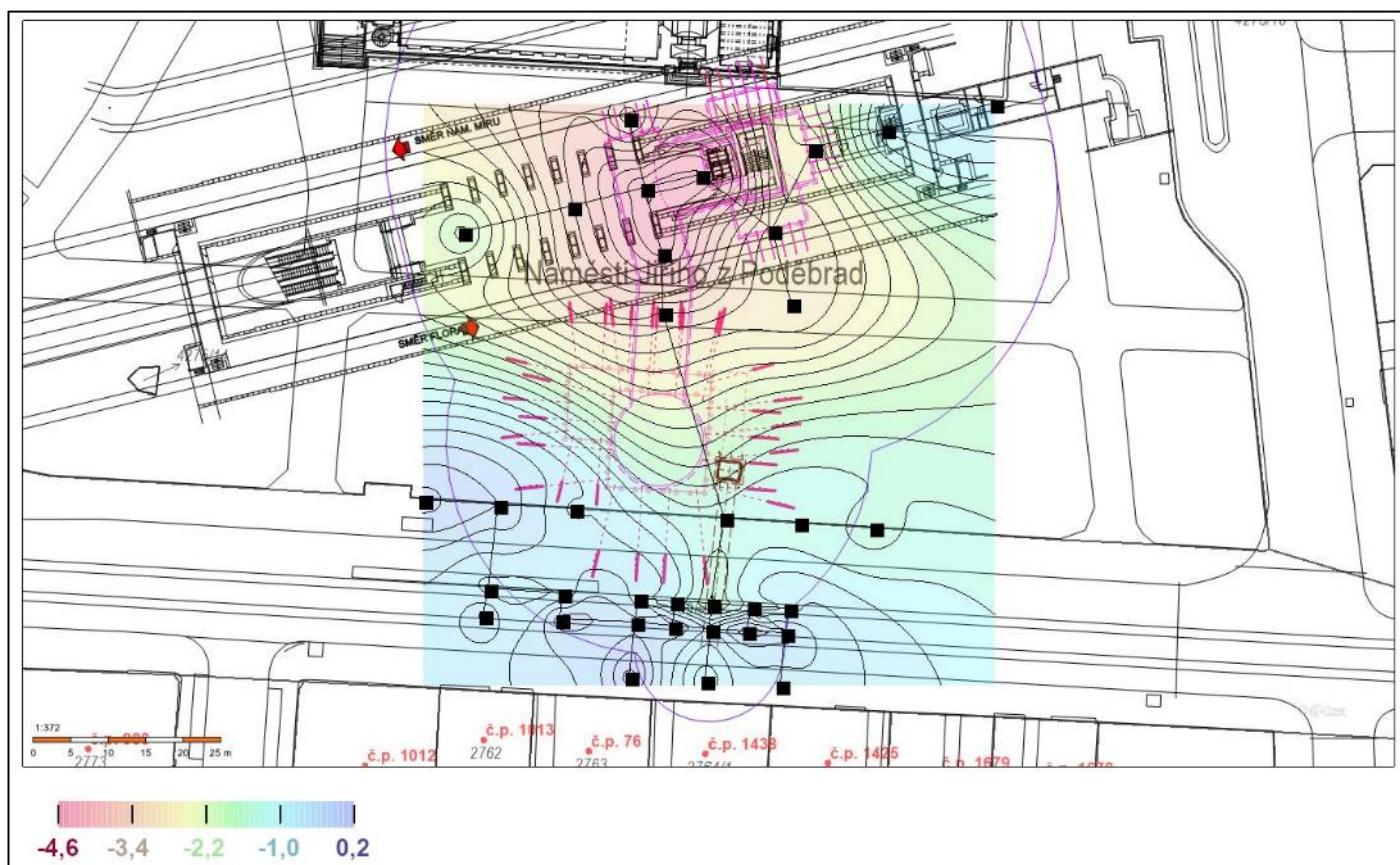
Figure 9 shows the contour lines of terrain settlement from the leveling points. The area where the greatest subsidence occurred corresponded to the most demanding excavation sites, namely above the transfer corridor from which excavations were carried out towards and from the church and the excavation of the shaft connecting the transfer corridor level and the platform level.

Figure 9: Contour lines of terrain subsidence at the end of the measurement (on May 13, 2024)

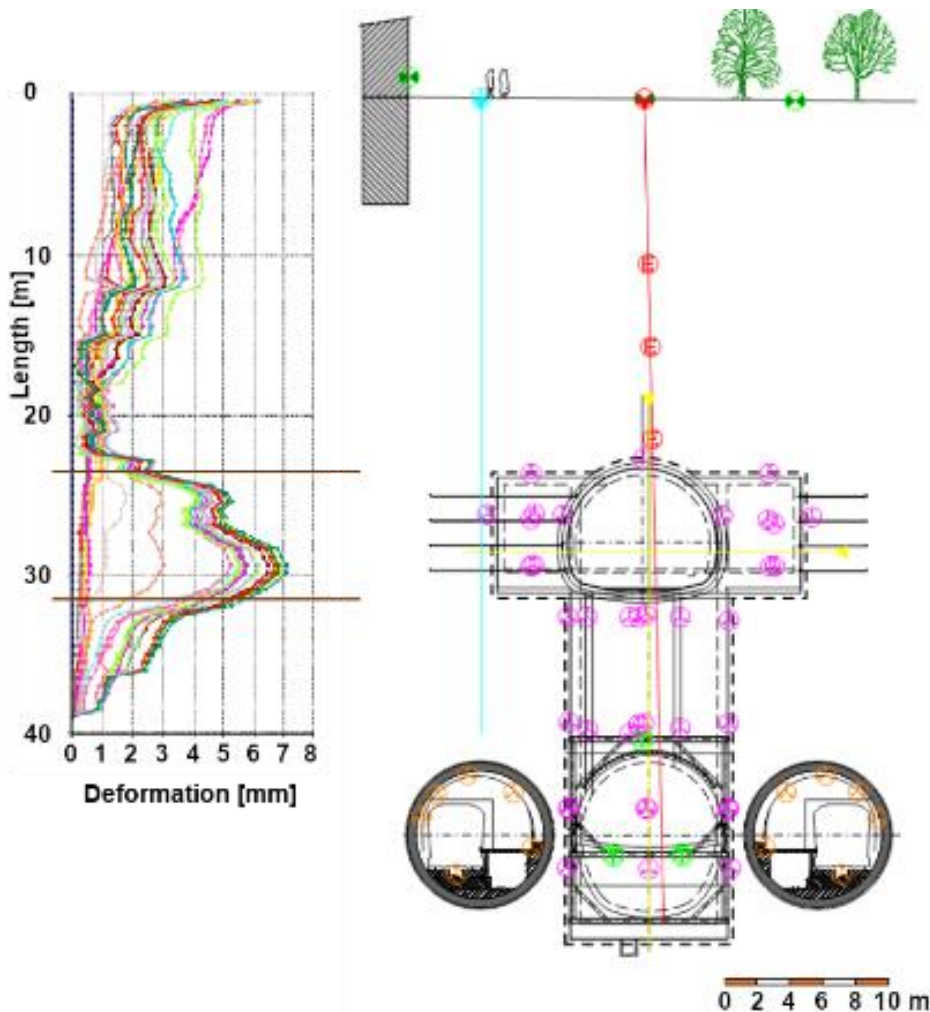
The location of the borehole had to be adapted to the presence of a water main, and the depth of the borehole was terminated above the station tunnel. The left part of Figure 10 shows the total horizontal deformations as sums relative to the fixed base of the borehole. Due to the progress of shaft excavation and tunneling at the platform level, these were no longer measurements with a fixed base.

Figure 10: Measurement results in the inclinometer borehole – on the left, the deformation vector corresponding to this section, and on the right, a section from the Sahure information system (borehole shown in turquoise).

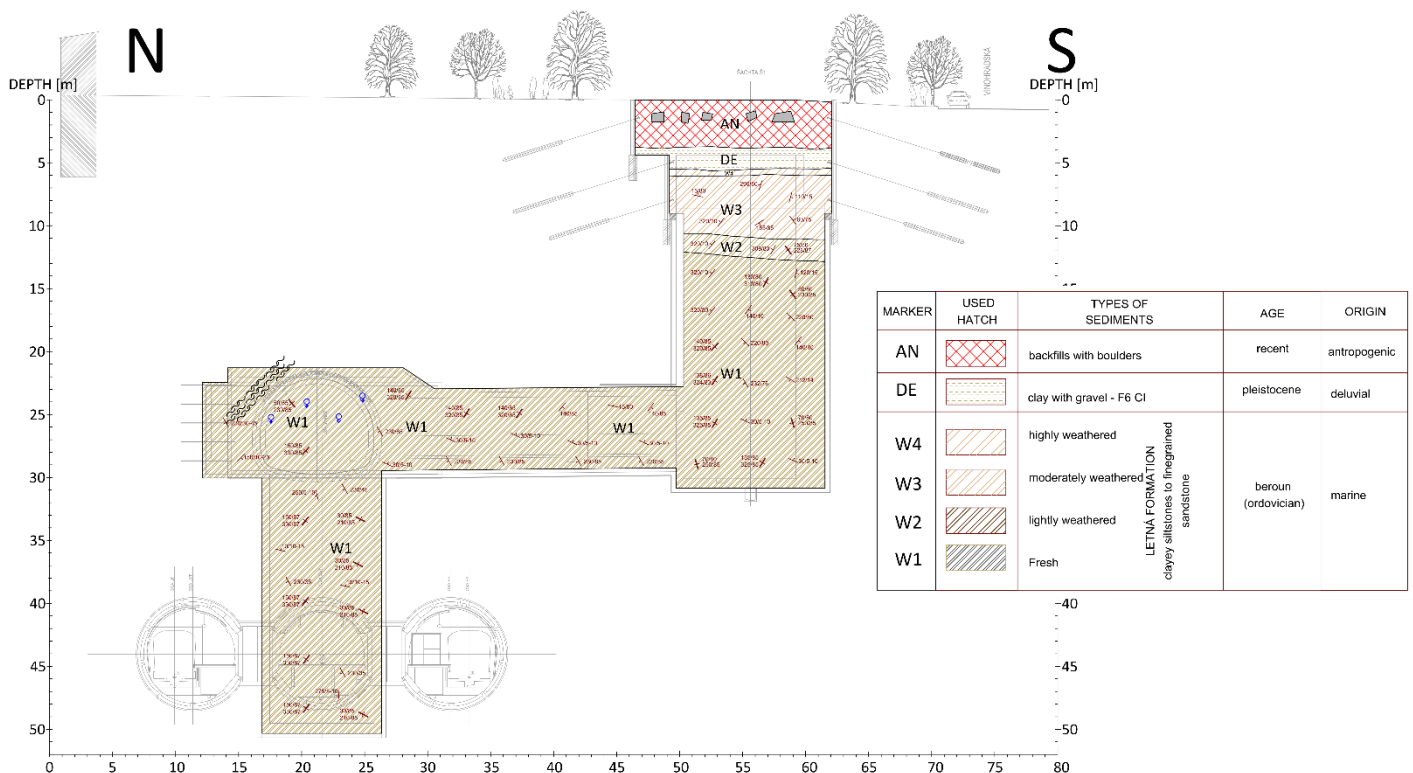
The outputs from the geological documentation were processed in west-east and north-south geological sections (Figure 11) instead of a classic mining map, taking into account the structure of the excavation and tunnelling.

During the excavation of shaft Š1, layers of fill containing concrete blocks up to one meter in size were first encountered. Beneath a layer of deluvial clayey soil, rocks of the Letná Formation were encountered. The excavation of the access tunnel began from shaft Š1 at a depth of 30 m. The access tunnel first ran 41 m northward, then 22 m eastward. From the base of the access tunnel, shaft Š2 (14 m) was then excavated, running between the metro tunnels to the level of the platform in the area outside the station. From shaft Š2, 8 m was then excavated westward to the station. During excavation, only minor groundwater inflows were encountered, apparently associated with a fault zone (see Figure 11). The groundwater level was encountered below the level of the existing metro base in the Letná shale fracture system.

The rock mass was evaluated according to Tesař's classification, and the excavation was subsequently classified into NRTM classes. The quality of the massif from a depth of 30 m was rated 53-60.5 QTS points. In areas with tectonic rock disruption accompanied by moderate groundwater inflows, the point rating was reduced to 45.5 points due to the introduction of β and γ reductions. Degraded rock encountered during the excavation of the tunnel at the platform level was rated 40.5 QTS points.
