HARCOV DAM – ENSURING SAFETY DURING FLOOD

Martin Kyselák,

Valbek spol. s r.o., Liberec, Česká republika

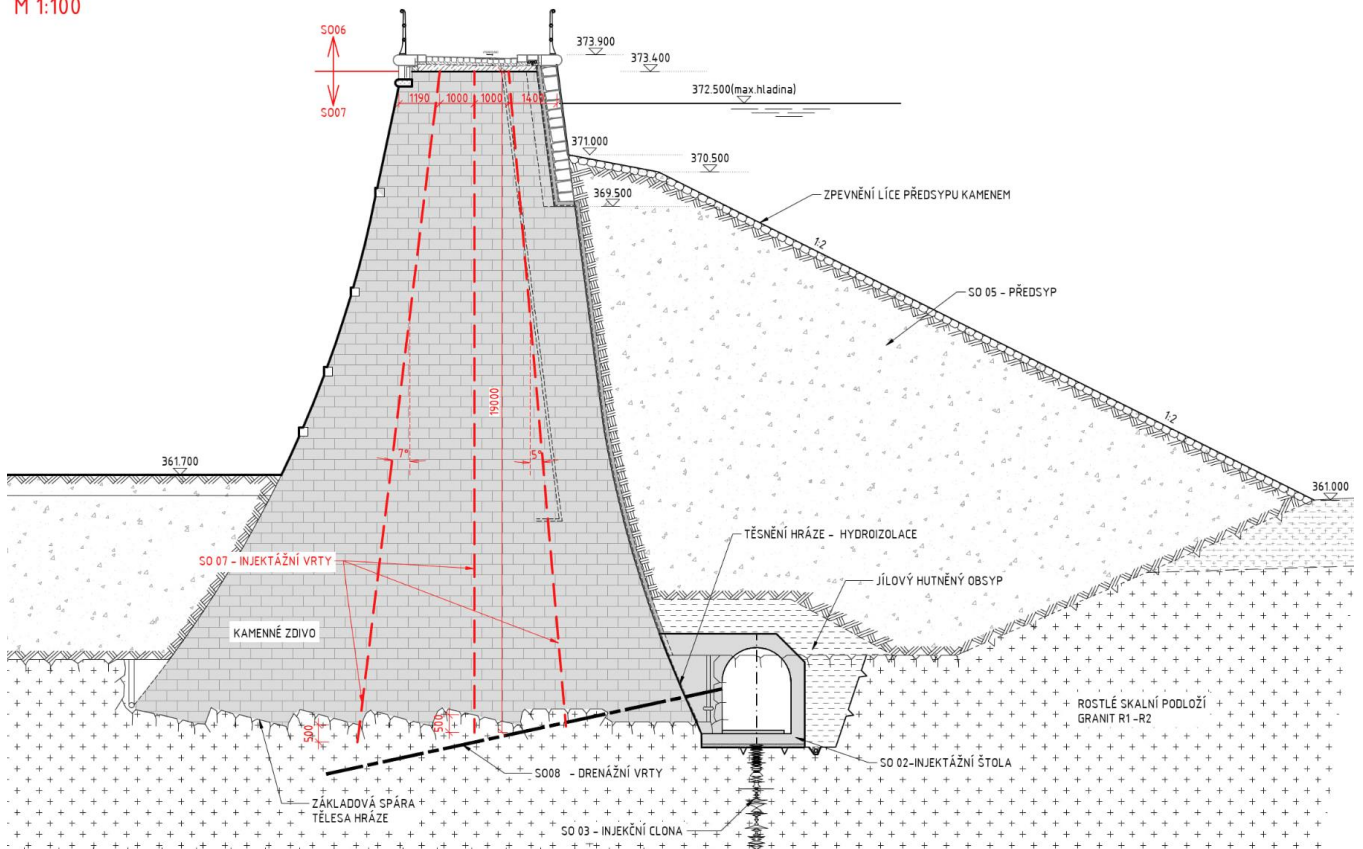
Fig. 2 Cross-section of the dam body grouting

After evaluating results of water pressure tests (VTZ) executed during the IGP (engineering geology survey, which also consisted of a construction technical survey of the dam masonry thanks to bore cores drilled from the dam crest), it was proven that the masonry of the dam has a very high permeability ($4.76\text{L}\cdot\text{min}^{-1}\cdot\text{m}$ at a pressure of 0,3MPa) and it can be rated as of poor quality mainly due to expected high degradation of binder. As a measure for the improvement of primarily physical-mechanical characteristics of masonry, the design proposed grouting of the dam body masonry. After assessing grouting performed on a test field, it was discovered that it is possible to alter the expected design values of grouting compound consumption per borehole meter from 157L to ca. 50L and to increase the maximum grouting pressures from 0.2MPa to 1.3MPa. Then, it was proven that the usage of previously designed chemical compounds is pointless, and grouting can be realised entirely using substantially cheaper materials based on clay-cement. To verify whether the dam masonry could be grouted, the realisation of test grouting boreholes was proposed. For their execution, a Technological regulation was made with the goal of assigning grouting works more precisely for the testing of masonry grouting ability. The grouting was carried out using clay-cement compounds in 3.0m grouting stages. Essential was the discovery that it is relatively easy to grout the masonry using clay-cement grouting compounds.

Grouting boreholes \varnothing 56 a 76mm were elongated contrary to the design (VALBEK spol. s.r.o. 2017) so that they would reach at least 0.5m below the dam foundation base. Maximum borehole length reached 20m. A double-core barrel was used to improve the core recovery quality. The technology of rotary-percussion drilling was not suitable in the given conditions. Then, in the lower section of some boreholes

in the dam subsoil, entirely weathered granite was encountered, which also had to be grouted. The average consumption of clay-cement grouting compound came out at 52.26L/m. All boreholes utilised ascending grouting with a simple packer. According to the results of VTZ in control boreholes, the dam masonry permeability was three times smaller after grouting (1.6L·min⁻¹·m at a pressure of 0.3MPa).

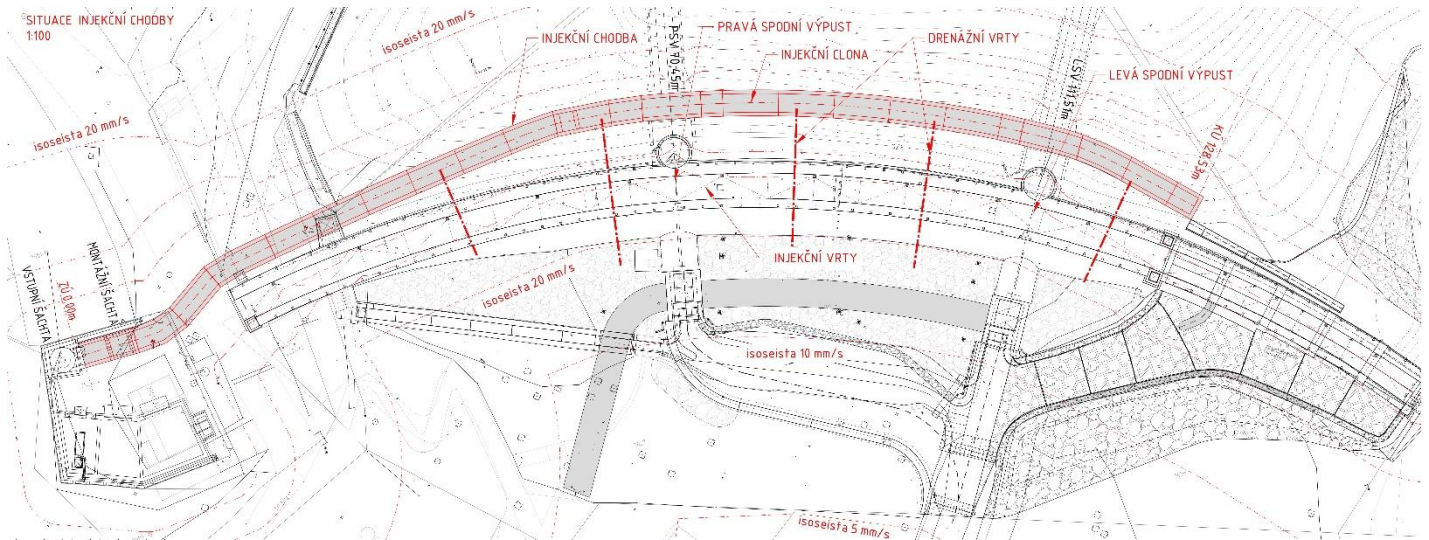
Fig. 3 Plan view of the grouting gallery along the dam heel

trench near the structures of the lower sluiceways, it was then discovered that the foundation of the lower sluiceways is not built down to the level of the dam body foundation base; therefore, it was necessary to proceed with the stabilisation of the area near the excavation. The material composition of this area was very diverse, and it was formed by low-quality concrete, individual stones, and weathered granite with strength ranging from R2 up to R5. The construction pit stabilisation in the area of lower sluiceway tower foundations was carried out with SB 25/30-X0 SBII J2 sprayed concrete, a KARI wire mesh, and grouted IBO Ø 32mm soil nails 4m in length. The nails and umbrellas were grouted using a micro cement suspension with plasticizers in a ratio of 1.0–2.0% of cement weight and a water-cement ratio of 0.8–1.0.

From the viewpoint of NATM, the entire section was classified into one technological class – VT3. During earthwork for the realisation of the gallery, mainly taking place in a rock environment, pressurised water springs were discovered in the foundation base that were not expected in the design. Near the lower left sluiceway, a laboratory analysis discovered carbon dioxide aggressivity of water, and a corresponding concrete class had to be used. Since the excavation took place under a flowing stream at the bottom of a dam, it was necessary to collect inflows into catch pits and continually pump water from the construction pit over the course of excavations and gallery construction. This seepage and fissure water was released into the stream. Even though the extent of excavations was only a few meters, due to the variability of the rock environment and presence of stone structures of the reservoir, the excavations were a difficult task for all involved parties.

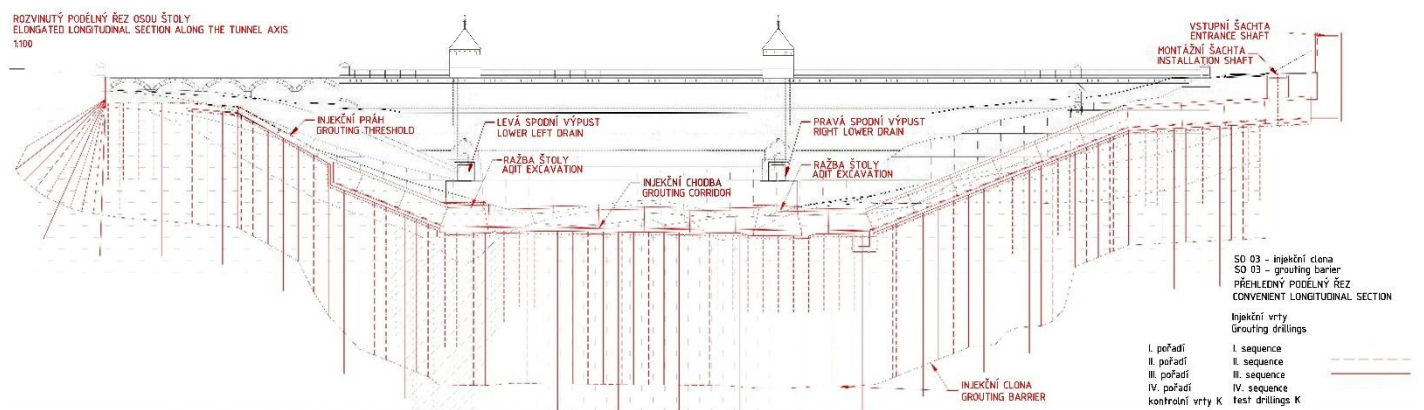
Fig. 7 Grout curtain of the dam subsoil

- Granite in differing stages of weathering was discovered in all boreholes below the foundation base.
- It is true for the entire observed profile that even healthy, otherwise strong granite is broken up (most common fissures are almost vertical with an incline of 70° – 90°), the disintegration is lumpy to blocky. The subsoil rock is substantially permeable, therefore water losses from the reservoir through the subsoil are sizeable.
- The rock subsoil has failures due to significant fissure systems. Open fissures reach at least 15 below the dam foundation base level.
- The subsoil in the area below the dam is less permeable than the subsoil below the reservoir. This fact is caused by an increase in buoyancy underneath the reservoir.

The average clay-cement grouting compound consumption came out at 50.62L/m and microcement grouting compound at 65.29L/m. It was clear from the VTZ results that the dam subsoil in the section of the grouting field reached an average permeability of 6.86L·min⁻¹·m at a test pressure of 0.3 MPa prior to the completion of test grouting. The subsoil permeability undeniably decreased more than eightfold. Maximum grouting pressures ranged from 0.5 to 1.3MPa in relation to the location of the stage. Fundamental was a finding that the dam subsoil can be relatively well grouted using clay-cement grouting compounds and cement compounds from really finely ground microcements.

The grout curtain itself was then carried out down to a depth of 24.0m in the middle section of the dam and 15.0m at the attachments to the VD shores. The number of grouting boreholes was 183pcs, 8 of them being control boreholes. The total length of boreholes was 2872m. The grout curtain was executed preferably using ascending grouting. Although descending grouting, or a combination of both, had to be utilised in places with significantly damaged rock. The grout curtain was designed as a single row with four sequences. The final spacings of grouting boreholes were adapted to the expected rock environment. For example, in areas with completely weathered and disintegrated granite and in tectonically faulty granite 0.75m, and in sections with more compact and healthy rock 1.0m. Core boring was utilised for grouting and control boreholes with a minimum diameter of 59mm (maximum 76mm). A double-core barrel was used for higher-quality of core recovery. The technology of rotary-percussion drilling was inappropriate and unacceptable in the given conditions.

The discovered grouting parameters of the compound and results from the grouting test field were successfully applied to the entire grout curtain. The resulting quality of the dam subsoil grouting will be determined by the amount of seepage water and water pressure below the dam, which will be monitored by five drainage boreholes.

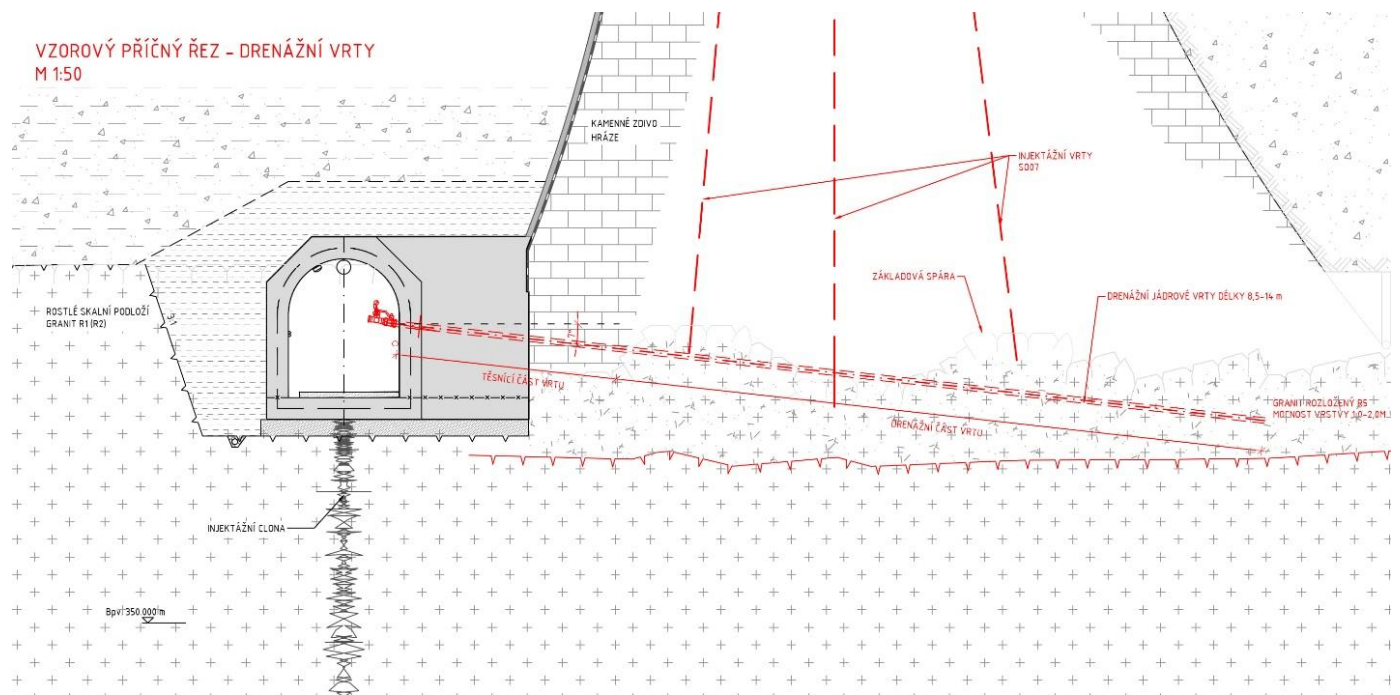
Fig. 8 Sample cross-section – drainage boreholes

It was clear from the stability analysis of the dam body carried out by the VD-TBD Company as a part of (D. Richtr, T. Klemša 2008) that the safety factor for movement during an extreme load state is unsatisfactory.

A distinct factor in the calculation is buoyancy in the foundation base of the dam body. For their monitoring and if necessary short-term lowering, five relief boreholes will be available that will be led from the ICH at a slightly downward angle underneath the foundation base of the dam body. The length of drainage boreholes is 8.5–14m. In regard to the presence of highly weathered Liberec granite attitudes

that caused substantial instability of borehole walls already during executed drilling works, on top of the presence of pressurised water, it was even necessary to alter the design and equipment of the borehole, using a $\varnothing 114.3/94$ mm perforated steel pipe.
