## IN-SITU DAMAGE INVESTIGATION OF ADHESIVELY BONDED COMPOSITE REPAIRS

**Keywords:** x-ray tomography, in-situ, scarf repair, adhesive bonding, CFRP

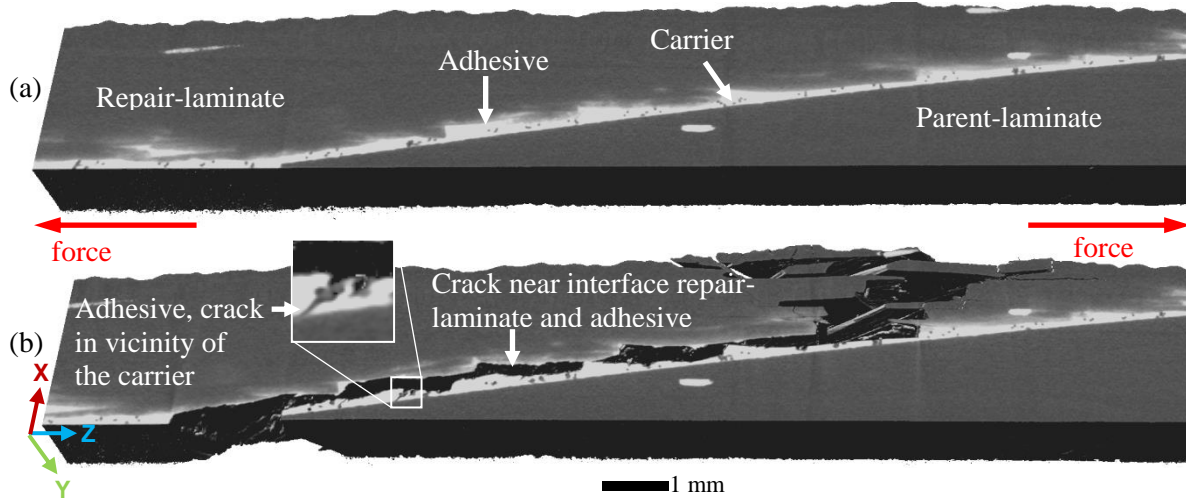
Comparison of the increasing damage sizes between the individual load levels allows to monitor crack initiation and progression. Initial cracks can be observed at the first load step (85 % of reference  $F_{max}$ ). An increase in damage size can be determined at 95 % of the reference's  $F_{max}$ . Figure 2 shows a 3D comparison of the unloaded and broken state of the as-received specimen. Adhesive, carrier and CFRP matrix can be detected, but the contrast is too low to identify the individual rovings. Nevertheless a final fracture in the vicinity of the interface between the adhesive and the repair-laminate can be determined. In the mid-section of the specimen (with respect to the z-axis) cracks also grow through the plies of the repair-laminate in x-direction until the surface is reached. Smaller cracks between carrier and adhesive are also visible and are highlighted.

**Figure 2.** Condition as-received: 3D comparison of the unloaded (a) and the broken (b) specimen.

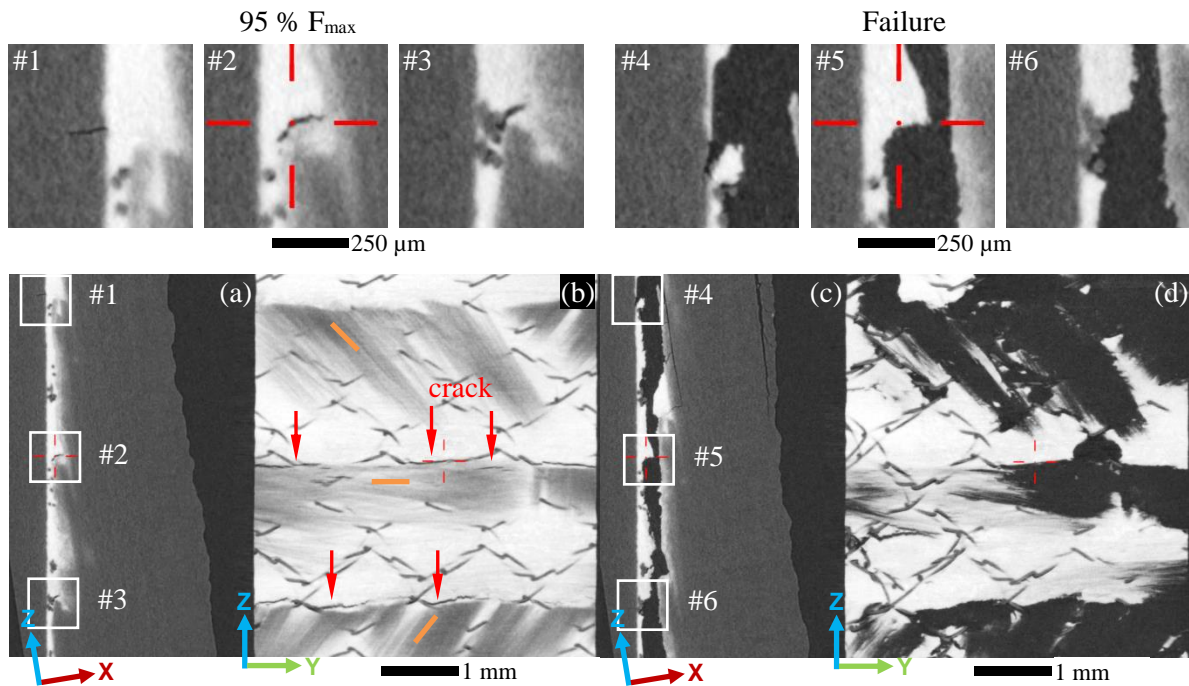
Figure 3 shows a comparison of the as-received specimen directly before (95 %  $F_{max}$ ) and after failure. An influence of the ply orientation on the crack origin and propagation cannot be seen (see figure 3 (b)). The damage types identified are: cracks in the parent-laminate (see figure 3 detail 1), interface cracks between repair-laminate and adhesive (see figure 3 detail 2) and interface cracks between carrier and adhesive (see figure 3 detail 3). It is obvious that the cracks between the repair-laminate and the adhesive as well as in the parent-laminate are expanding in y-direction (z-direction = load direction) in the vicinity of the repair-ply-terminations of the scarf joint. The crack in the parent-laminate (transverse direction, see figure 3 detail 1) is closed after the specimen's failure (see figure 3 detail 4). Cracks in the repair-laminate (longitudinal direction) are visible in the broken specimen.

**Figure 3.** Comparison of load step 95 %  $F_{max}$  and failed state of as-received specimen (slice images): (b) and (d) ply orientation (highlighted orange where applicable) close to the adhesive, (a) and (c) overview bondline, laminate and (1)-(6) respective details.

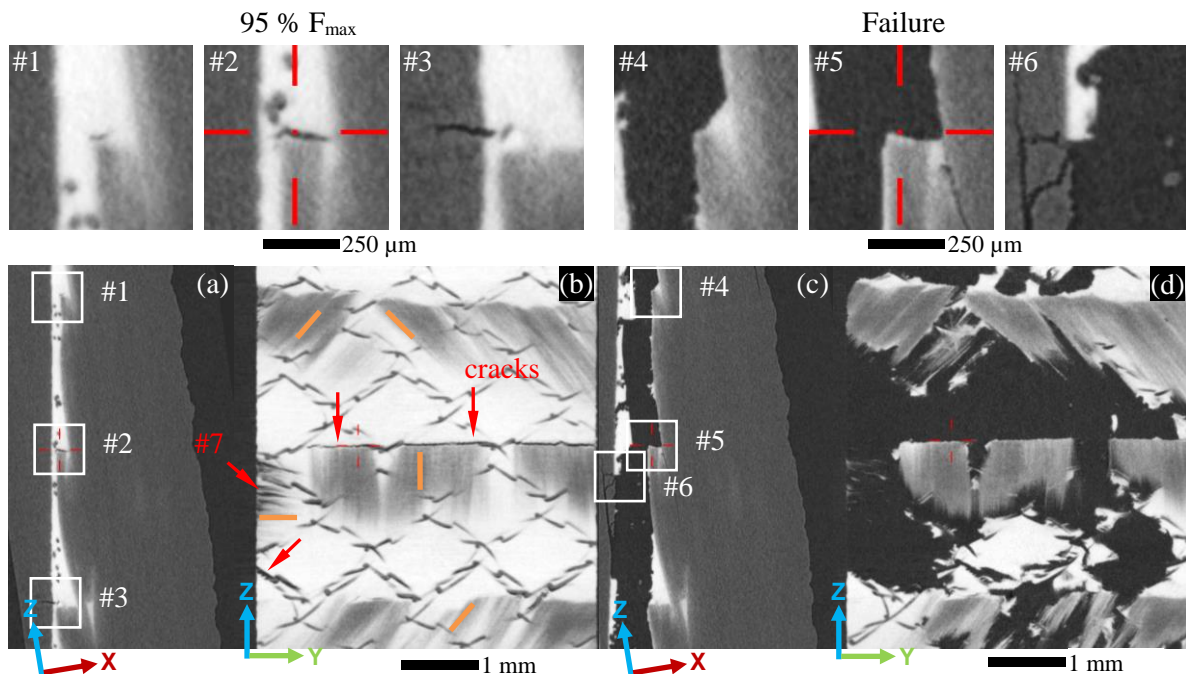
Figure 4 shows a comparison of the conditioned specimen directly before (95 %  $F_{max}$ ) and after failure. A mass loss (moisture) of 0.09 % was detected during in-situ investigation. Regarding the maximum force at failure, no significant influence of the conditioning could be investigated. In general, the same damage types as for the as-received specimen can be observed, which are propagating in the same direction as in the as-received specimen. Transversal and longitudinal cracks in the parent-laminate after failure are shown in figure 4 detail 6. Furthermore cracks in the repair-adhesive in the y-z-plane oriented from the specimen boarder to the centre are visible (see figure 4 detail 7).

**Figure 4.** Comparison of load step 95 %  $F_{max}$  and failed state of conditioned specimen (slice images): (b) and (d) ply orientation (highlighted orange where applicable) close to the adhesive, (a) and (c) overview bondline, laminate and (1)-(7) respective details.

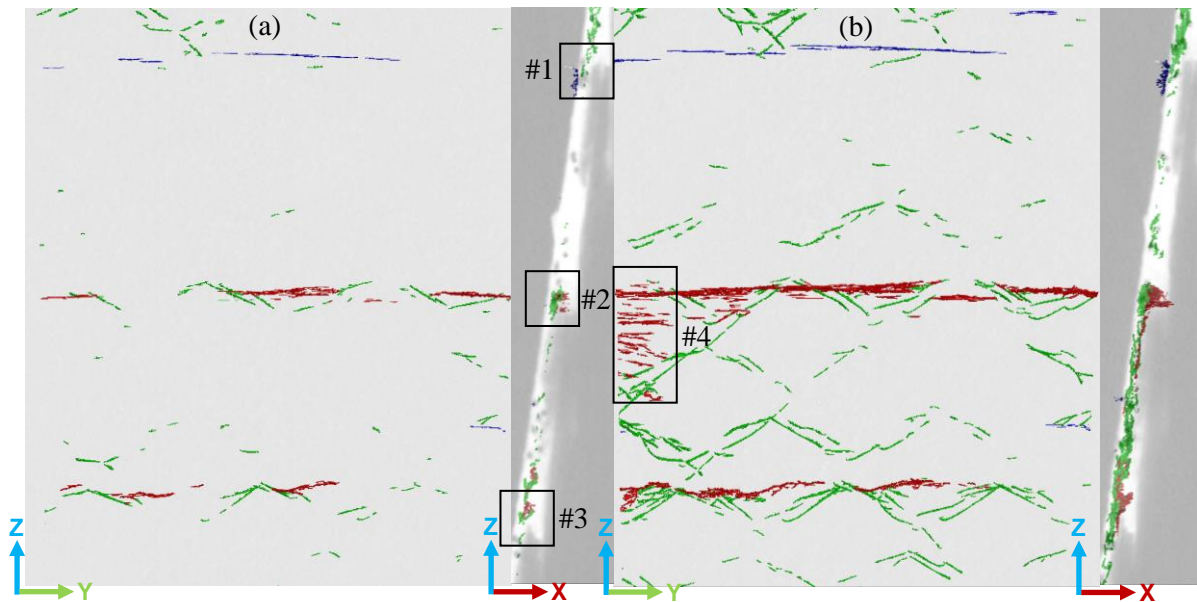
Figure 5 shows the segmented damage propagation of the as-received specimen. The defects are colour-coded according to their type. In load stage 85 %  $F_{max}$  first cracks can be detected mainly in the vicinity of the terminations of the repair-ply (see figure 5 detail 1 - 3). Mollenhauer et al. mentioned a strain concentration induced by changes of the adhesive thickness (resin rich pockets) of adhesively repaired CFRP [7]. The strain concentration in the areas with higher adhesive thickness as main factor for the initiation of cracks is plausible in this case. Furthermore no significant influence of the ply-orientation on the formation of cracks could be detected. It can be observed that the cracks in the vicinity of the interface between the adhesive and the repair-ply as well as in the parent-laminate are growing in y-direction along the terminations of the repair-ply (see figure 5 (b)). This behaviour is expected due to the fact that the load-direction is perpendicular to the x-y-plane. In comparison to this the cracks between carrier and adhesive are expanding along the respective interface.

**Figure 5.** Comparison of segmented defects at different load steps ((a): 85 %  $F_{max}$ ; (b): 95 %  $F_{max}$ ) for the as-received specimen. Defects are colour-coded by type (green: interface cracks between adhesive and carrier; red: cracks in the vicinity of the interface between adhesive and repair-laminate; blue: cracks in parent-laminate).
