IUD issues in clinical practice

Dr Amy Moten

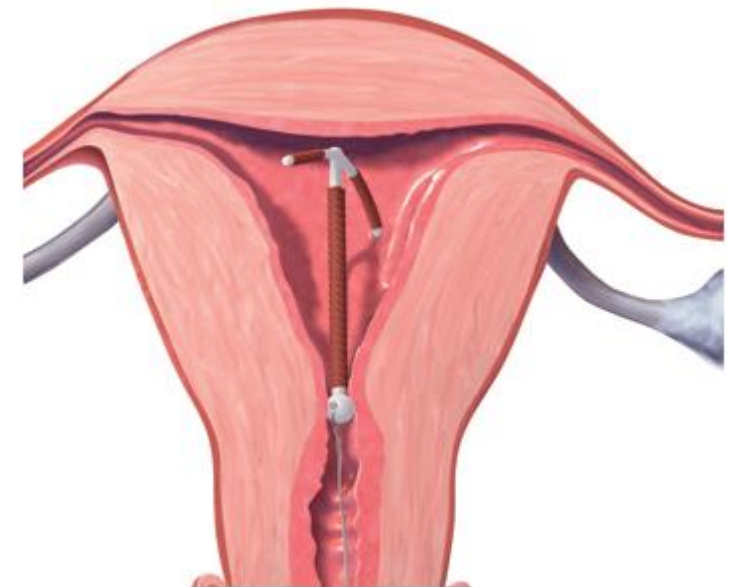
FIGURE 2 Rotated IUD

- located in the lower uterine segment or cervix
- rotated
- embedded in the myometrium
- partially expelled
- protruding through the serosa or within the uterine cavity

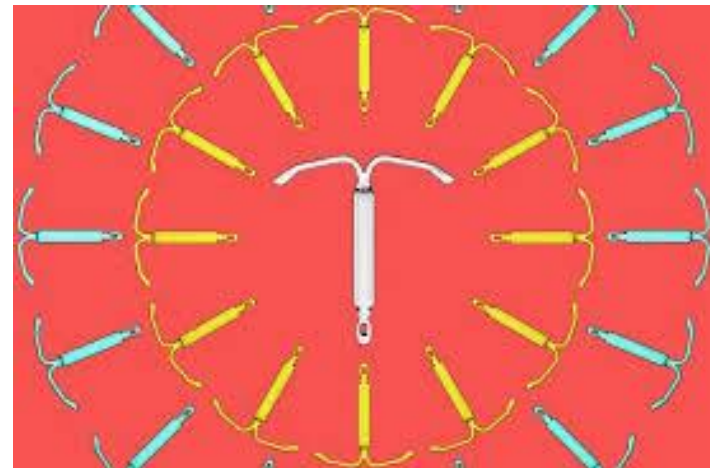
Low lying IUD

>20mm below the uterine fundus

Cu-IUD vs LNG-IUD

May reposition over time

No association with increased bleeding or pain

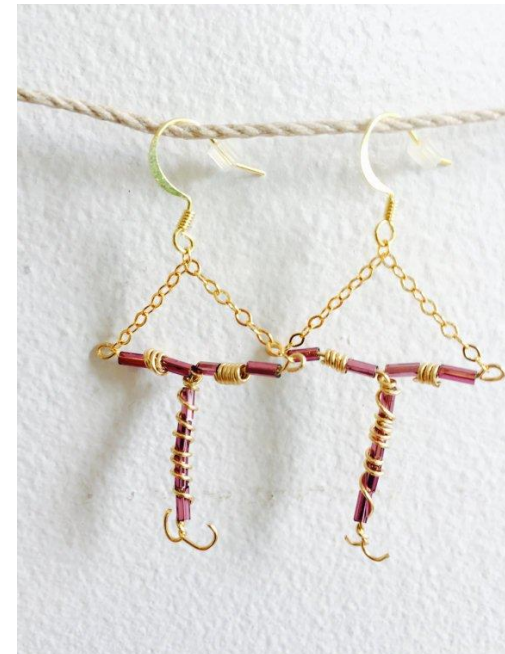
Low lying IUD

Intracervical IUDs recommended to be removed and replaced

Decreased efficacy particularly Cu-IUD

LNG-IUD intracervically may cause irregular bleeding

Expulsion risk is higher

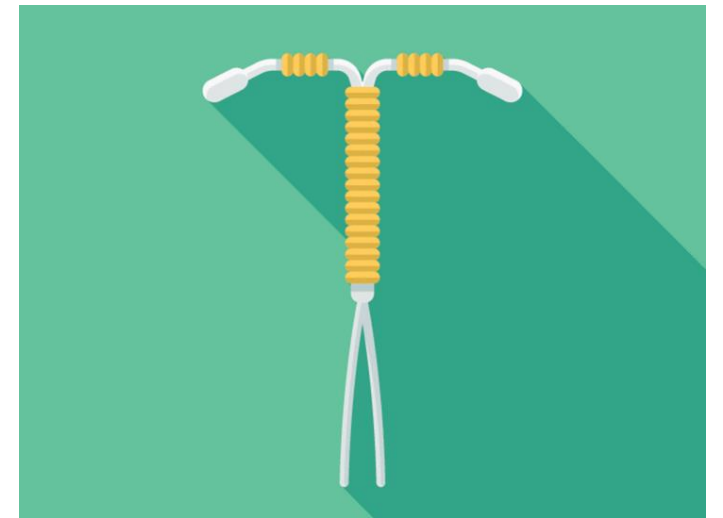
IUD perforation

Protruding through the serosa (partial)

Or completely outside the uterus and within the abdominal cavity (complete)

An embedded IUD may lead to further perforation – the “wandering IUD”

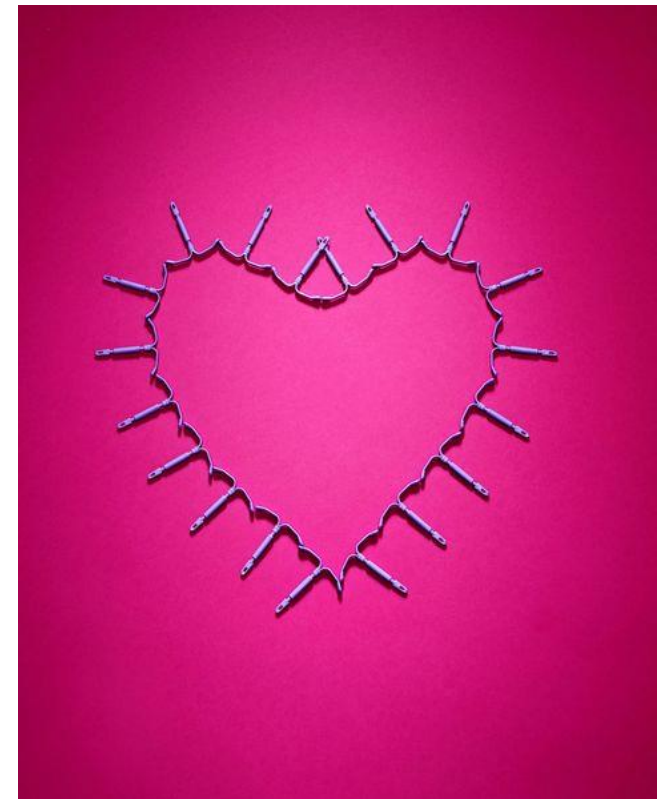
Case 1:

- 44yo para 2 was fitted for an LNG-IUD
- Routine speculum exams – strings seen
- Strings not seen at next cervical screen
- IUD found attached to the rectus sheath

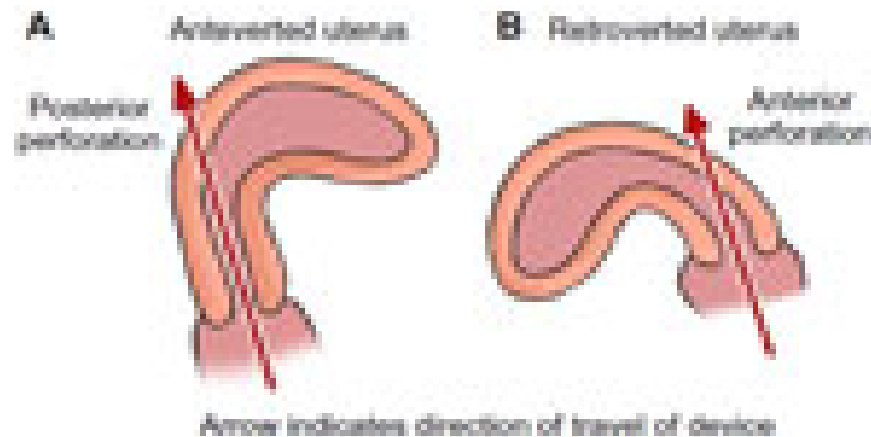
Case 2:

- 46yo para 1 long time user of DMPA
- Multiple co-morbidities
- LNG-IUD inserted to 11cm after sounding
- USS post procedure confirmed correct position
- Subsequent repeat CT scans
- 26 months post insertion CT scan showed device had perforated

On review CT scan at 3 weeks post insertion suggested embedded IUD

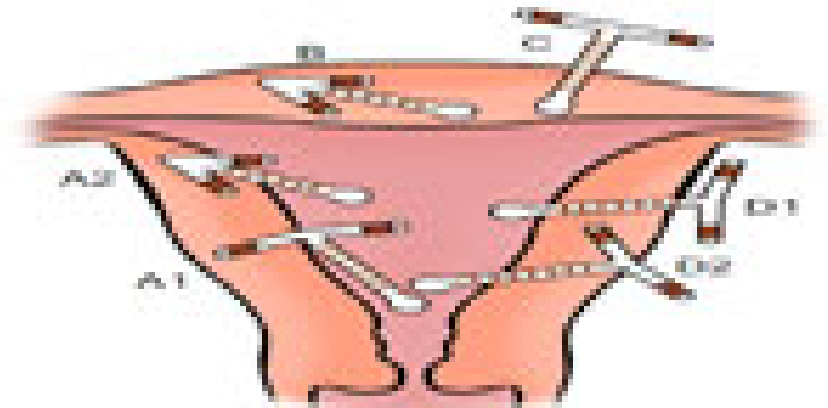
Mechanism

Perforation with sound at time of insertion

Perforation with device at the time of insertion

May be completely painless

The most common location for a complete perforation is the pouch of Douglas

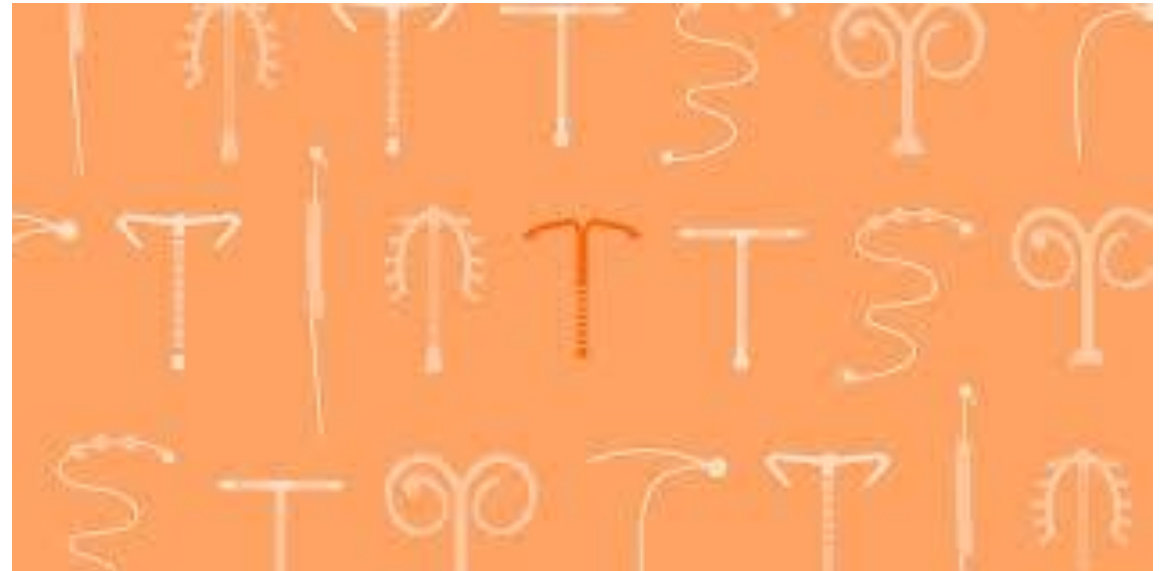
Management of perforation

Management of suspected perforation with IUD:

- USS/AXR to locate IUD
- Haemodynamically stable/pain controlled
- ?Antibiotic cover
- Laparoscopic removal
