Panorama of the Camden Township

The opportunities

Overview of project sites

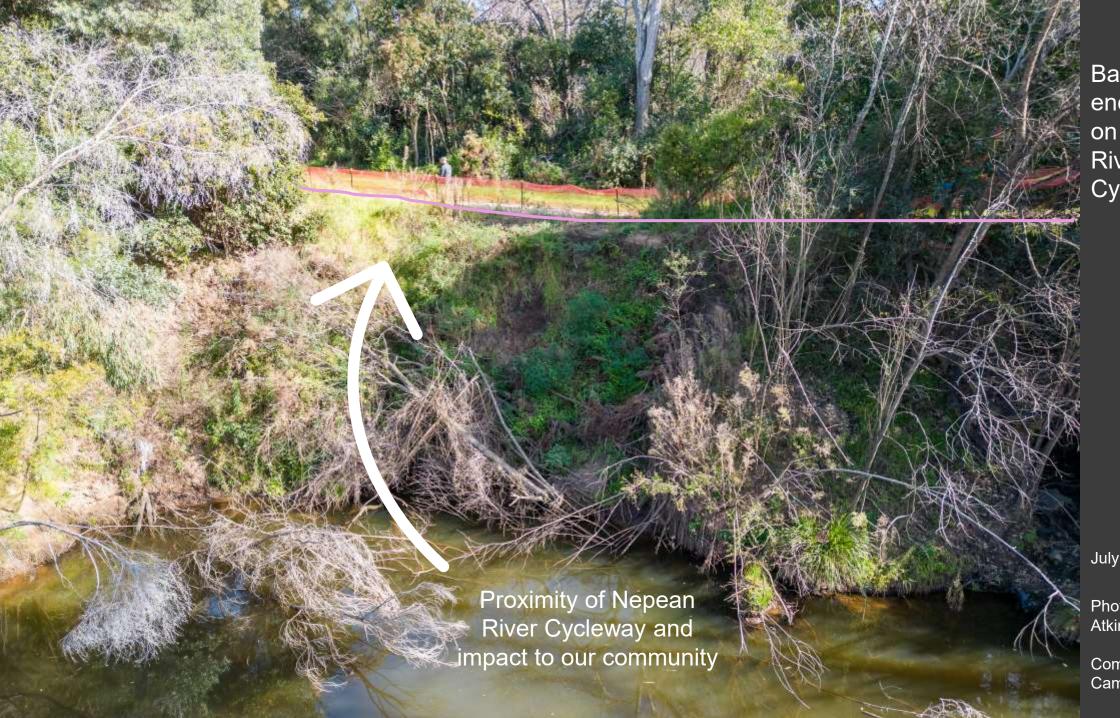
Bank erosion encroaching on Nepean River Cycleway

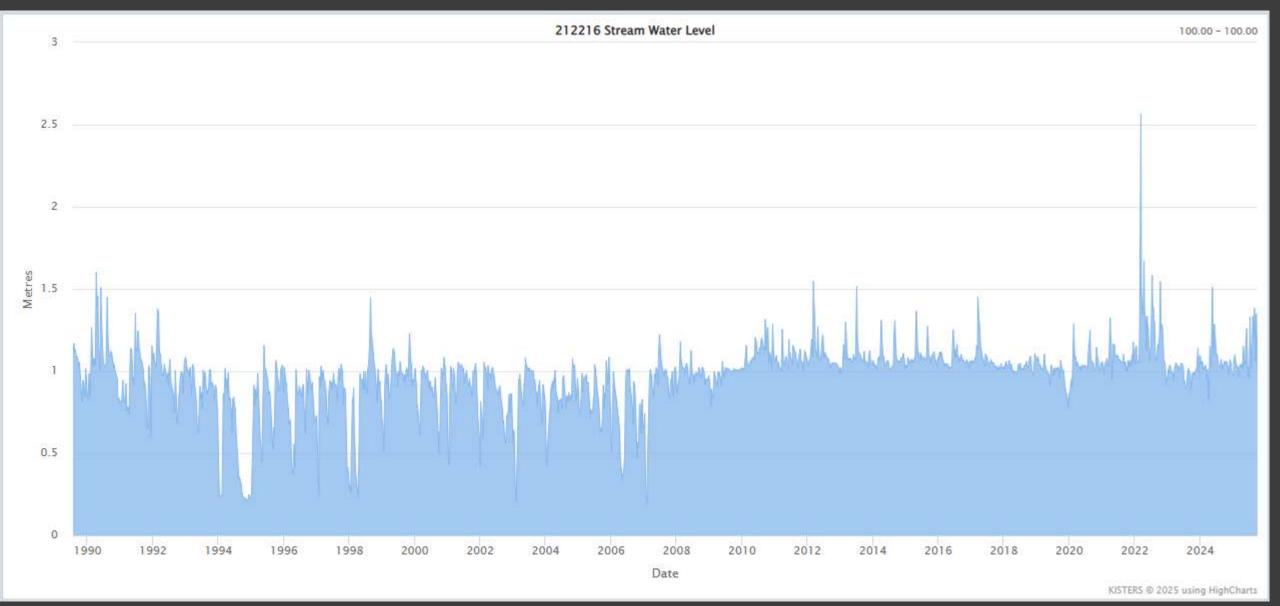
Stream Water Level records since 1989

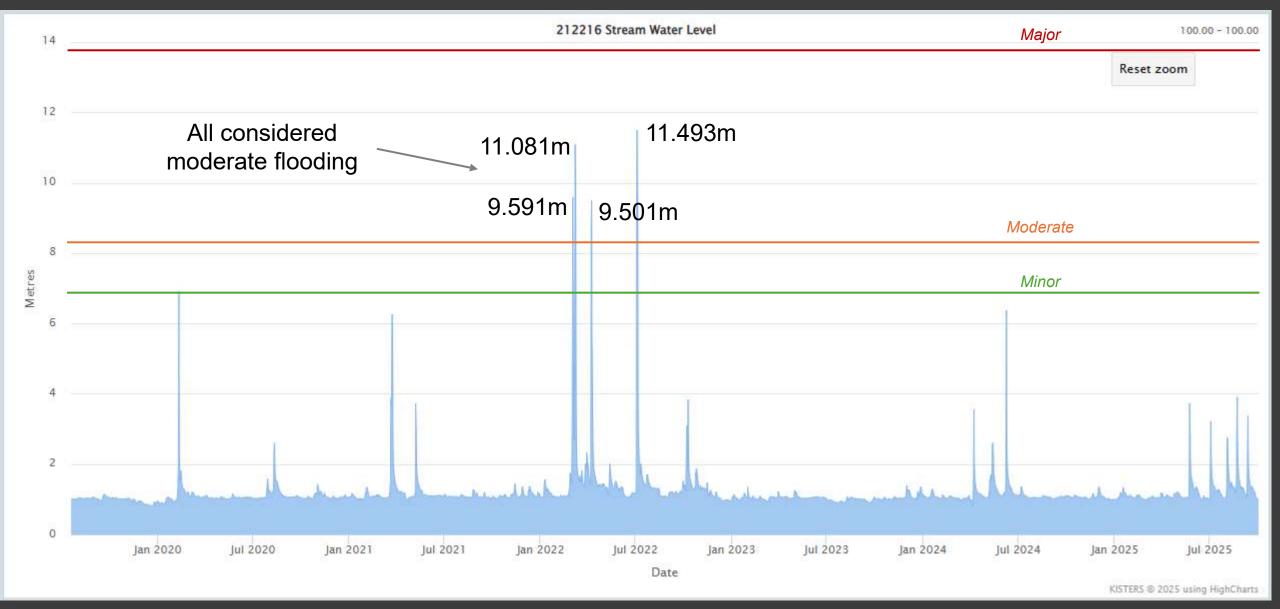
Stream Water Level records for 2020-2025

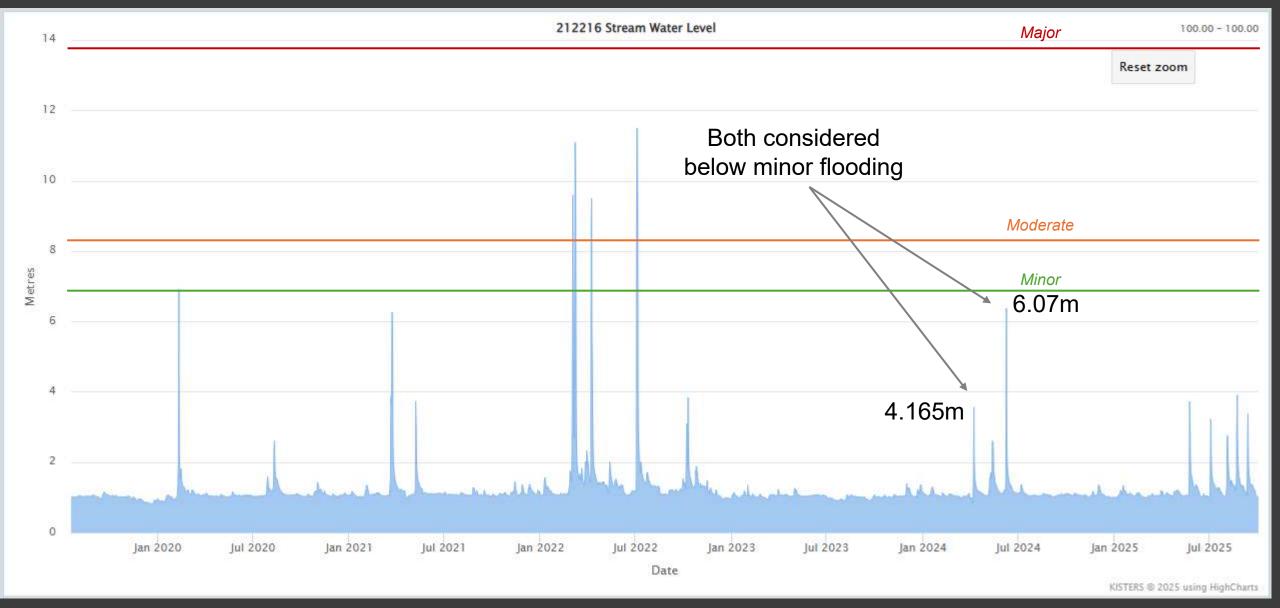
Stream Water Level records for 2020-2025

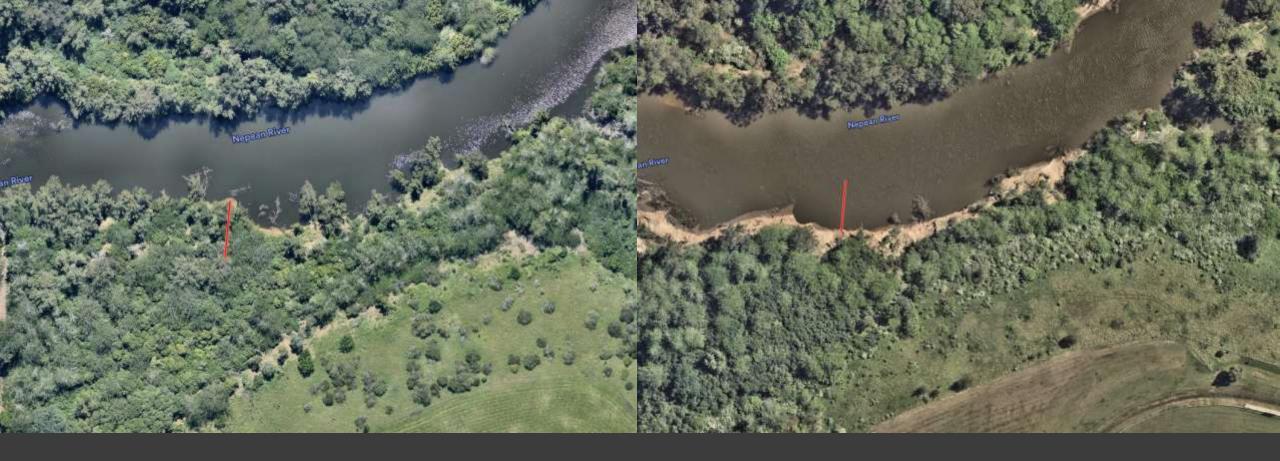
Ferguson Reserve

February 2016

Some parts experienced more than 30 metres of riverbank retreat since 2016

>13,700 cubic metres of soil was lost between December 2021 and July 2023

AFTER

October 2022

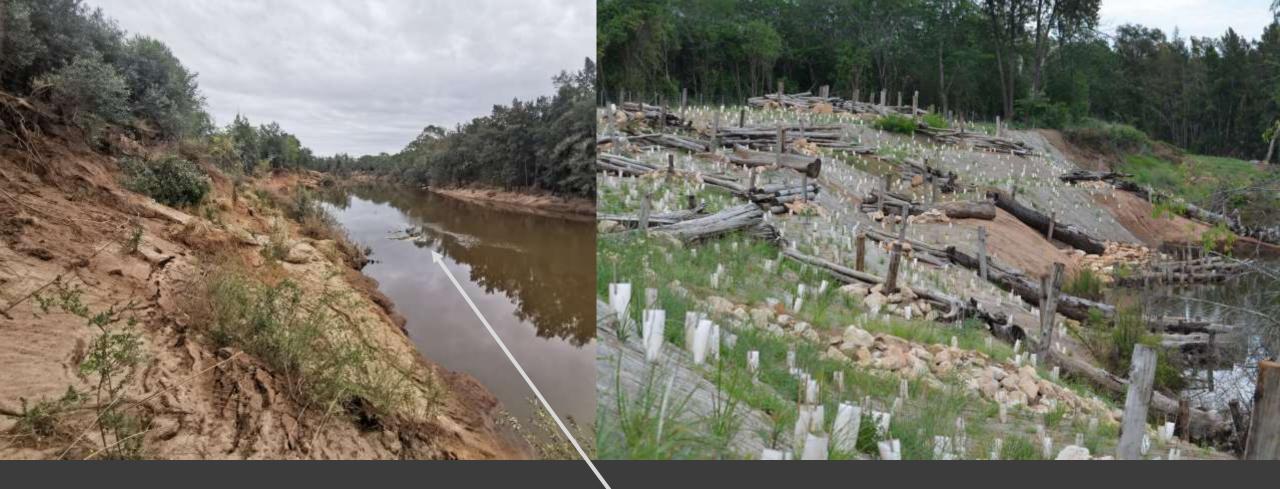
April 2022

Indicates previous bank toe

AFTER

January 2024

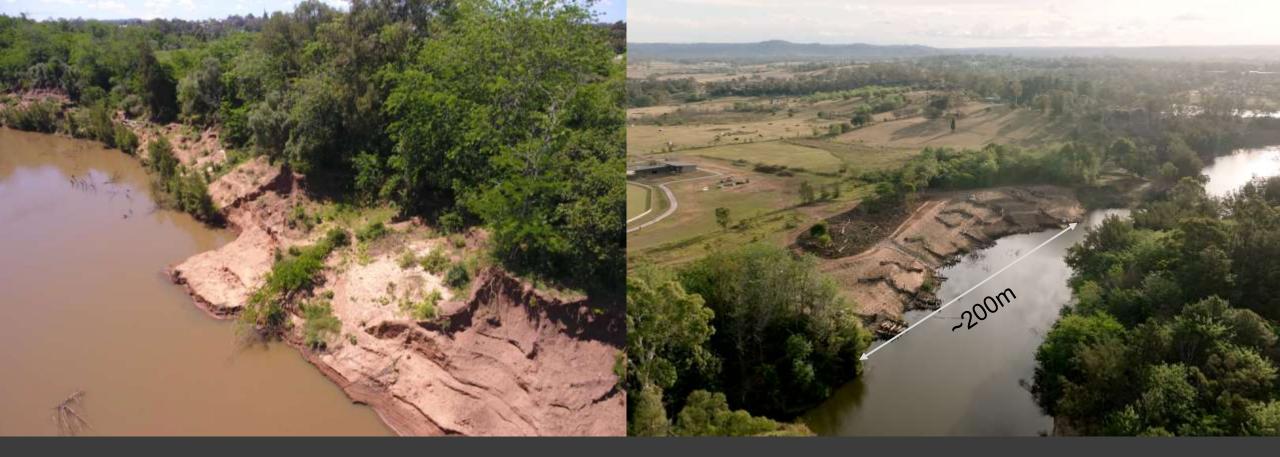
November 2022

AFTER

February 2024

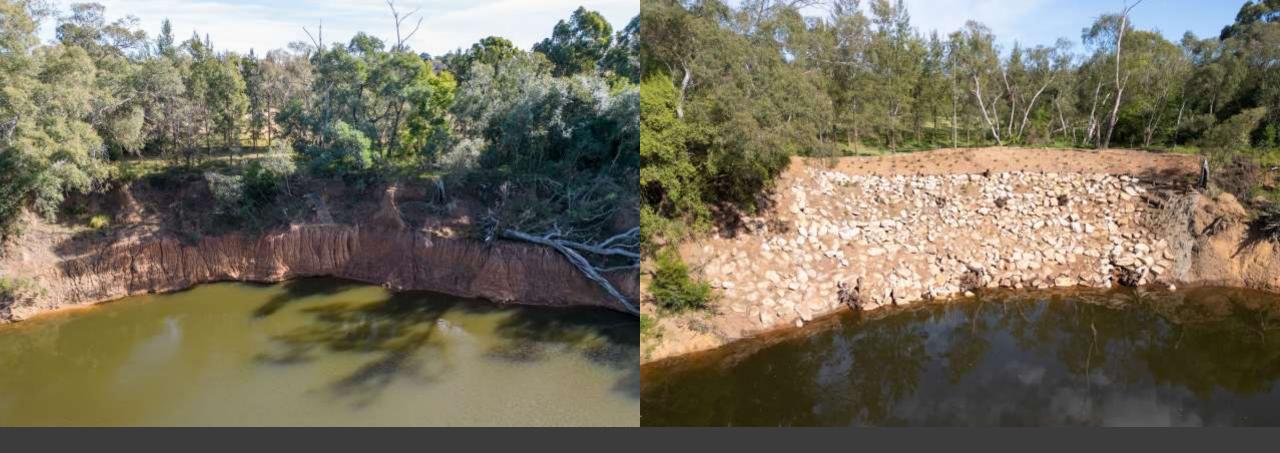
Nepean River Cycleway

July 2023

AFTER

October 2024
