# TRANSPORTATION CONFERENCE 2026 Auckland Cycle Separator Condition Study Findings

## **Abstract**

Given increasing budget pressures, Auckland Transport is increasingly using low cost, quick build infrastructure to expand the cycling and micromobility networks.

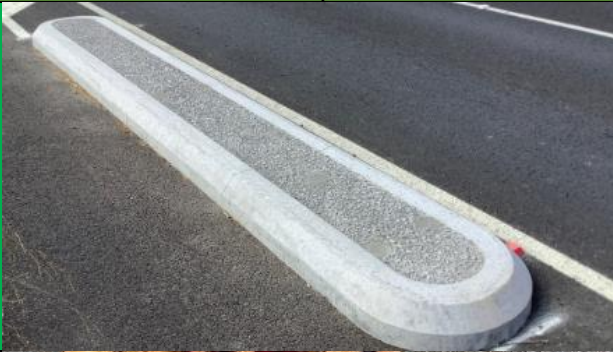
Condition	Description	Example
1	Recently installed OR almost new. No damage or tyre marks

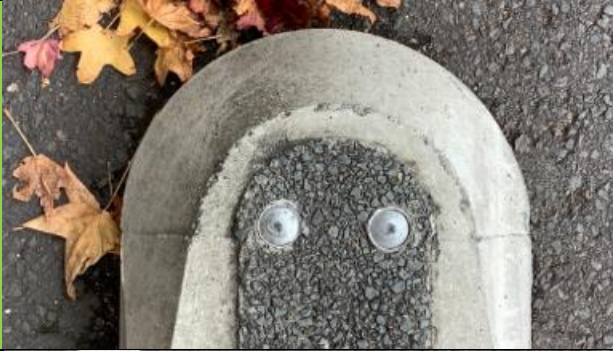
2	Minor wear/ tear (paint chips, faded paint) Either minor tyre marks OR minor chipping (from weathering)

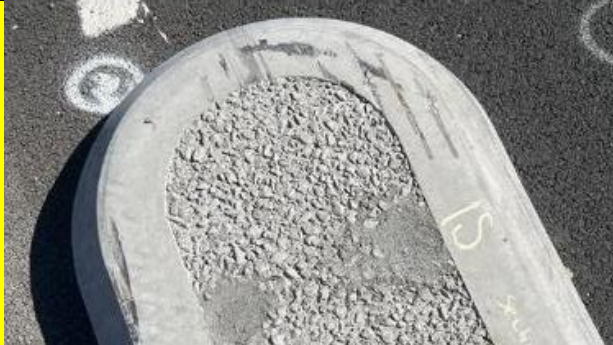
3	Typical weathering. Tyre marks AND minor chipping from mounting. Moderate damage likely to be sustained by single hit/mounting from vehicle.

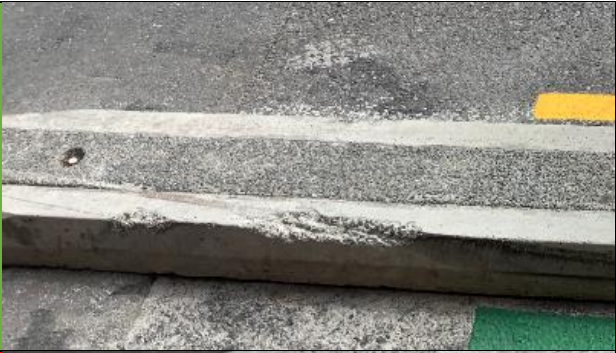
4	Cracked, smashed, scratches Chipped corner but intact and functional. Multiple tyre marks and chipping, moderate damage likely to be sustained by multiple hits/mounting from vehicles.

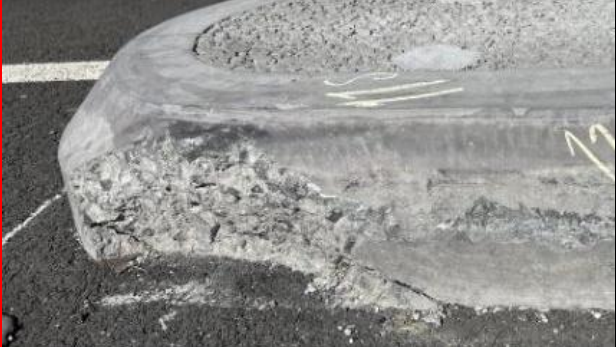
5	Separator is missing, dislodged or seriously damaged

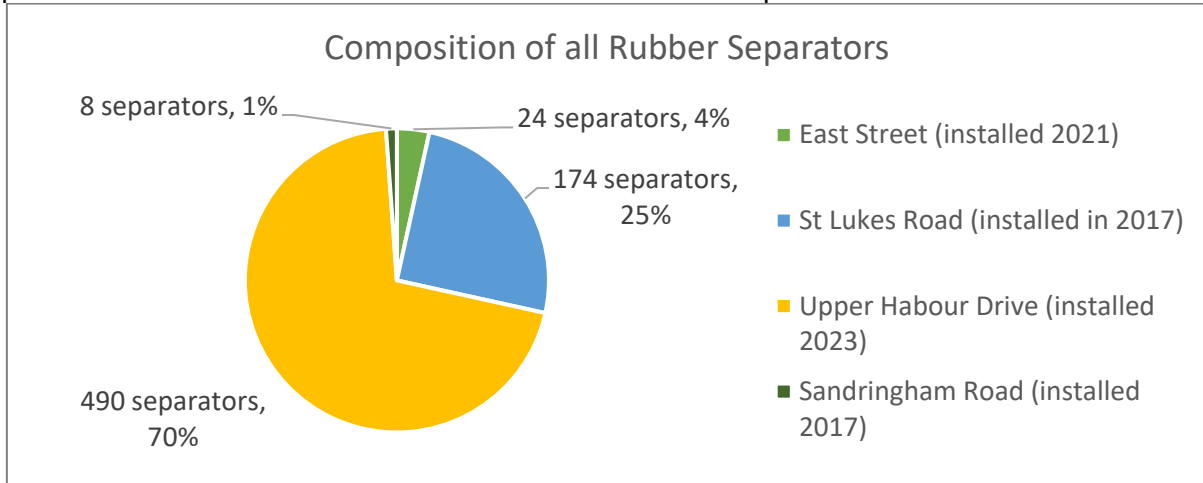
Out of the total survey assets, 696 rubber separators were assessed, representing 26% of the total. These separators are primarily from four sites, and the graph below (Figure 2) illustrates that Upper Harbour Drive contributes to 70% of the total rubber separators.

**Figure 2: Composition of the 696 rubber separators**

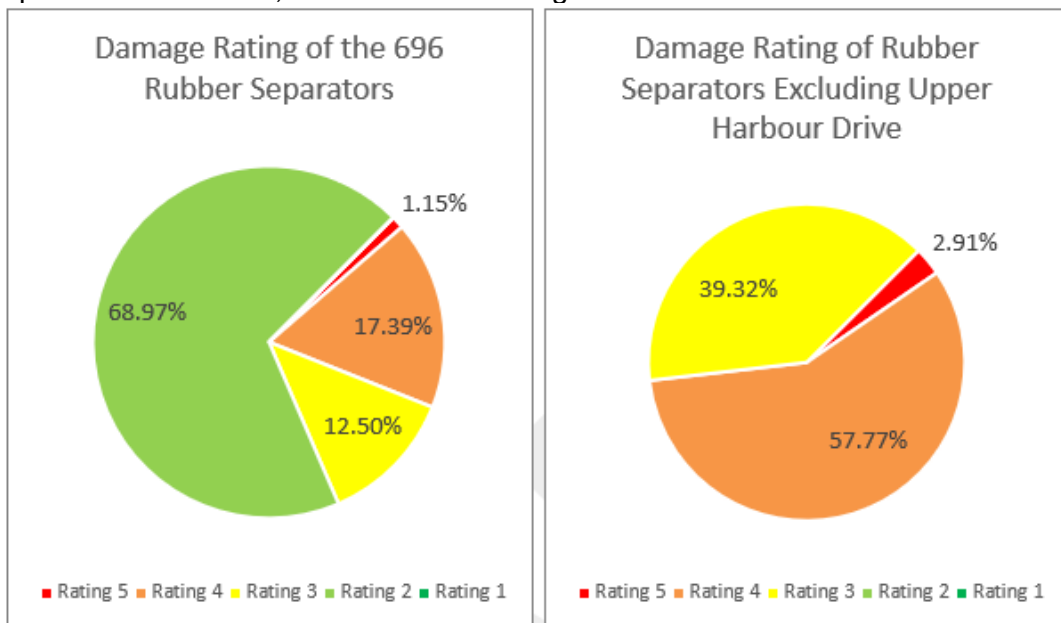
**Figure 3: Comparison of damage rating with and without Upper Harbour Drive**

The majority of rubber separators are rated 2 due to the separators on Upper Harbour Drive being recently installed in 2023 and therefore showing minimal damage. East Street was constructed in 2021 and was intended for short term use with an anticipated design life of 2 years due to construction of the City Rail Link station nearby. In addition, the high proportion of the separators rated 4 or worse are likely attributed to frequent site access by construction vehicles. The wear and tear is atypical and not representative of normal usage conditions and skews the analysis. Meanwhile, the expected design life for St Lukes Road and Sandringham Road is uncertain; both were installed seven years ago in 2017. Note that sample size from Sandringham Road only
