IMPROVING ACCESSIBILITY OF TRAILS AND CAMPGROUNDS

(This paper has been peer reviewed)

John Lieswyn, MET, BSc, PTP, FCIHT, MEngNZ
Director & Principal Transportation Planner – john@viastrada.nz
ViaStrada, Christchurch, New Zealand
(author for correspondence)

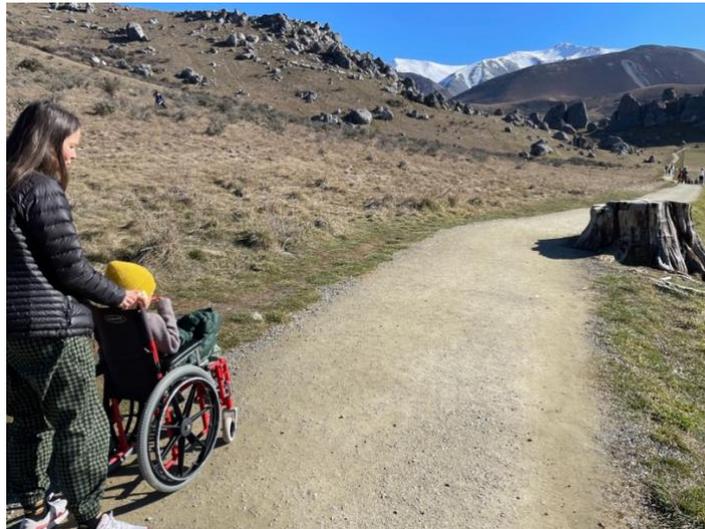
Figure 4: a member of the public on the Kura Tawhiti (Castle Hill) walk - the pilot audit site

For example, many of the DOC experiences lack information that could help the public determine how far they will be able to go at each location before reaching a barrier. At the pilot audit location, Kura Tawhiti Canterbury, the track is wide, smooth and well graded – but only for the first half of the experience. Currently, people have to guess and discover how far they can go, and then turn around on a narrow and busy track.

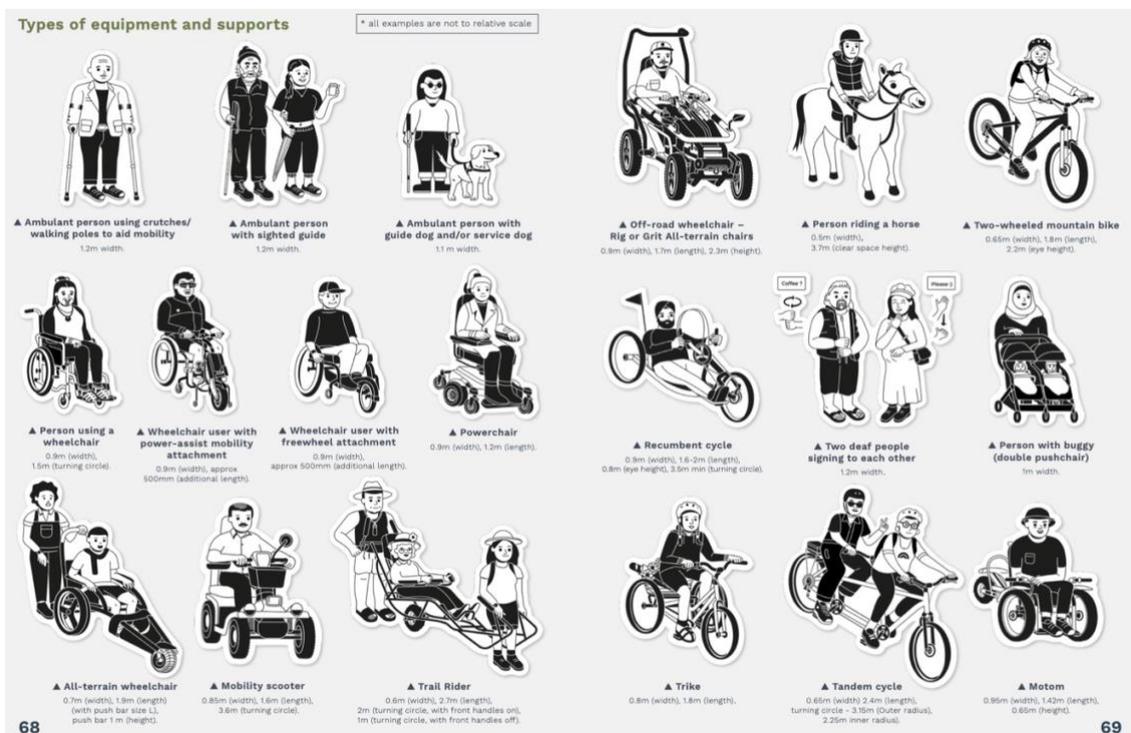
Figure 5: Types of equipment and supports (Recreation Aotearoa OADG)

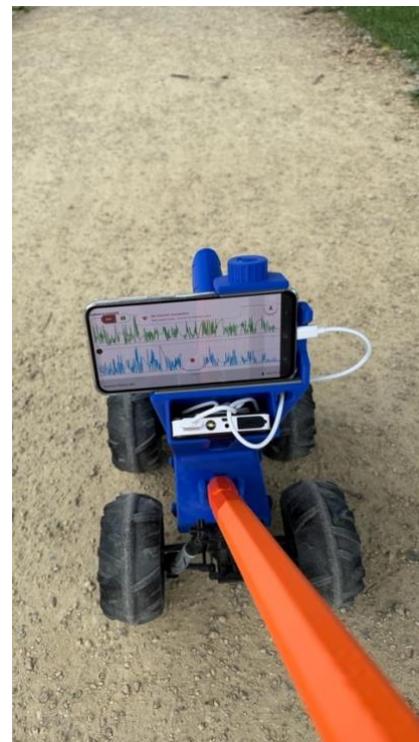
Figure 7: The Access Cart upgraded for trails use with a stronger body, suspension and larger tyres

The Access Cart (Figure 3) is 3D printed and mounted on a radio control car chassis. Upgrades over the model originally designed for urban footpaths included larger wheels and tyres, stiffer springs, a redesigned body for easier carrying and secure phone mounting, and improved metal-reinforced pusher stick. The current version is sturdy and rolls over most obstacles encountered, although no wheeled device can make it over the volcanic scoria of the tougher Rangitoto Island tracks or over the many steps encountered throughout the DOC estate.

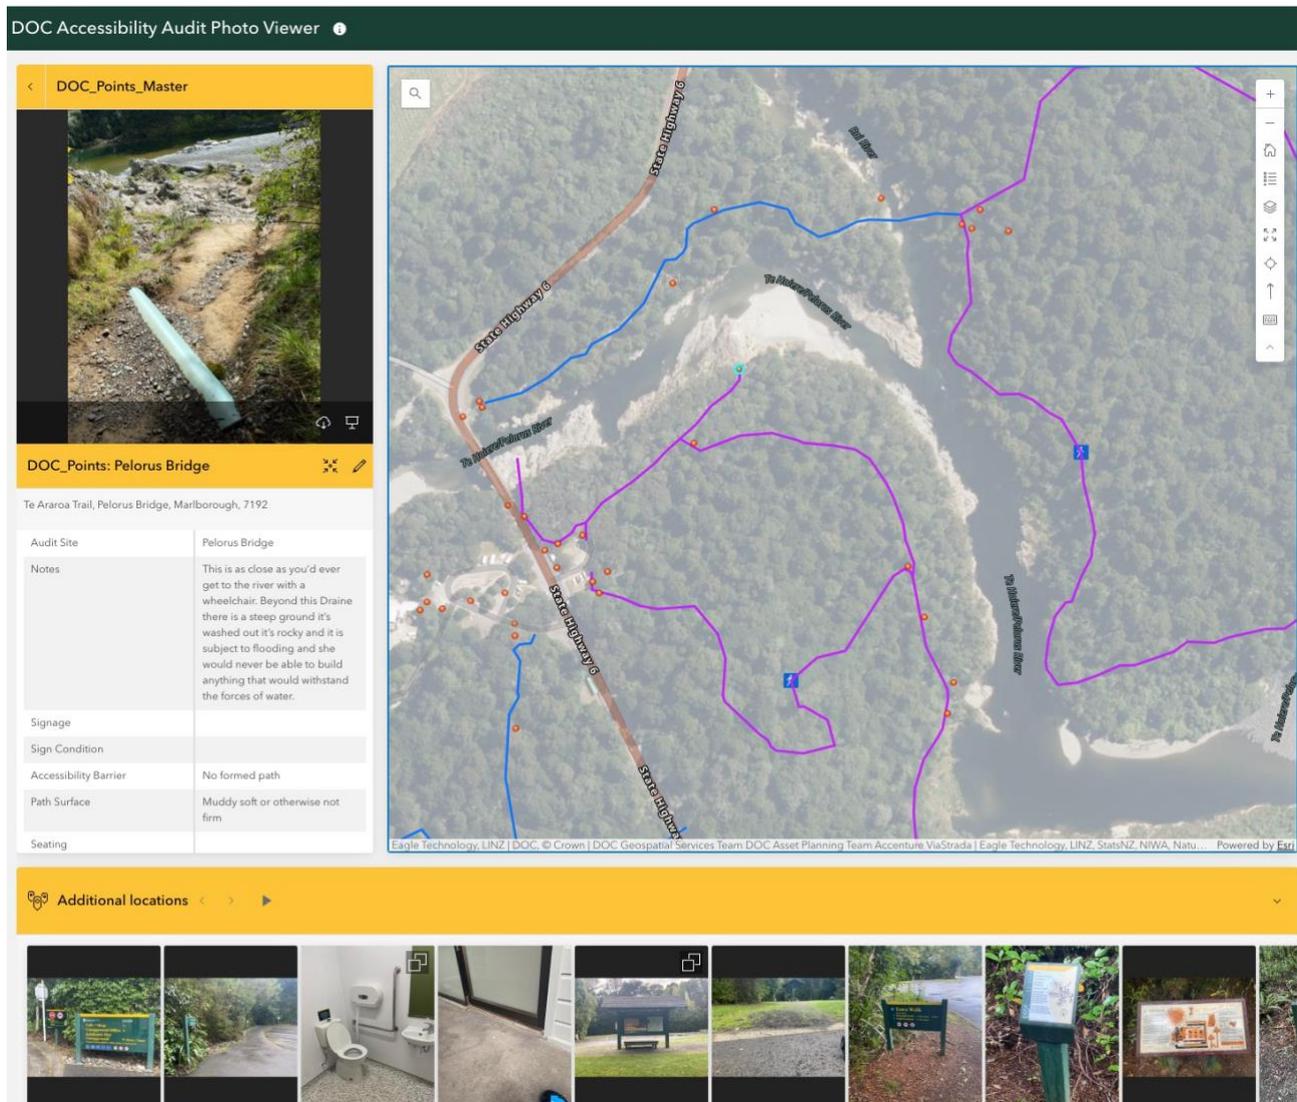
Figure 8: Full screen view of the Photo Viewer application

Additional information was recorded using ArcGIS FieldMaps and added to a web map with locations and routes of all audited tracks and campsites and the audit findings. Point features contain the recorded information which can be accessed by selecting a point. This opens a pop-up containing the information and photos. [A photo viewer application](#) enables users to see all recorded photos at once and by selecting a photo they can access the recorded audit findings. Zooming in and out of the map will make more (or less) points and photos visible.

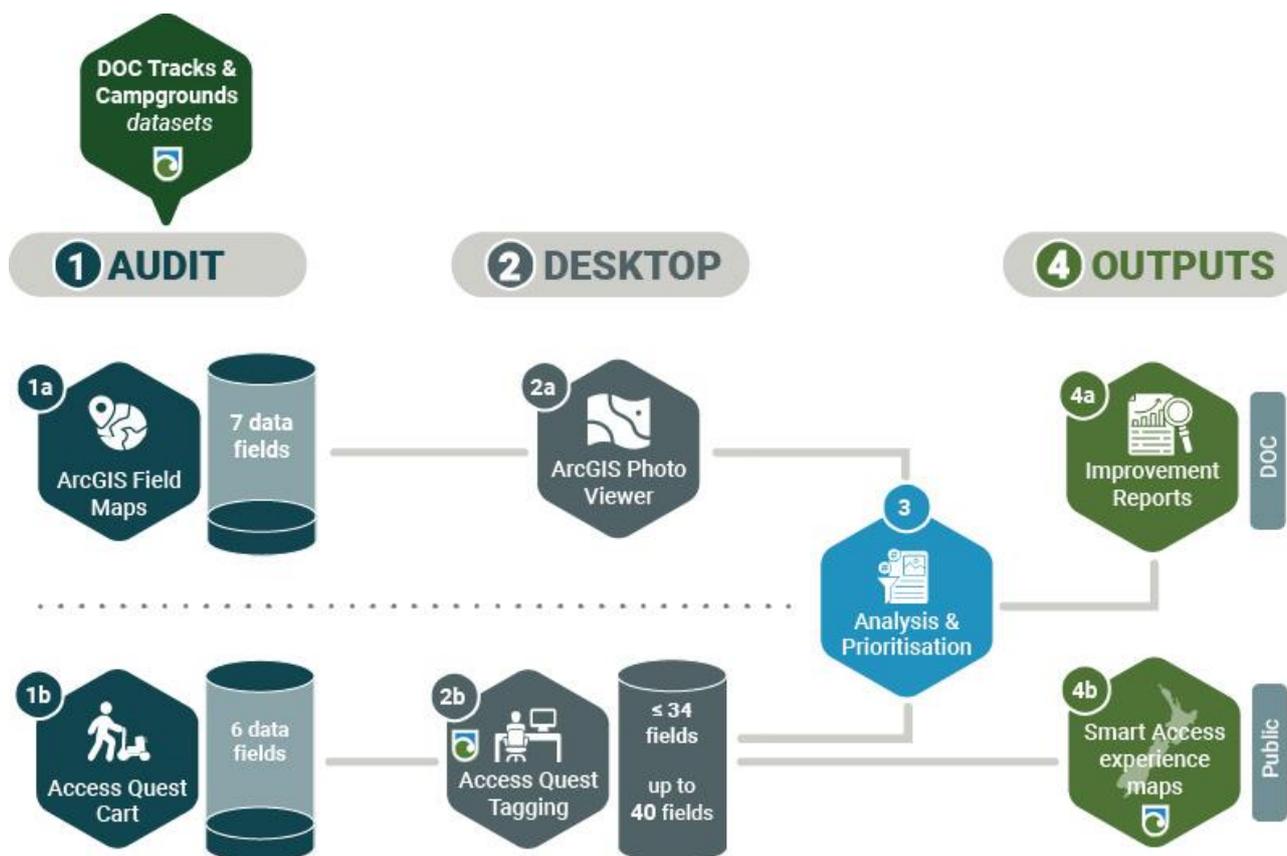
Figure 9: Data management schematic

Data collected during the project is used in different ways as shown in Figure 9.

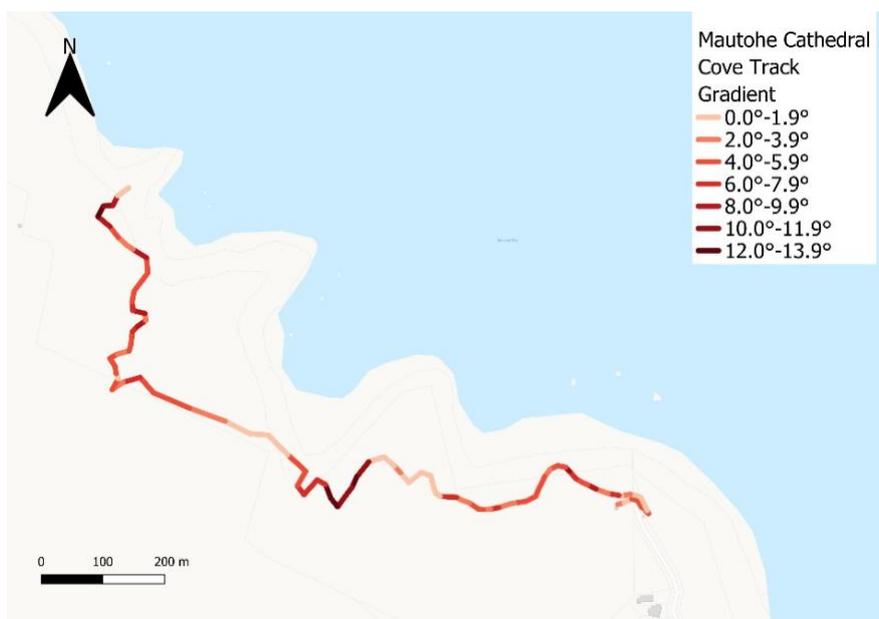
Figure 10: Typical output: a gradient map (for internal use to determine possible track improvements)

The audit process enabled the quick production of gradient (Figure 10) and cross fall/camber figures that would take much longer to develop using other methods such as LiDAR. With this data available to users, they can make more informed decisions when selecting their next outdoor experience. Both the average (presented in a range bin) and the maximum gradient offer vital context. For example, the Tōtara Walk has a maximum gradient of 6.86° (12% or 1:8 slope). That section is short and most of the walk has a shallower gradient. From this information, one user might assess the maximum gradient for the Tōtara Walk as too steep, while another user might consider the walk an acceptable challenge as it is steep only over a short distance. Future work that investigates accessibility challenges for shared paths and trails will need to consider the differing needs of those using wheeled devices, and in particular, powered devices that can comfortably handle gradients of 8° or higher.

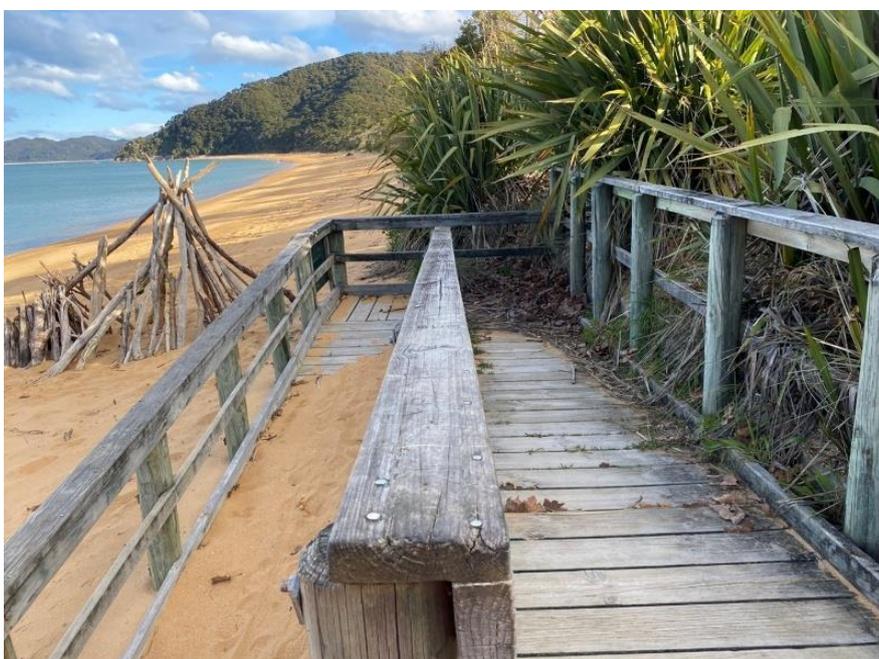
Data includes photographs and notes detailing surfaces, structures (such as bridges or steps), and a range of features and facilities such as orientation panels, accessible toilets, mobility car parks, and bench seats (Figure 11). The audits showed that many short walks and campsites do not have SOS – Safe, Obvious and Step-Free routes (NZ Transport Agency, 2025). Few sites had baby changing tables, rubbish bins, water fountains, or seating outside toilets for people waiting on other members of their party. By adding such facilities, experiences become accessible to a wider range of users.

Figure 11: Typical conditions photo showing the presence and condition of a feature or amenity – in this case a ramp that has a buildup of sand before reaching the beach
