Keeping motorcyclists (& cyclists) safer with low cost design

Practical engineering solutions for safer riders

Irene Tse, Technical Lead - Transport Safety
Auckland Transport

Dominion Road Trial

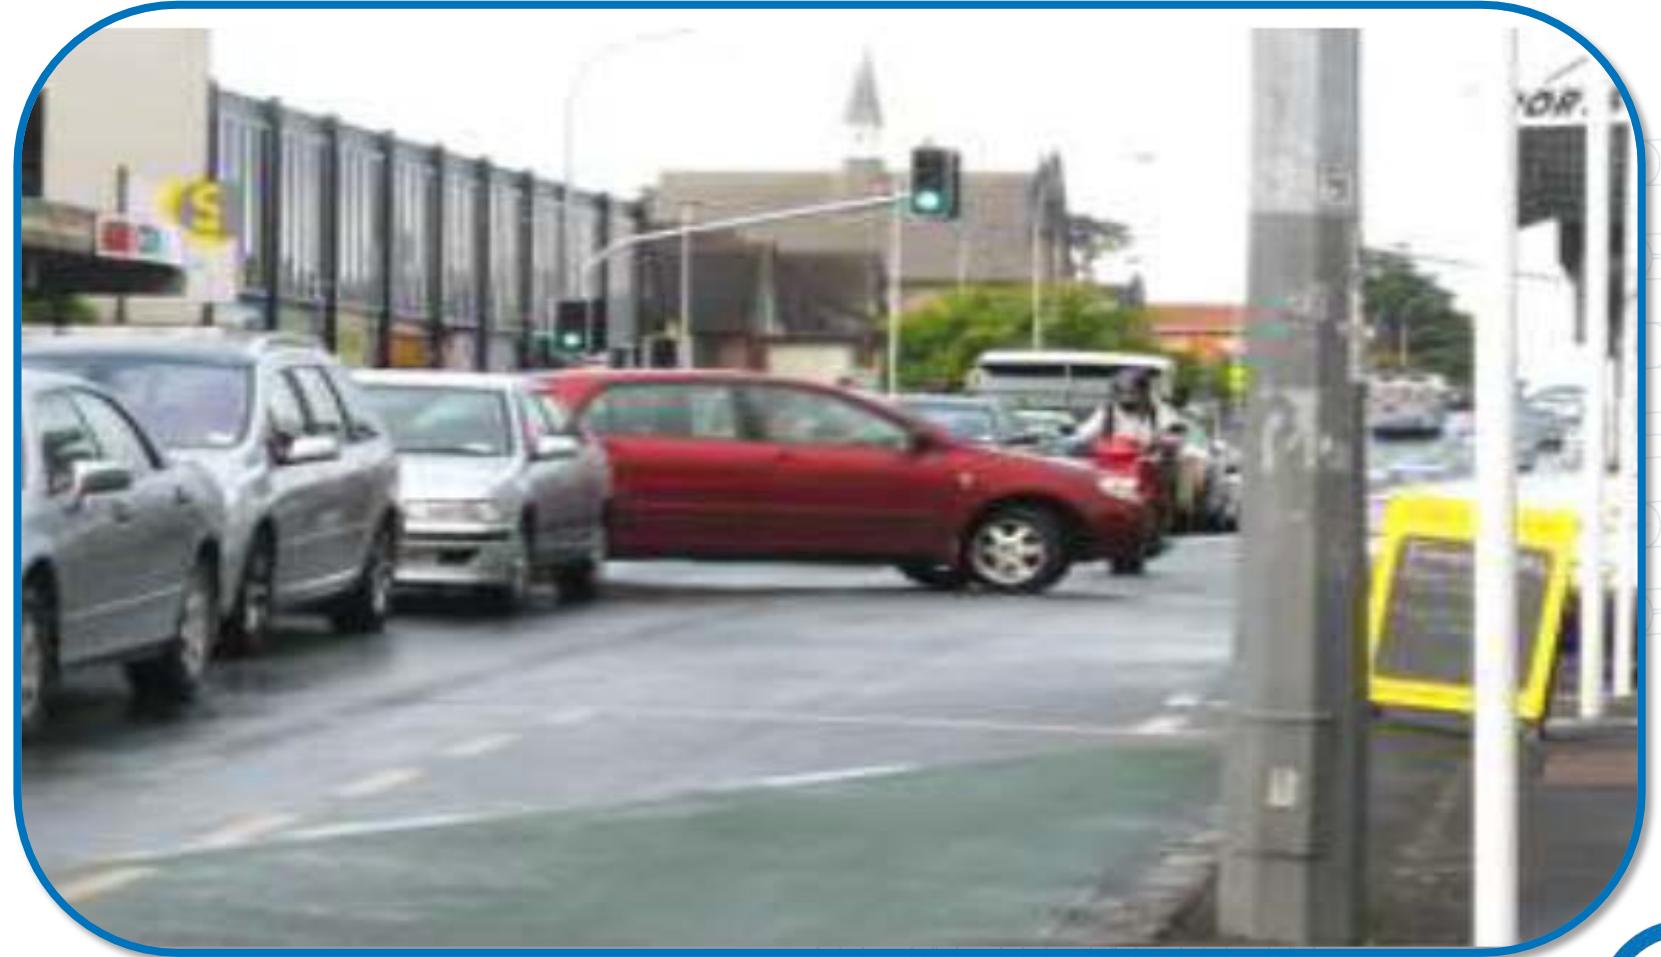
Stage 1 – The “yellow keep clear hatching” on general traffic lane

Changes implemented in 2020

- Keep clear hatching applied to general traffic lanes only
- Hatching extended 5-10 m in advance on each approach to the intersection
- Hatching length tailored to achieve sight distance

Intended outcomes

- Improved intervisibility between road users
- Reduced intersection blocking

- Injury crashes **halved** in 2.5 years
- Remaining crashes were less severe
- Fewer close calls observed
- **60% reduction** in vehicles blocking intersections
- **Improved visibility** for both drivers and riders was key
- **Design insight:** hatching alone may not be enough for meaningful results

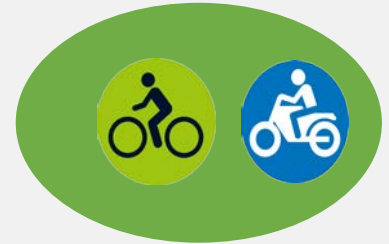
Stage 1a – Active Warning Device

- Active Warning sign with Flir camera detects riders' presence in kerbside (bus lane) lane.
- Activates a flashing warning sign facing the right-turning traffic

- Alerts right-turning vehicles to oncoming cyclists and motorcyclists in the kerbside lane

Motorcyclist / Cyclist detection

Flir camera detects or motorcyclist cyclist approaching

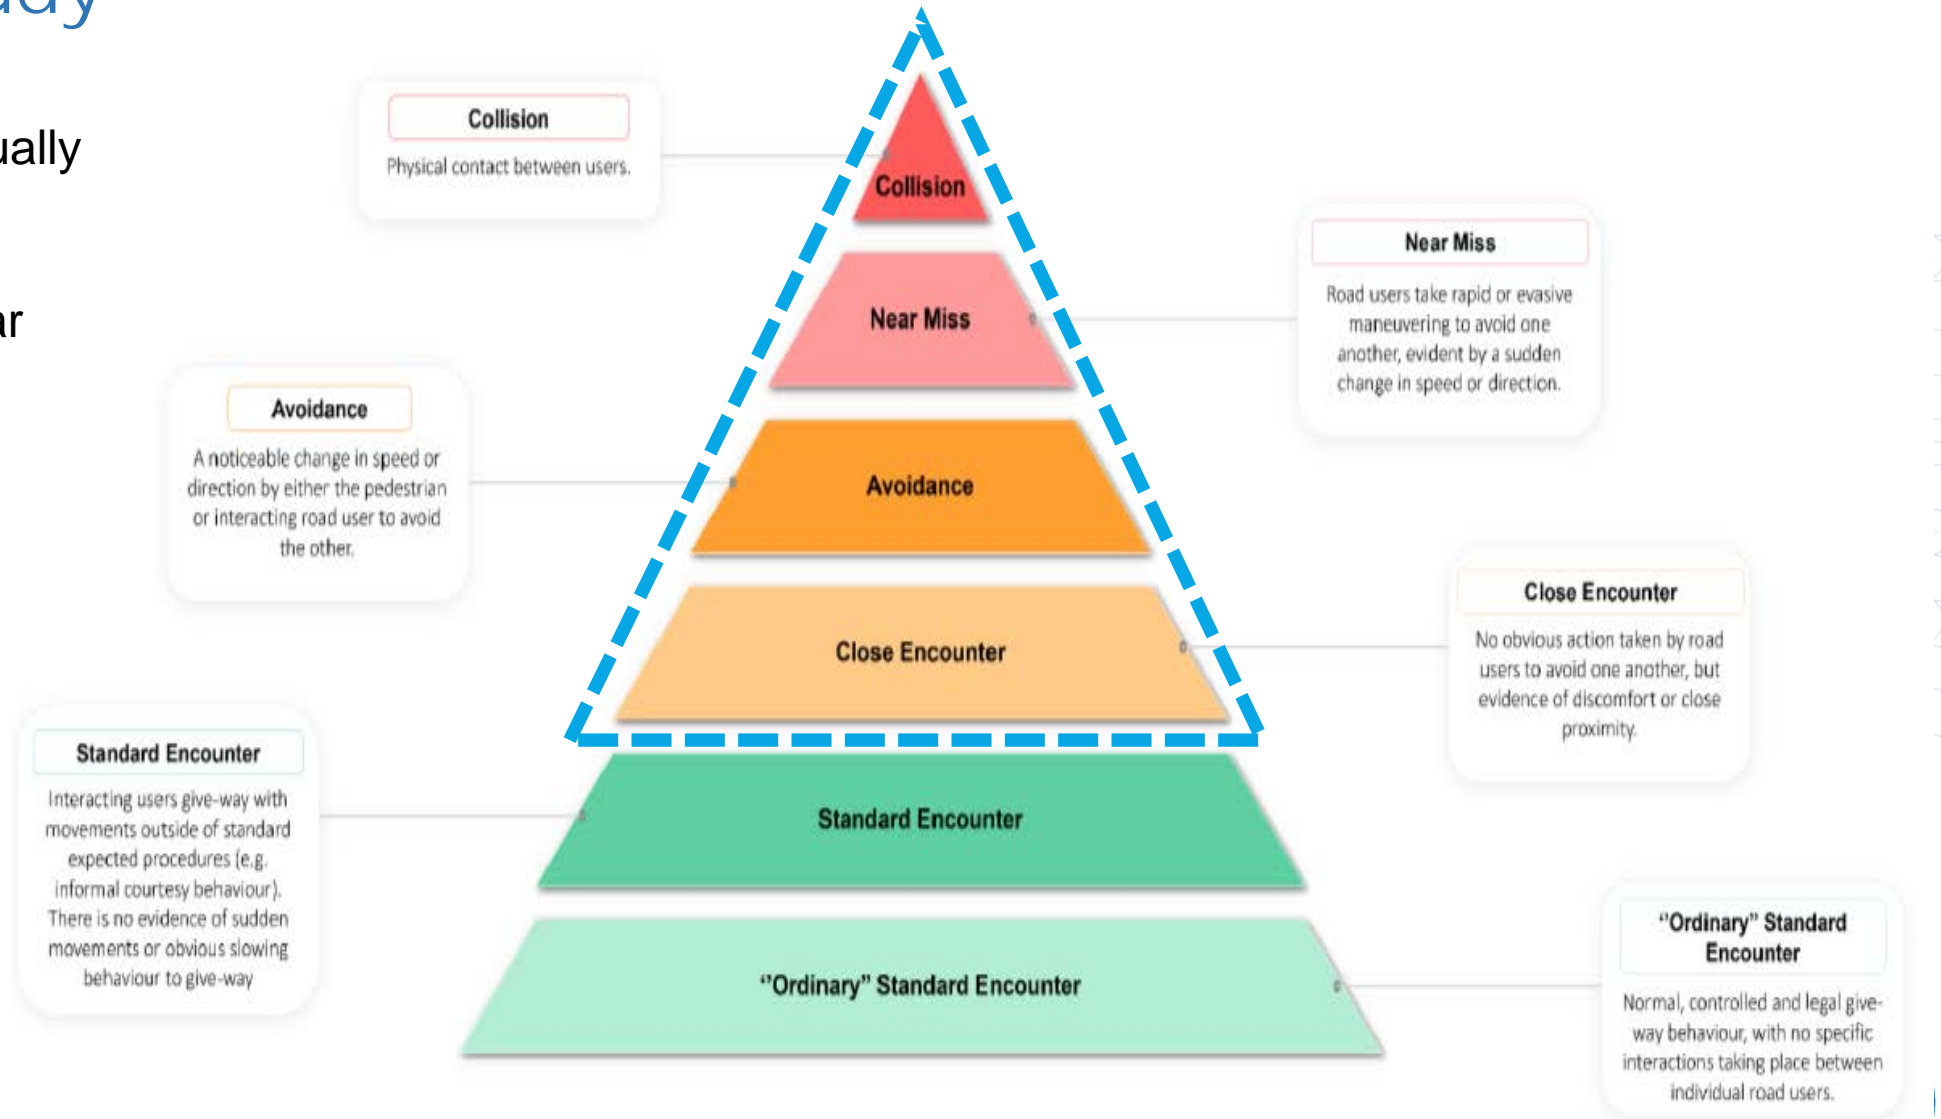
Figure 2 Encounter Types in Hierarchical Order

Conflict study

Two week peak – period video – manually analysed to identify serious, high risk interactions (i.e. near misses, avoidance manoeuvres or collisions).

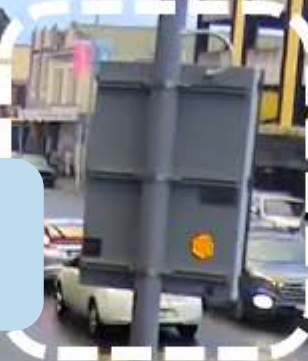
Vehicle sights flashing sign.
Stops for bike.

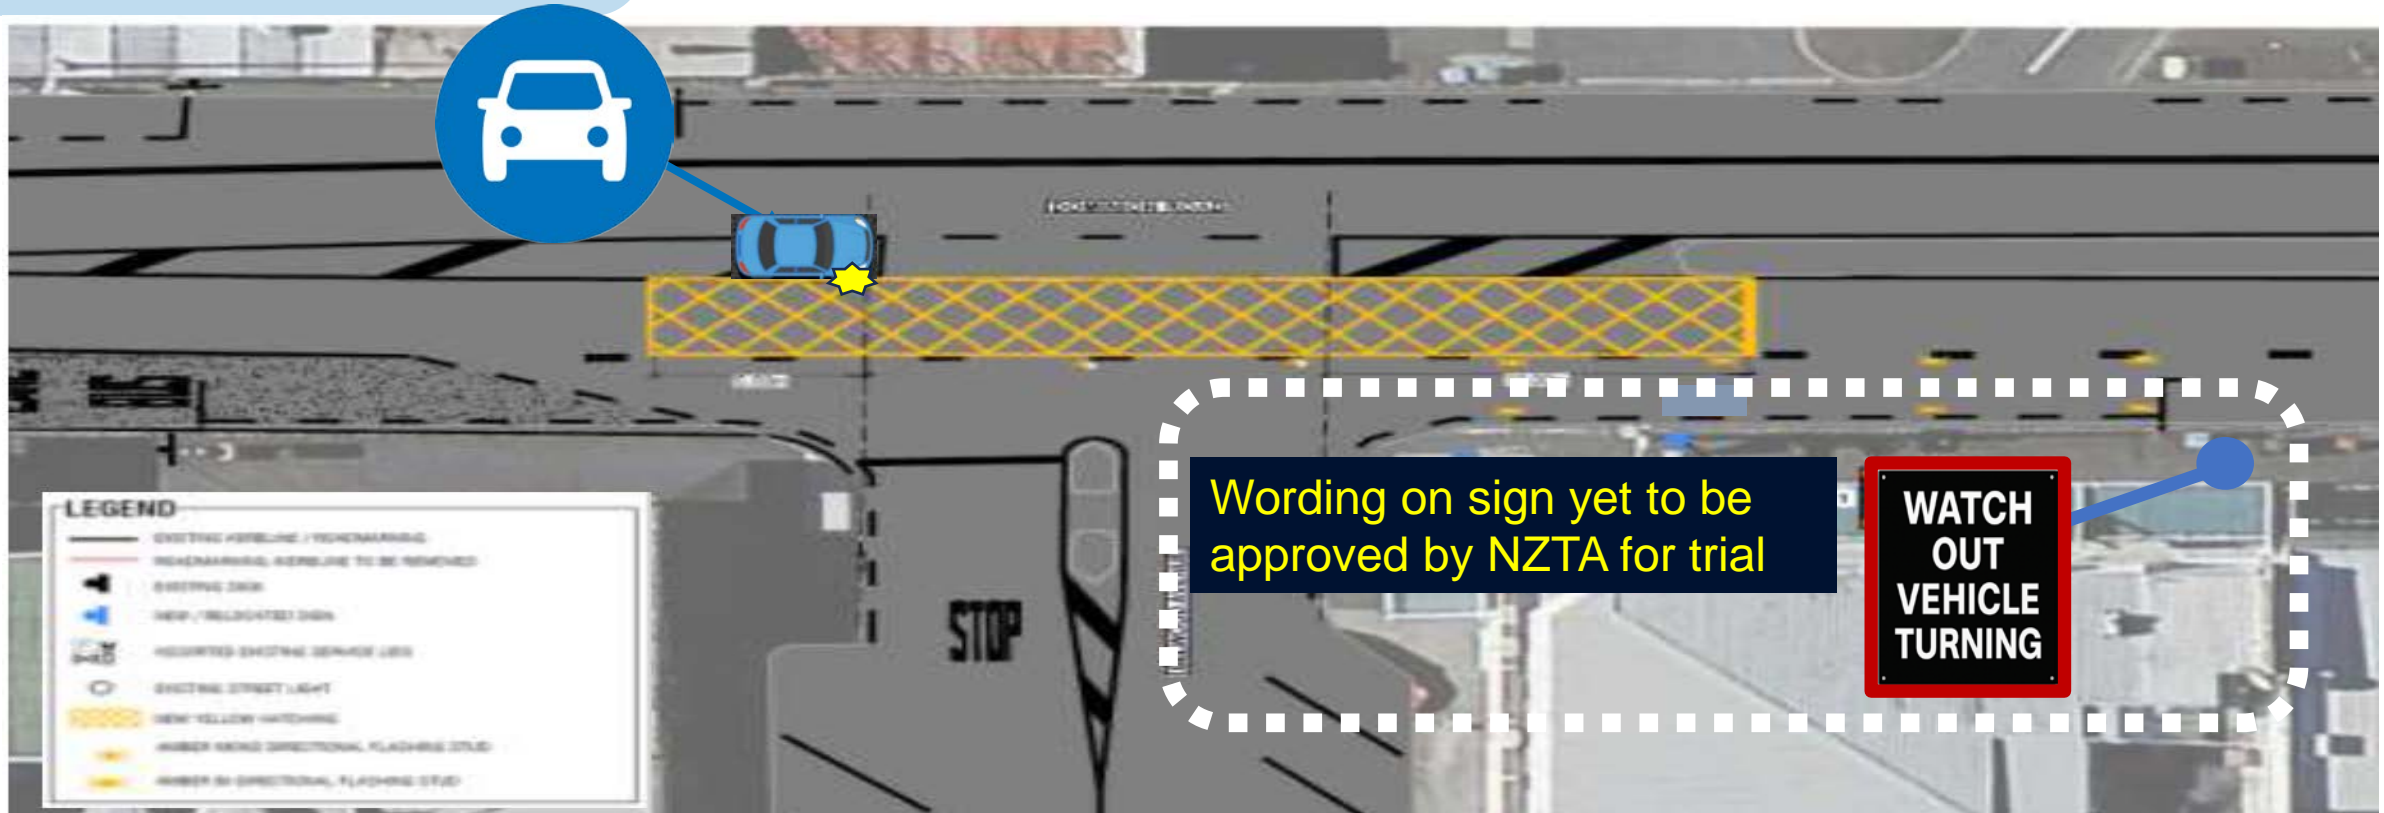
Next phase – Active warning device operation

Right turn vehicle detection

Flir camera detects the presence of right turning vehicle

The “watch out vehicle turning” sign warns cyclists / motorcyclists about right-turning vehicles so they can **slow down** (reduce both likelihood and severity should a crash happens) and stay alert.

Wording on sign yet to be approved by NZTA for trial

WATCH
OUT
VEHICLE
TURNING

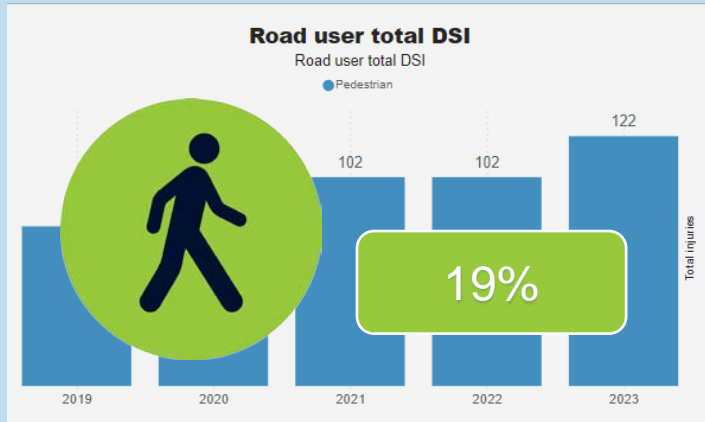
Pedestrian DSI trend – 487 DSI on AT network, 12 on state highways

Pedestrians made up 16.4% of DSI casualties on AT local road

- 32% at intersections (158 DSI).
- 53% of pedestrian intersection crashes were at priority controlled (GW & STOP) intersections.
- 42% of pedestrian intersection crashes were at signalised intersections

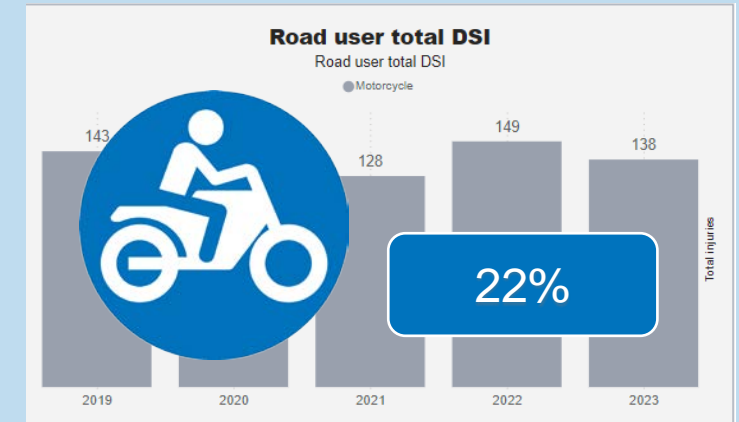
Motorcyclist DSI trend – 569 DSI on AT network, 98 on state highways

Motorcycle and Moped riders made up 19.5% and 2.1% of DSI casualties respectively on AT local network.

- 41% occurred at intersections (236 DSI).
- 64% of motorcyclist intersection crashes were at priority controlled (GW & STOP) intersections.
