# SH1 UTIKU LANDSLIDE

# OUTLINE

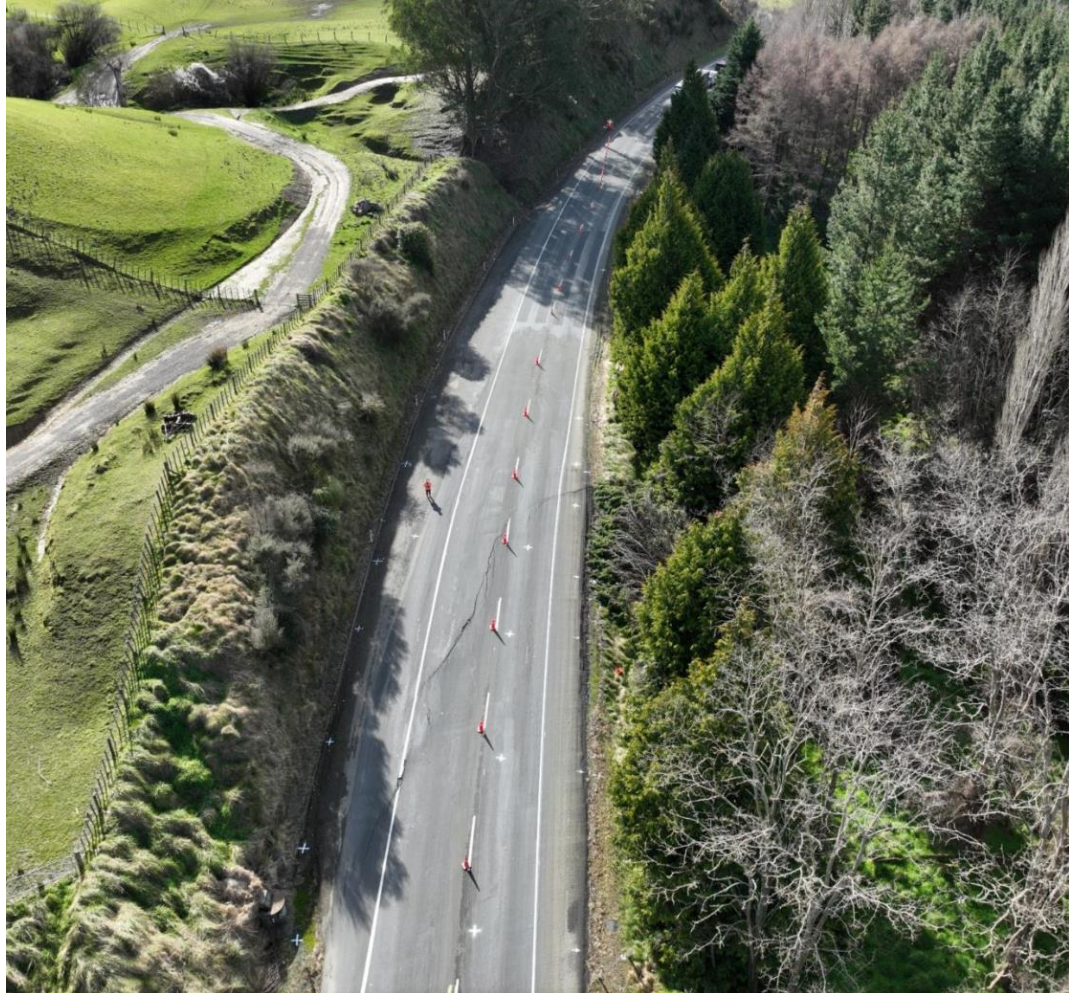
- August 2023: significant tension cracks observed across the landslide following prolonged above average rainfall.
- Emergency response consisted of:
  - Temporary road reinstatement and TTM
  - Monitoring and establishment of a TARP
  - Landslide assessments

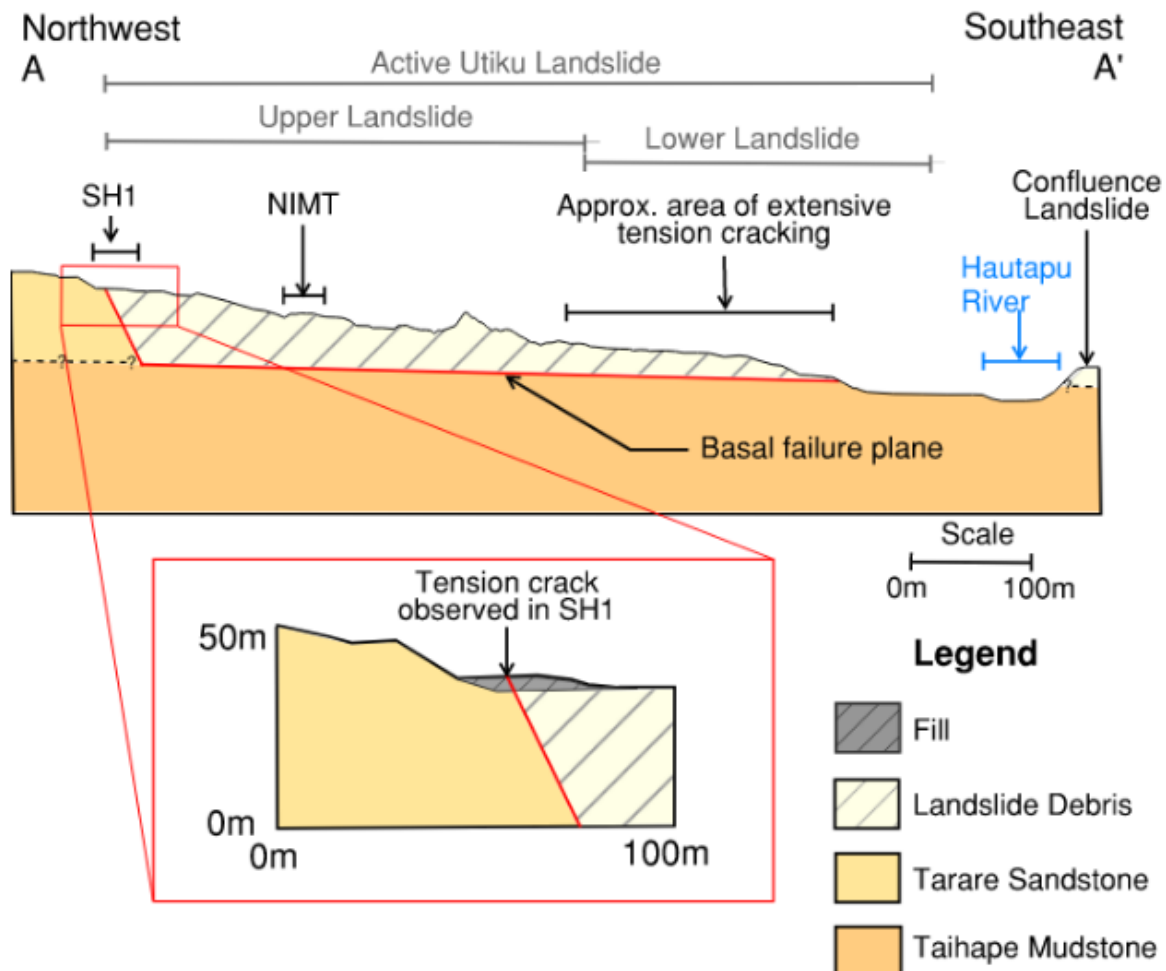
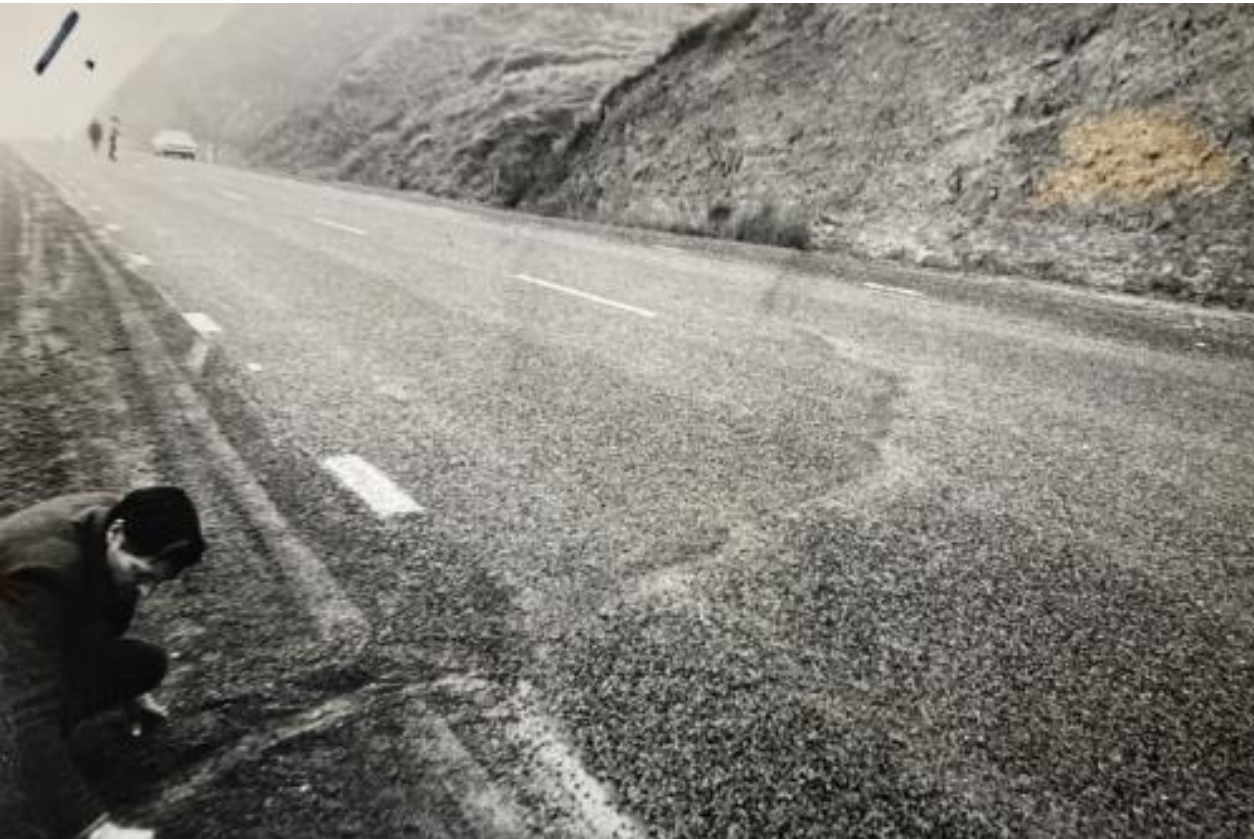
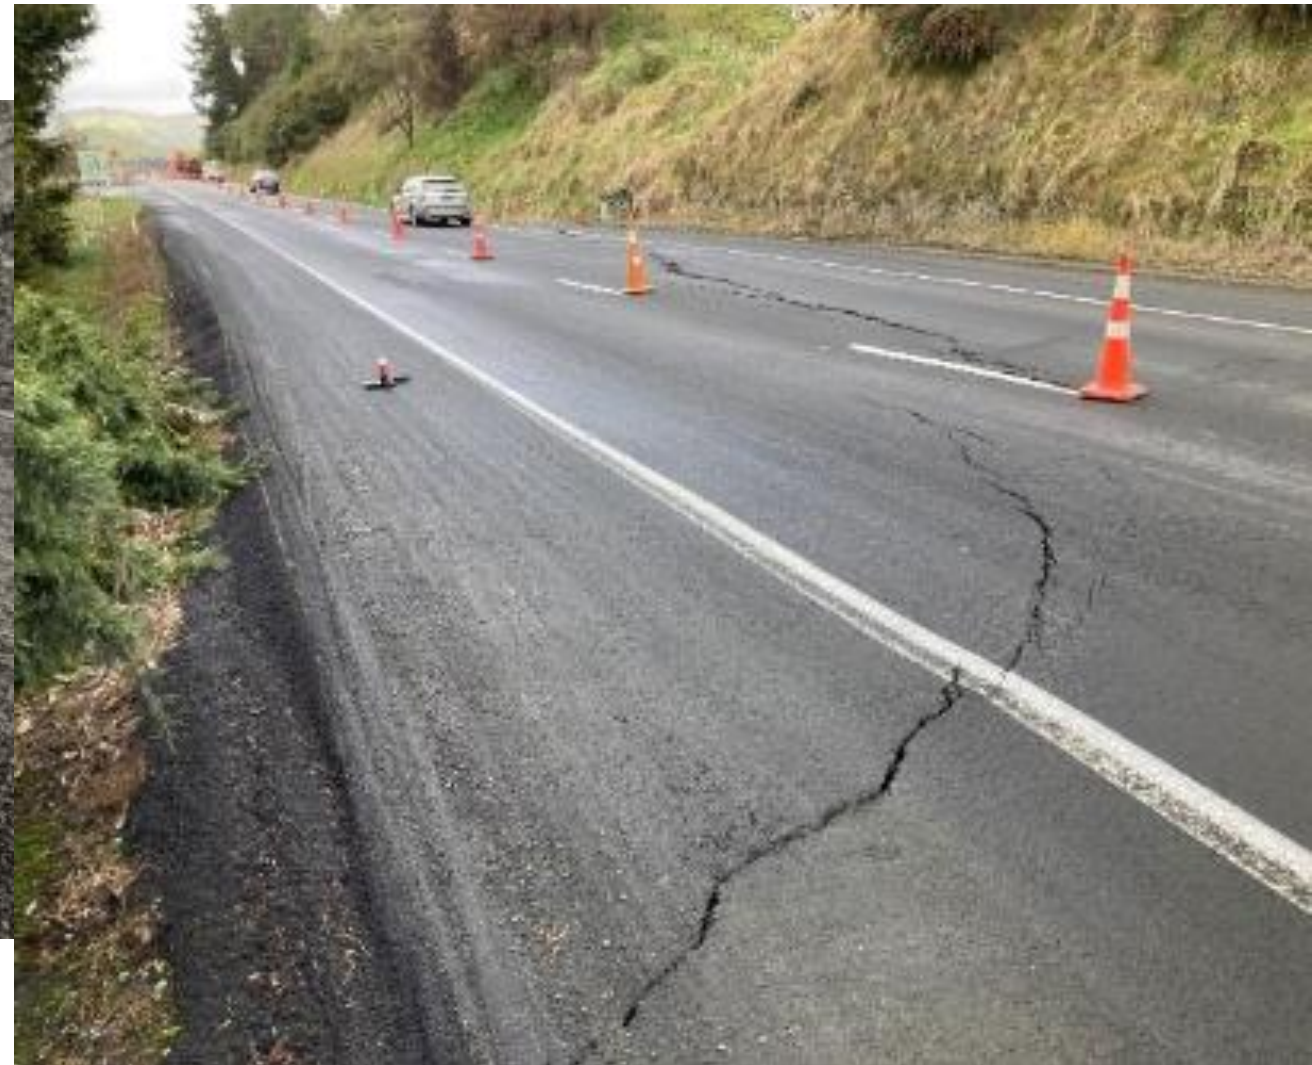
- Large, reactivated, deep-seated landslide
- Failing along a clay seam about 45-75m below road level
- Landslide movements are caused by elevated groundwater levels, related to long periods (12-20 weeks) of above average rainfall

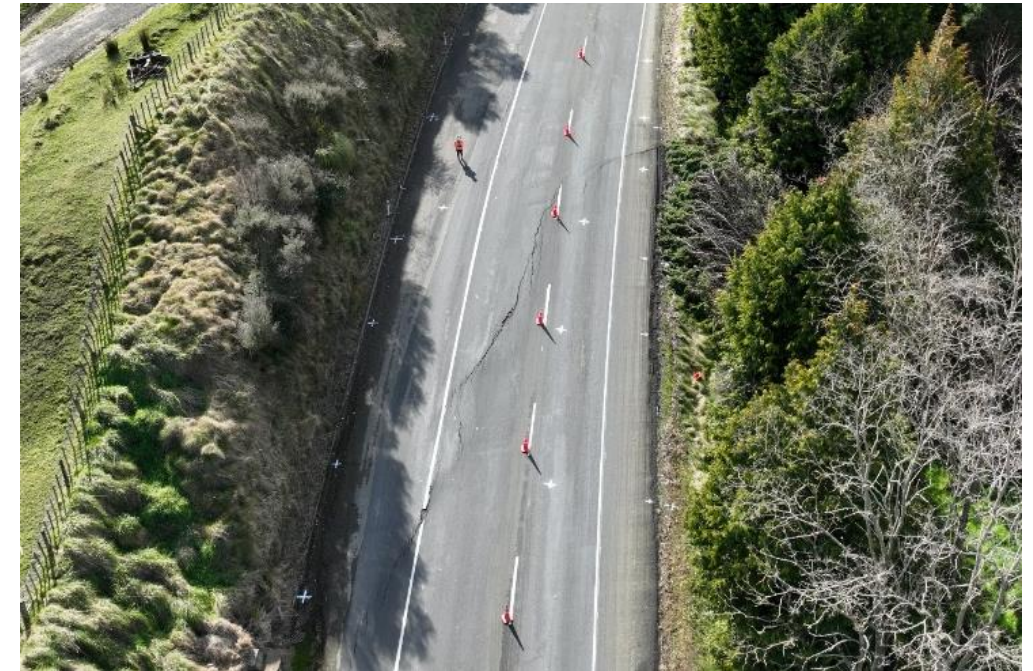
- Multi-faceted design:
  1. Minor road realignment including undercut and subgrade improvement, with surface water and pavement drainage improvements;
  2. Installation of fanned inclined drains to relieve groundwater pressure and improve landslide stability;
  3. Ongoing instrumentation and monitoring

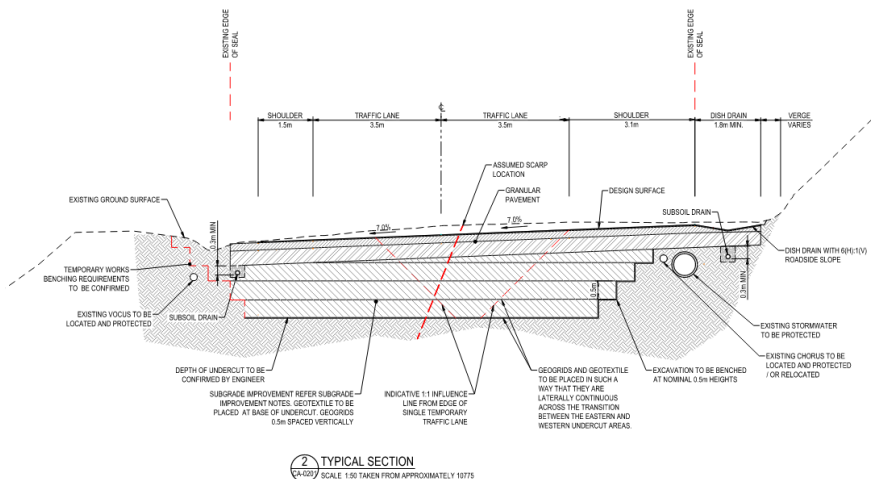
- Design intent: reduce surface expression of movements
- Undercut in areas where movement has been experienced or signs of deformation observed
- Surface and pavement drainage

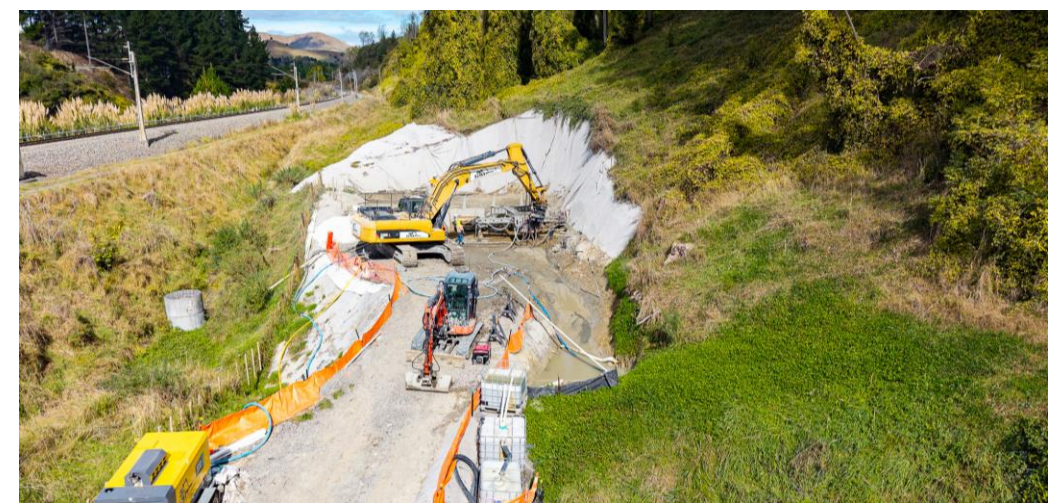
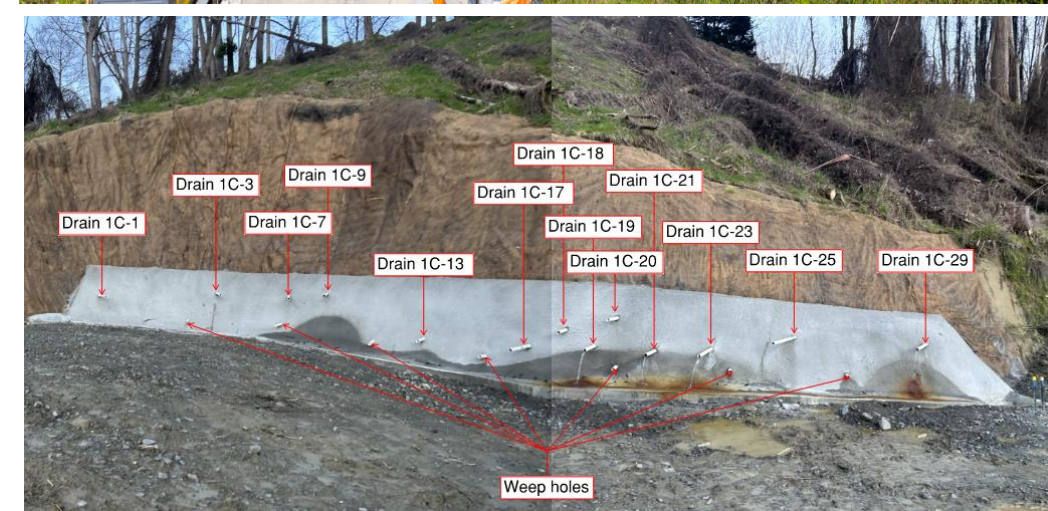
- Management of groundwater levels is key to reducing the likelihood of landslide movement.
- Fanned inclined drains (up to 100m long) chosen as preferred solution. Designed 4 drain platforms between SH1 and NIMT, based on:
  - Geology and hydrogeology
  - Efficiency
  - Cost
  - Resilience
- Constructed two platforms (1B and 1C) & total of 24 drains

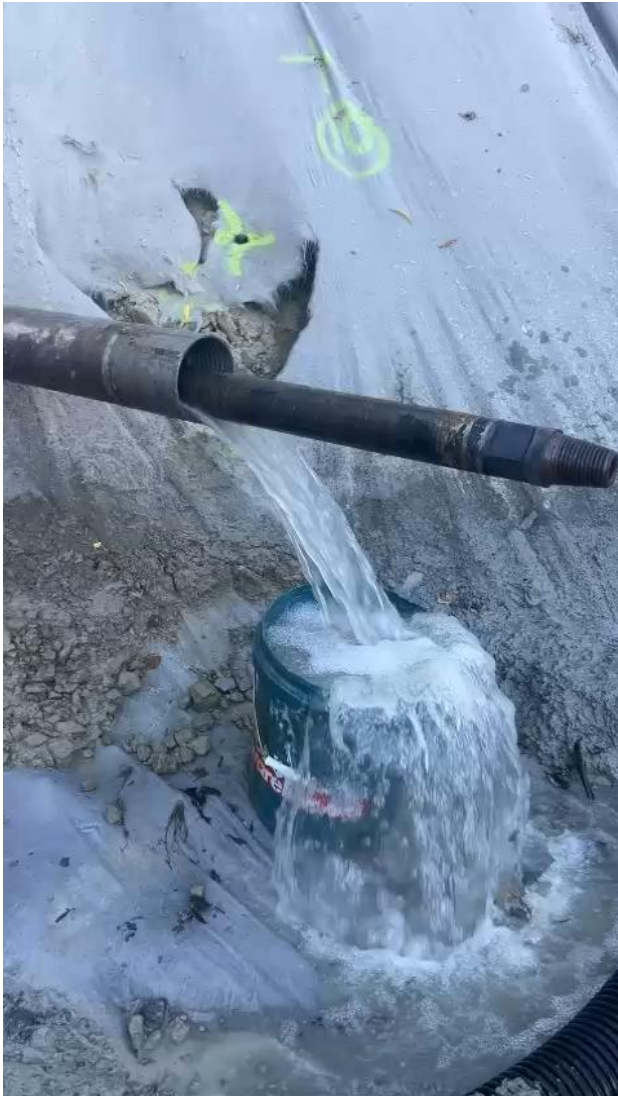
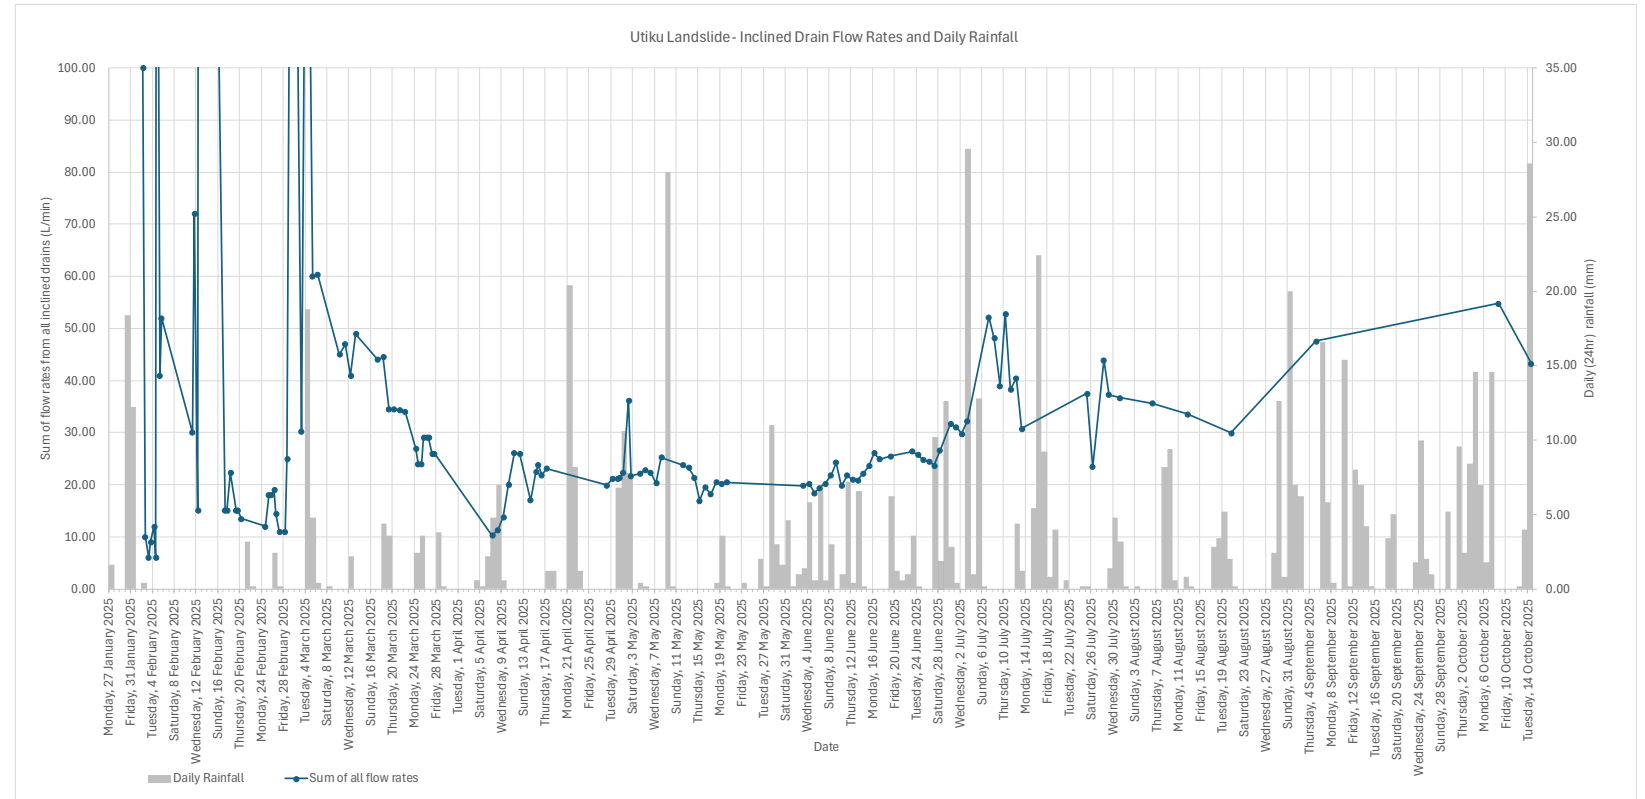
- Generally a high flow rate after initial drain installation, and then a significant decrease in the flow rates over time, with sustained flows at lower rates at a few drains.
- Combined flow rates on average 30 L/min

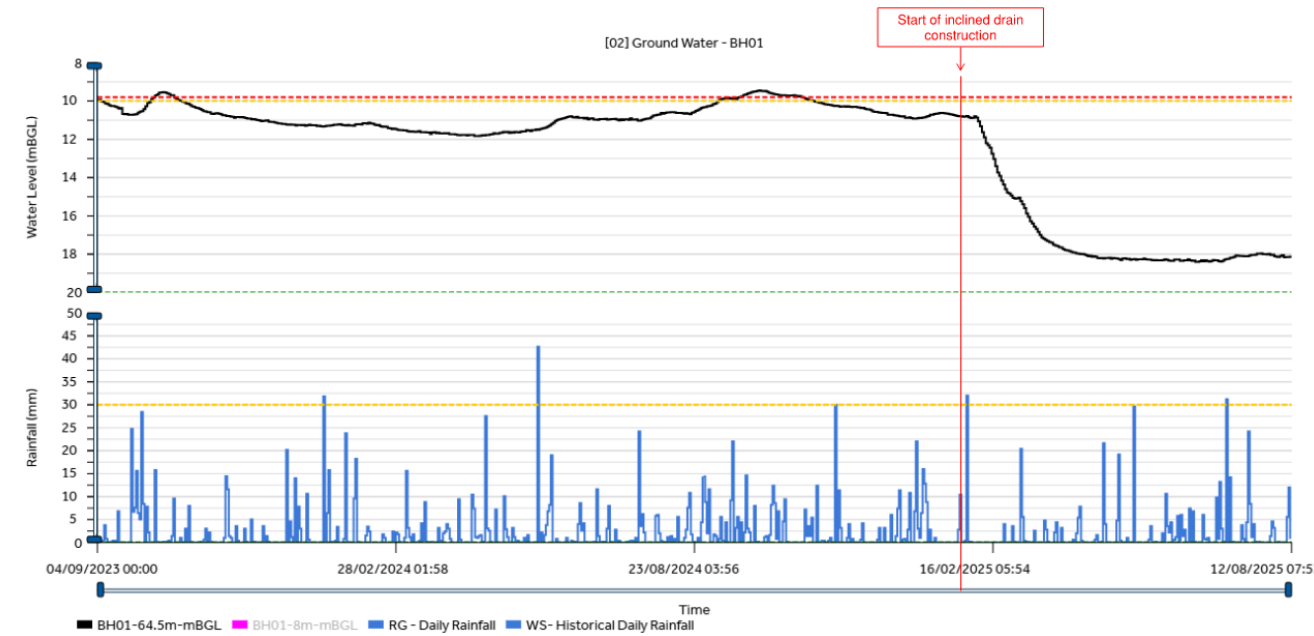
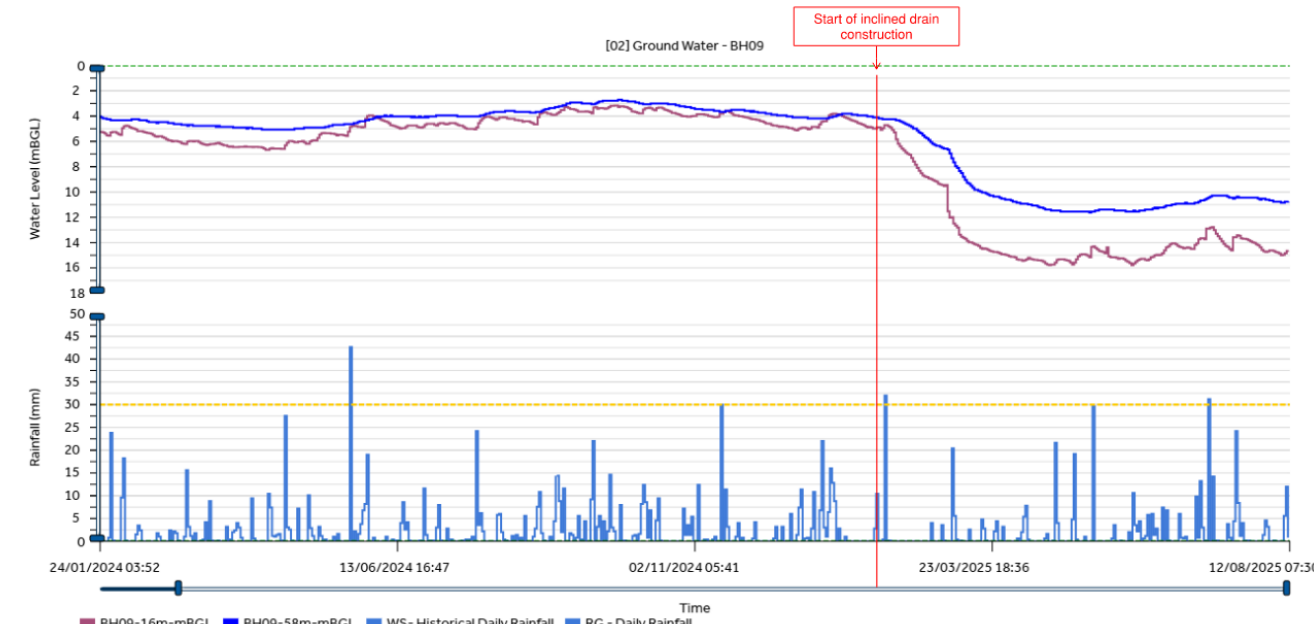
- Drains almost immediately had significant impacts on groundwater levels
- Groundwater lowered by up to 9 m
- Performance based observational approach (real time monitoring used to guide drain installation) enabled the team to:
  - target drain construction and maximize the effectiveness of the drains
  - utilise the available budget as efficiently as possible.

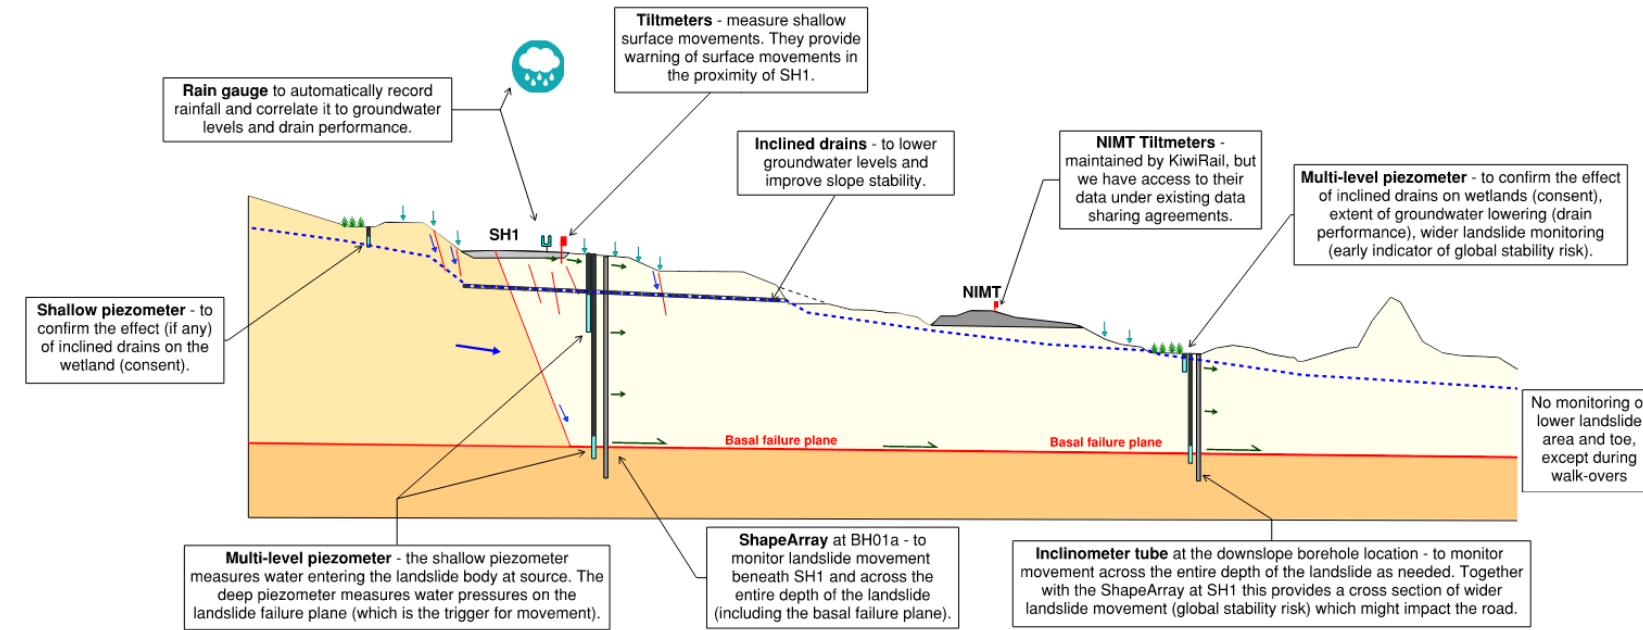
The instrumentation and monitoring has been, and continues to be, utilized for multiple purposes:

- Landslide risk monitoring (TARP)
- Inclined drain construction
- Inclined drain performance
