A dangerous, hostile pedestrian environment

auckland design office

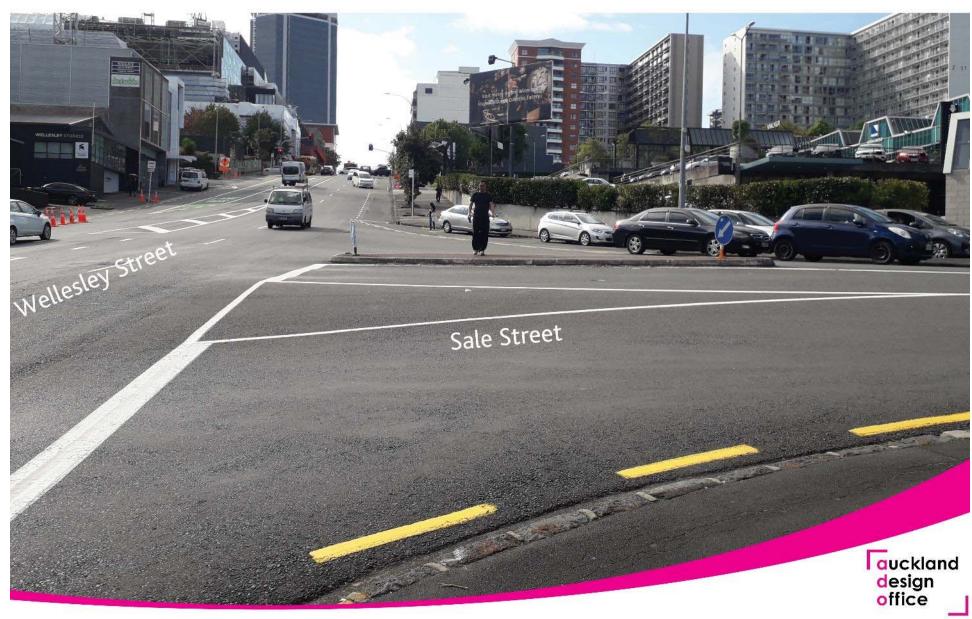
1. Remove 17 car parks

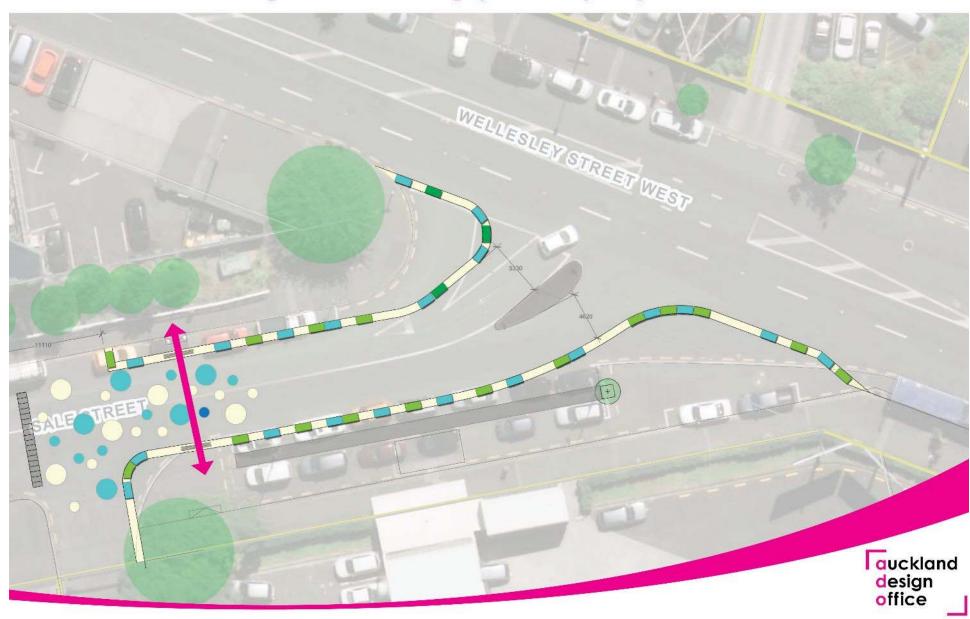
4. Define new public realm with graphic pattern

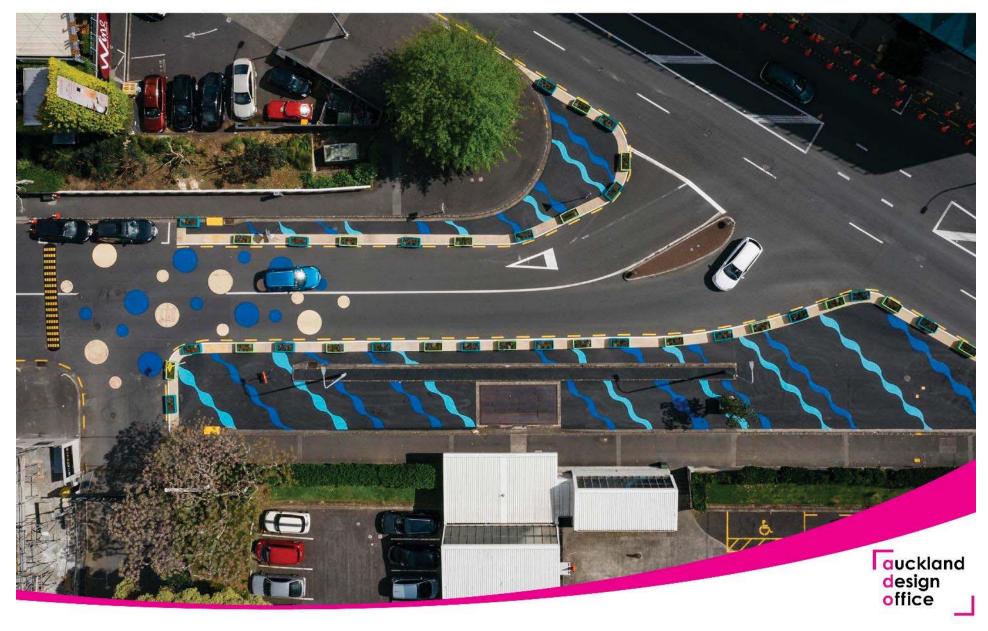
A significant increase in pedestrians taking the shortest path across Sale St

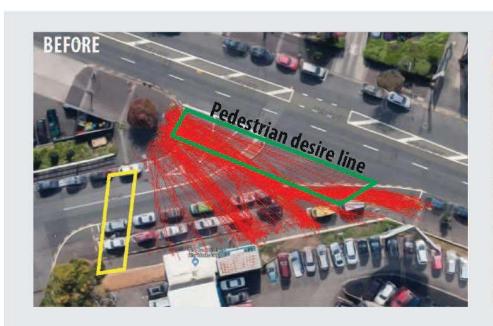
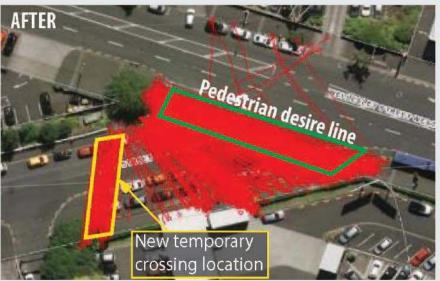
A significant improvement to crossing conditions
