Quick Build Cycle Lane Protection

Lessons Learnt in Auckland

Mitra Prasad – Technical Lead Active Modes Integration
Auckland Transport

Pop Up Protection Program

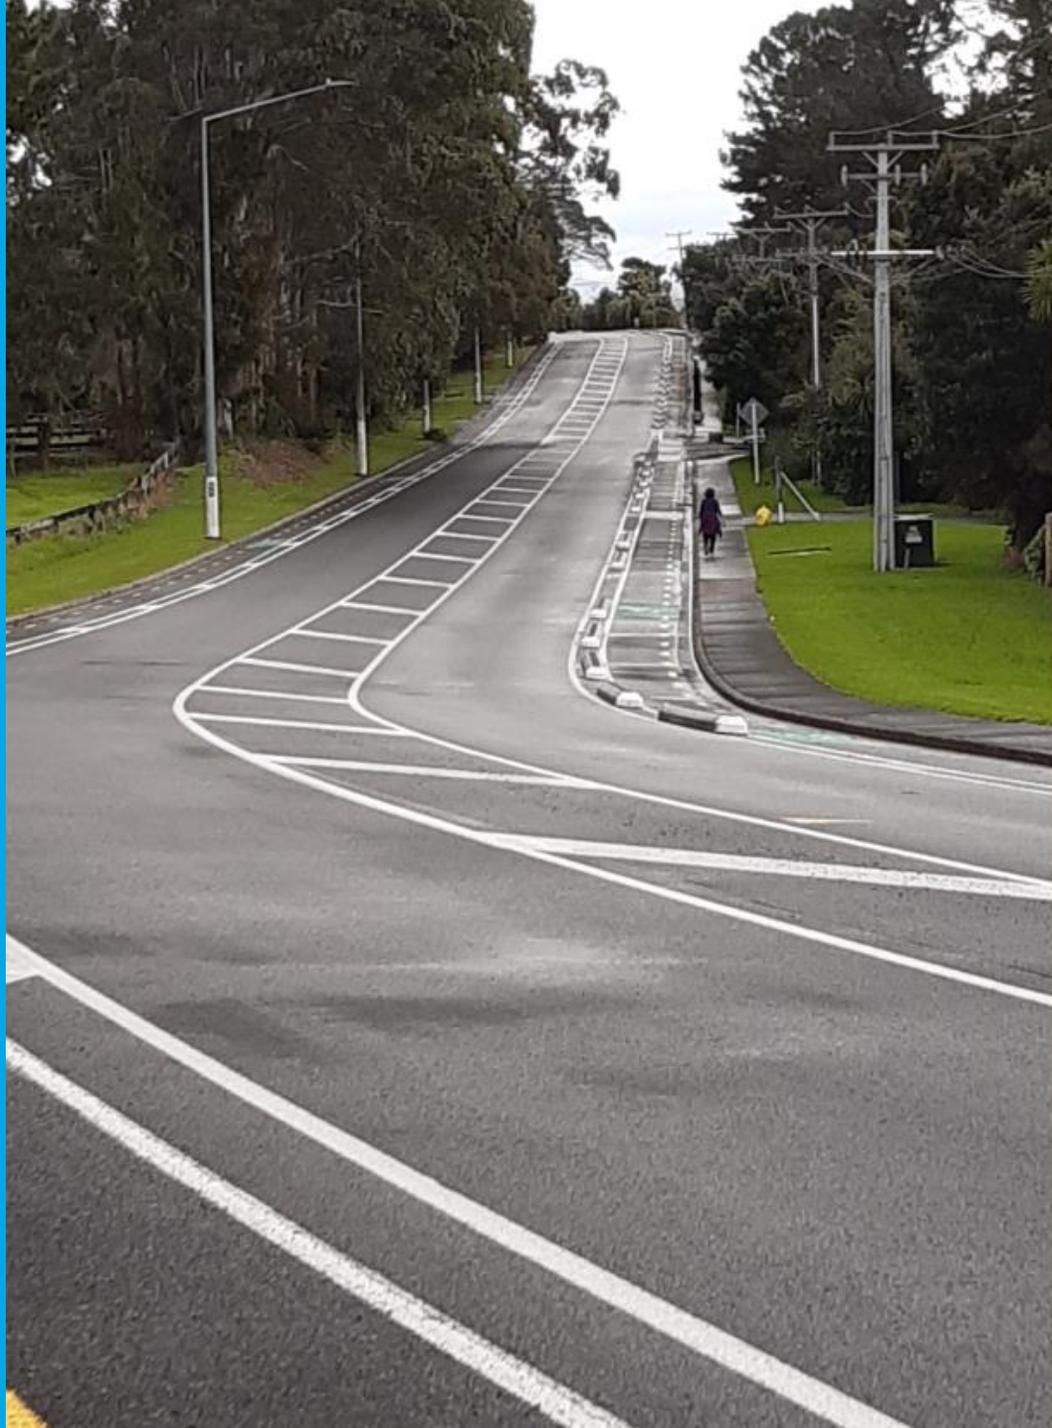
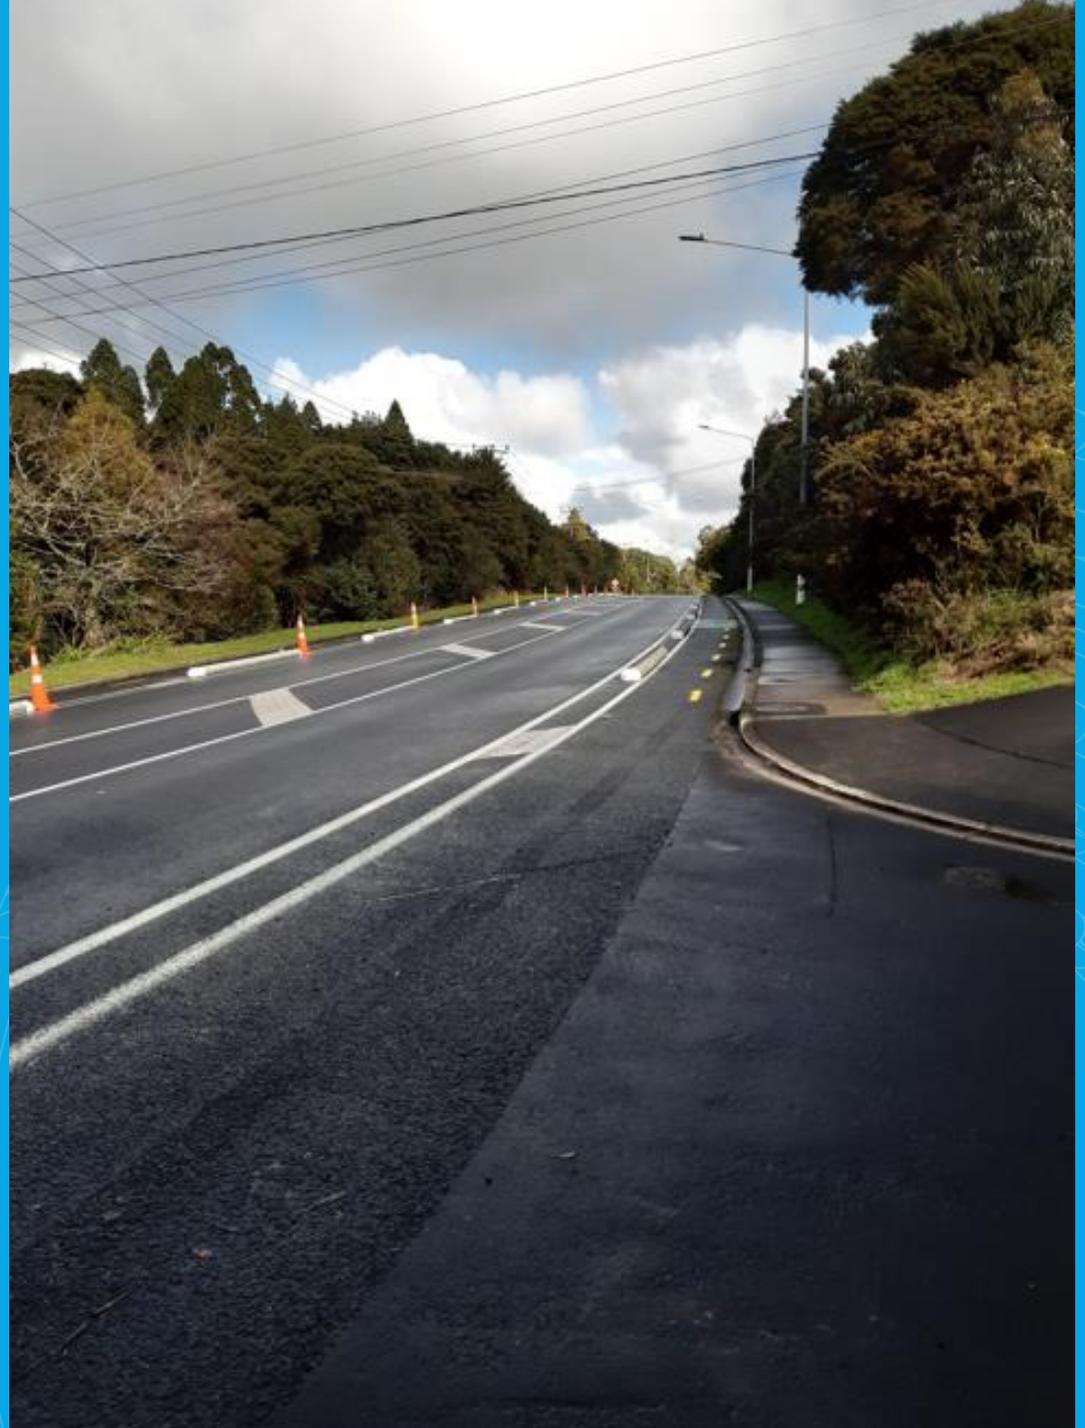
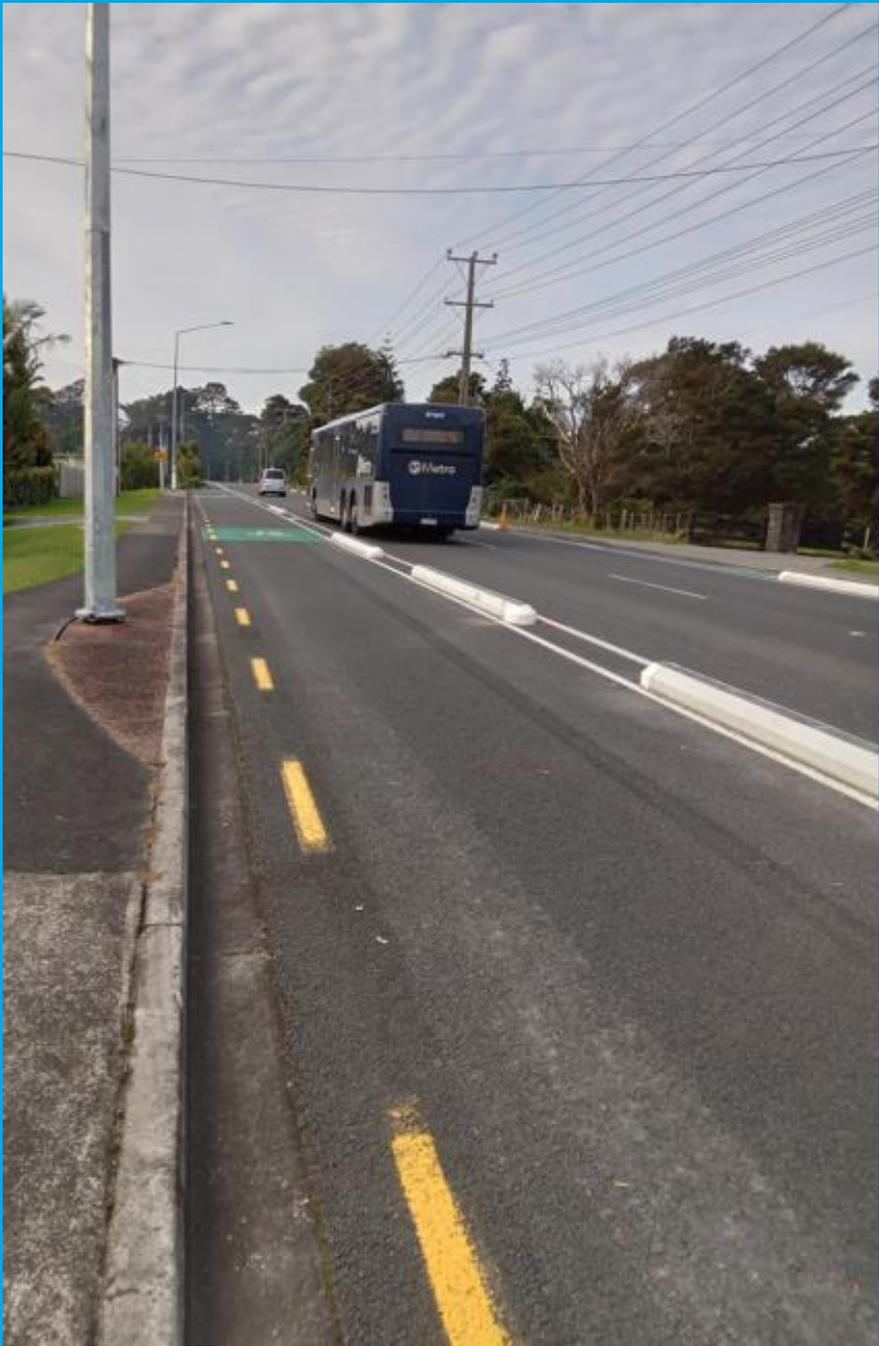
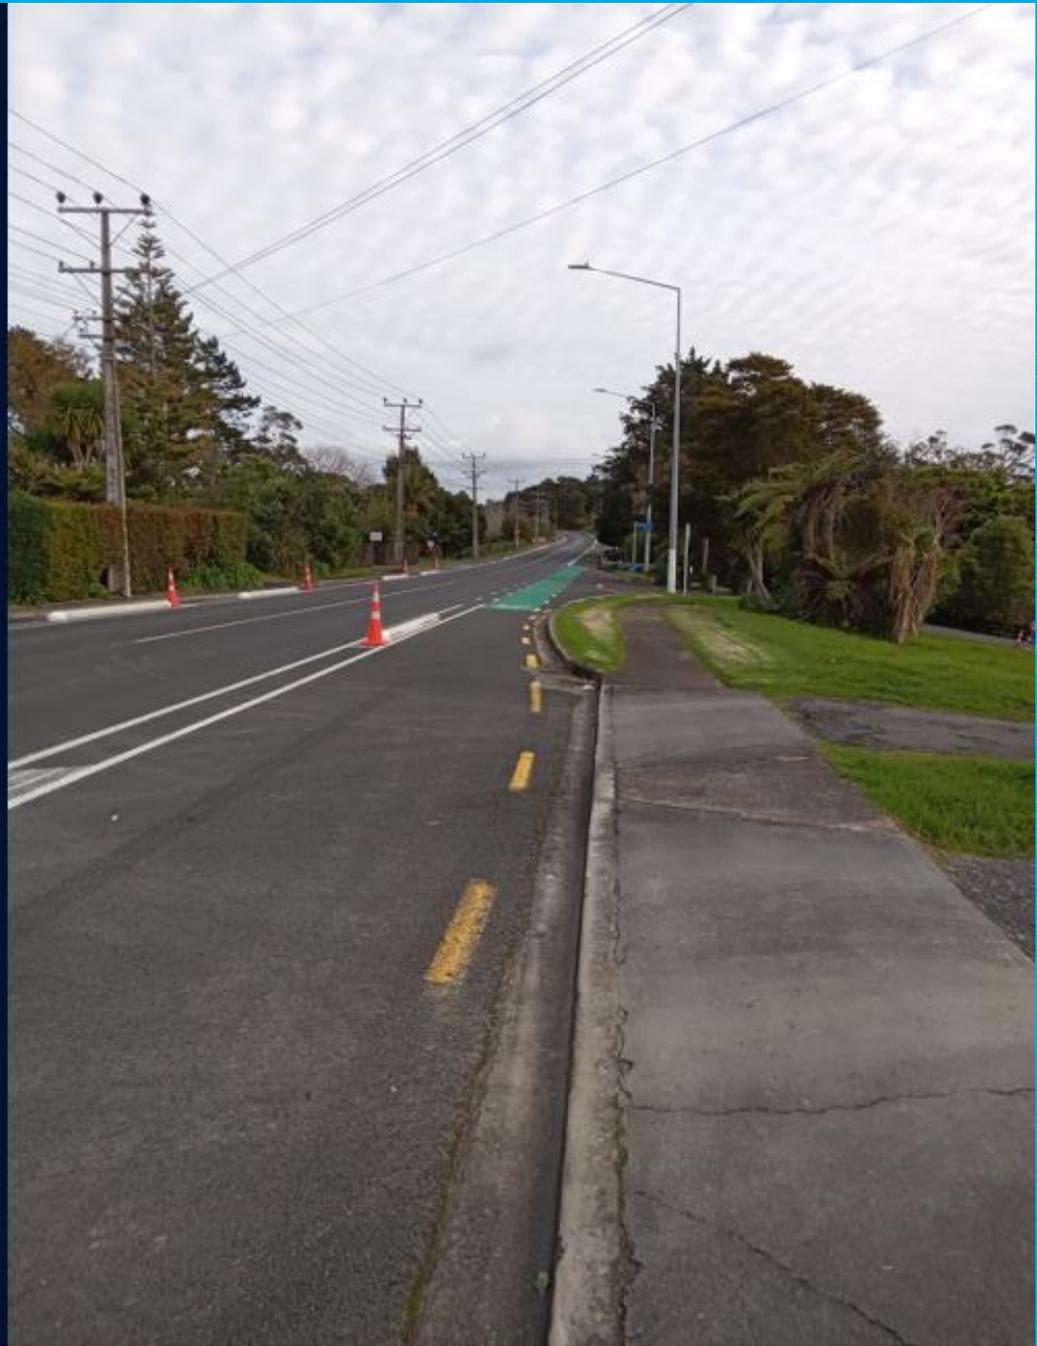
Upper Harbour Drive

- Carries around 6000-7000 VPD.
- Former State Highway and is often used as alternative route to Upper Harbour Highway (SH18).
- 70km/h speed limit, around 80km/h 85th percentile speed.
- Approximately 4km long between Albany Highway and Tauhinu Road.
- Important link for cycling between North Shore and West Auckland.
- Previously had existing painted cycle lanes with 0.5-0.6m wide buffer. The plan was generally to place separators within existing painted buffer.
- Installation of separators began in March 2022.

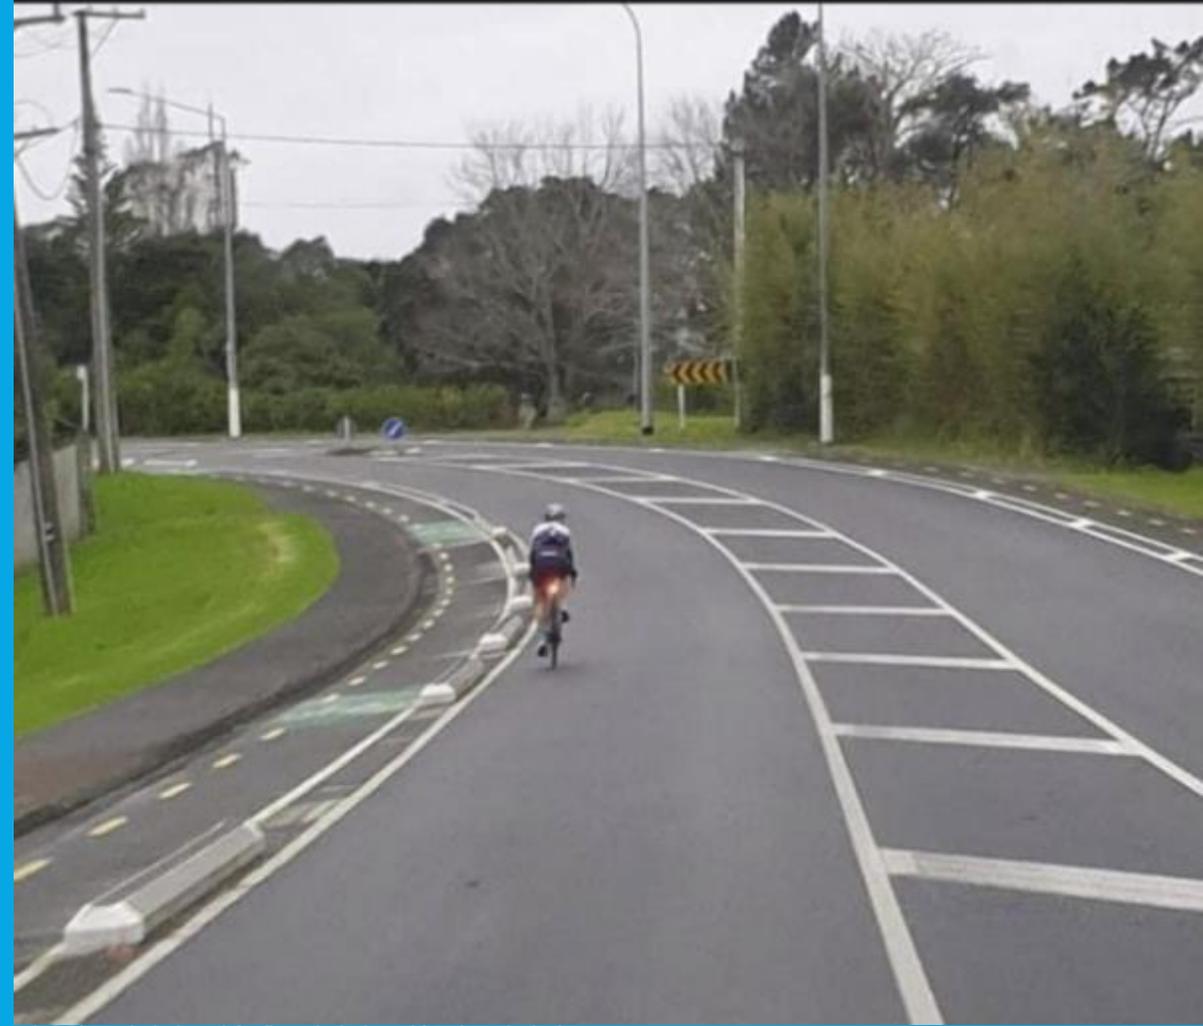
Upper Harbour Drive Accidents

- 34 accidents reported in total, including 3 of which involved cyclists hitting separators, all of which resulted in minor to serious injuries.
- Happened somewhat sporadically, on sections with both flush median and no flush median.
- Where collisions happen at speed, this results in damage, particularly wheel rims and tyres. Where damage occurs, appears to be vehicles colliding with front end of separator.
- Some vehicles have mounted over separators (160-180mm high) causing damage to underside.
- Some collisions have been reported getting in and out of driveways (low speed) and tyre marks on separators suggest this was occurring more often than reported.

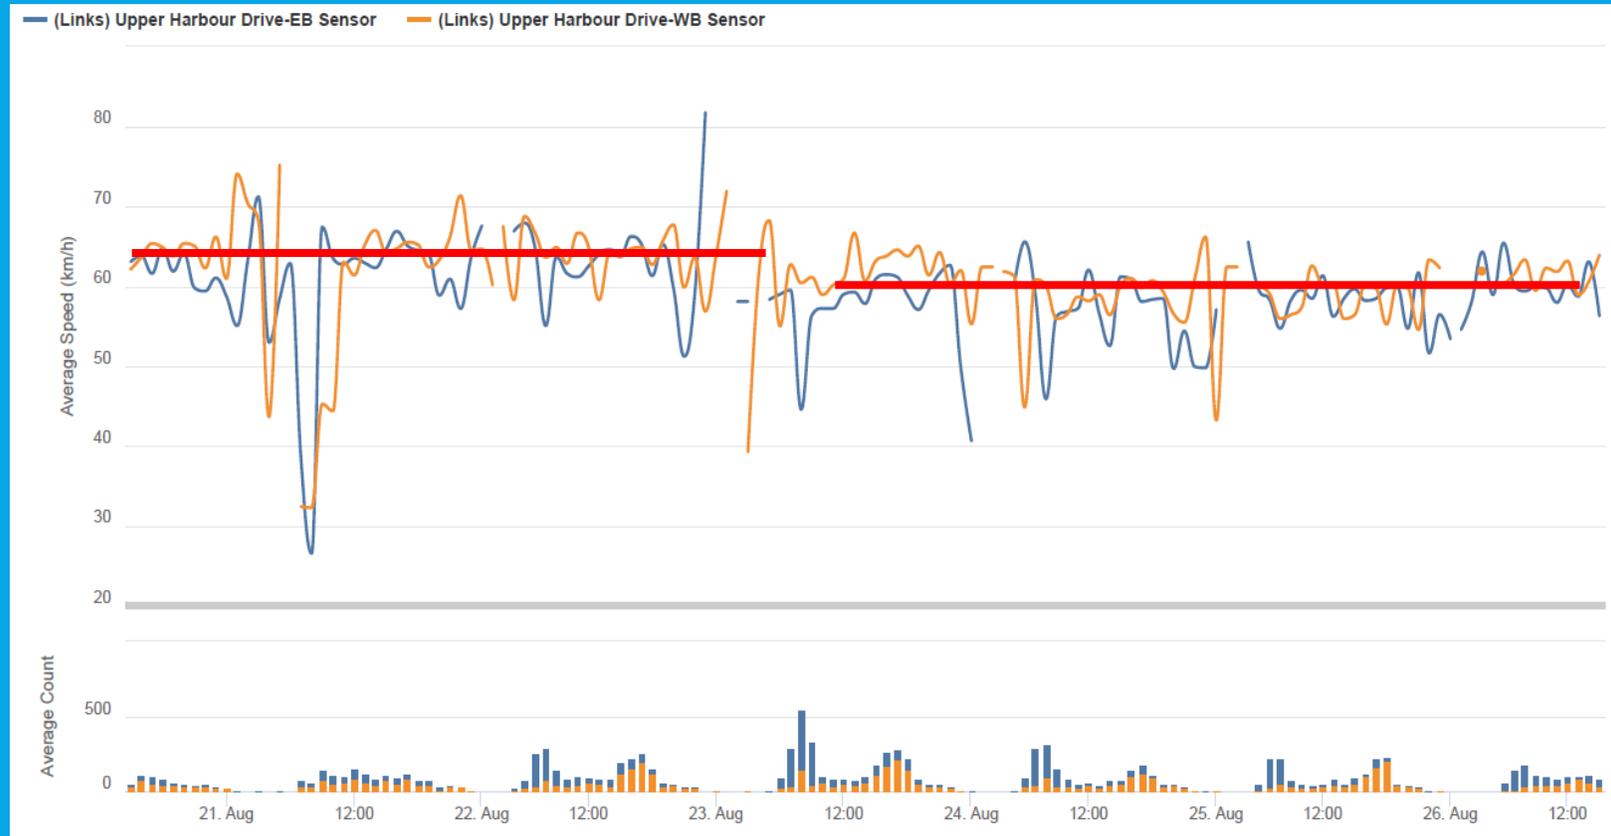
Upper Harbour Drive Vehicle Speeds

- Vehicle Speeds were much higher in Upper Harbour Dr than other locations separators have been used.
- Reducing speeds using temporary speed limit and traffic management made noticeable difference to frequency and severity of crashes.

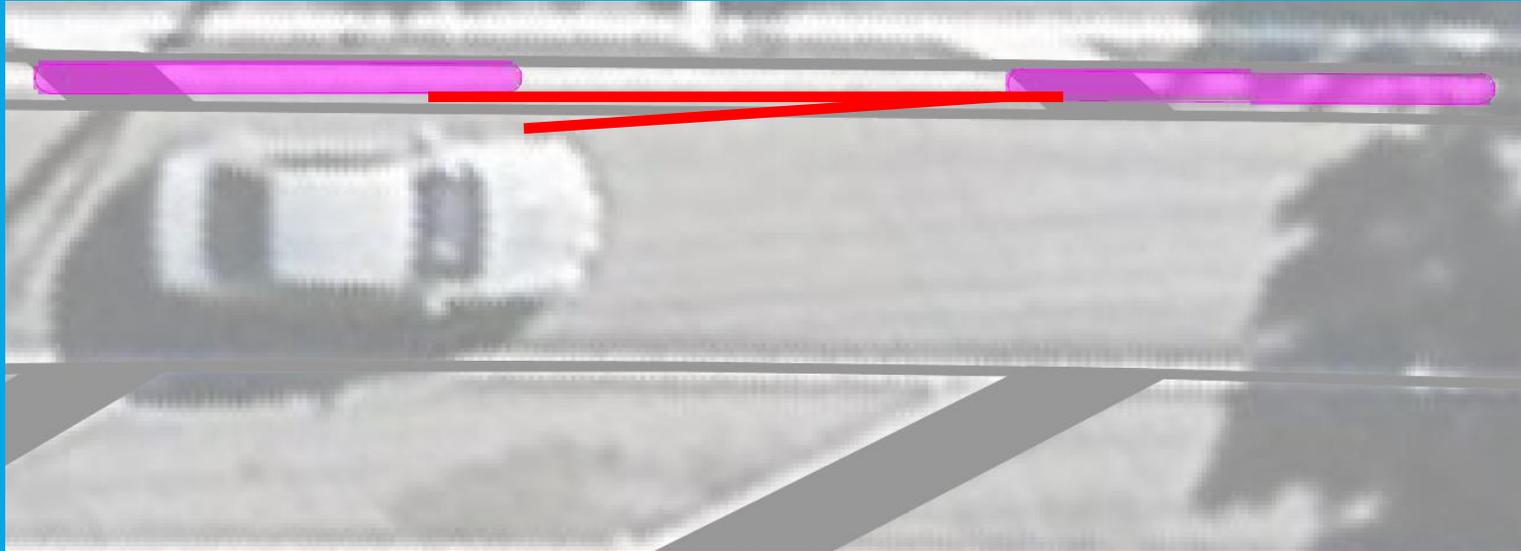
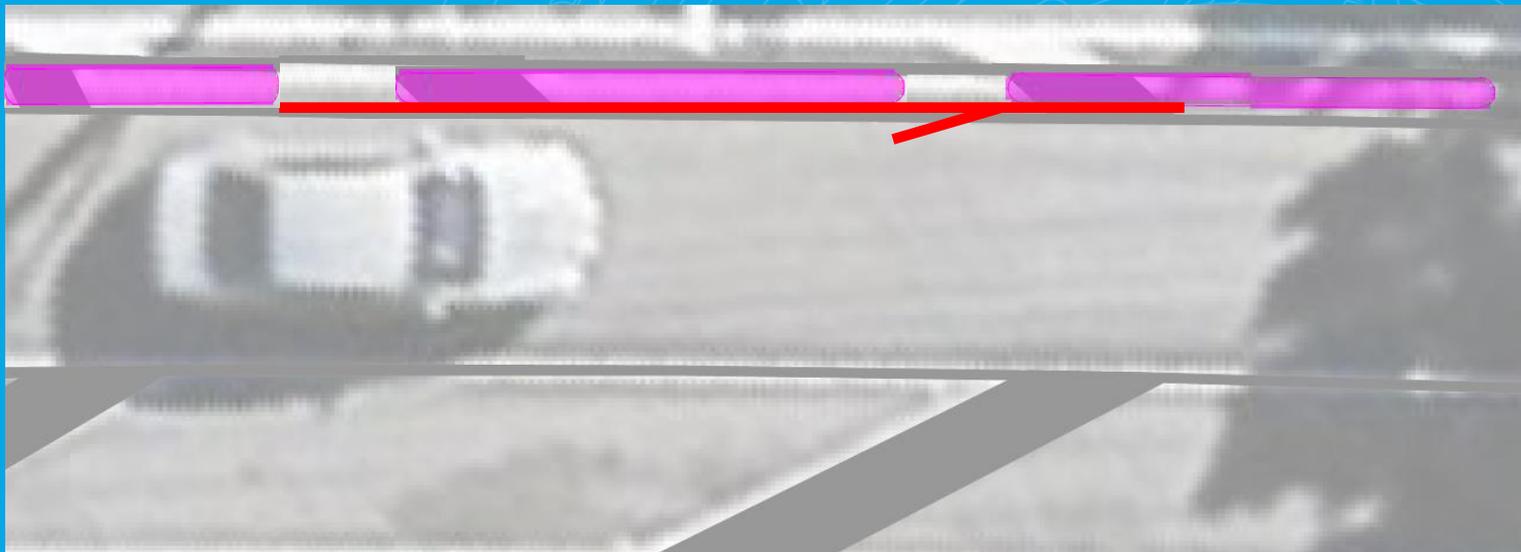
Upper Harbour Drive Gaps Between Separators

- Does the spacing of separators allow greater chance of drifting into end of separator?
- Driveways still cause gaps.

Spacing	Angle (degs)
0.5	30.0
1	16.7
2	8.5
3	5.7
4	4.3
5	3.4

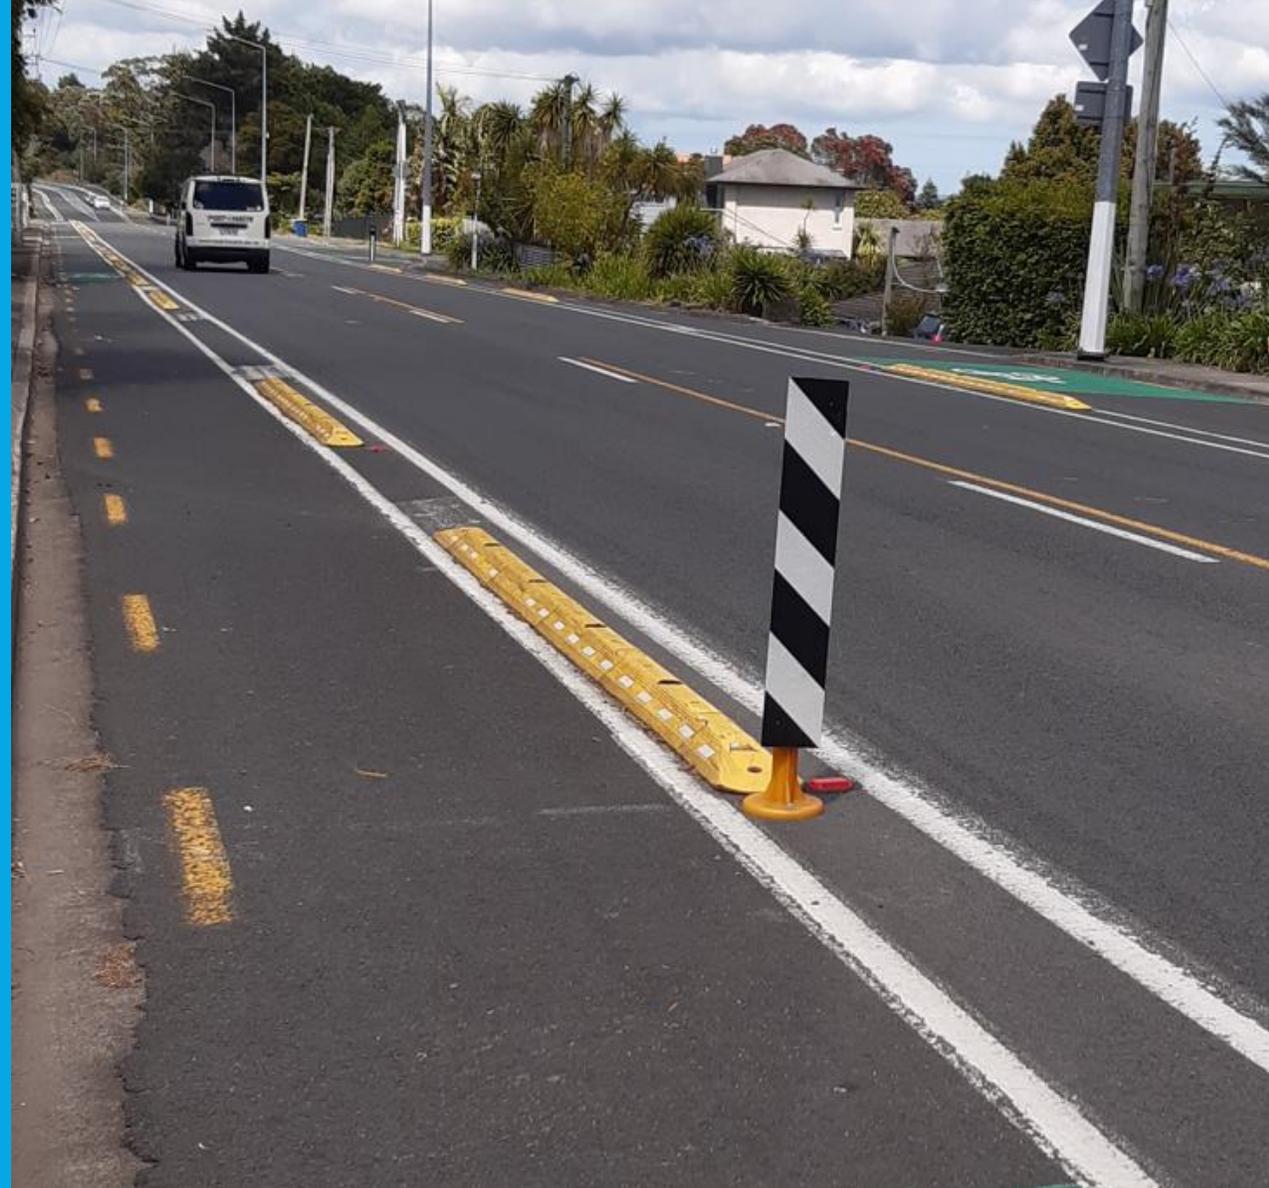
Upper Harbour Drive

- Despite the reduction in frequency and severity of accidents, some were still occurring
- A decision was made to replace the concrete separators with rubber separators while further engagement with the public took place around a longer term solution.

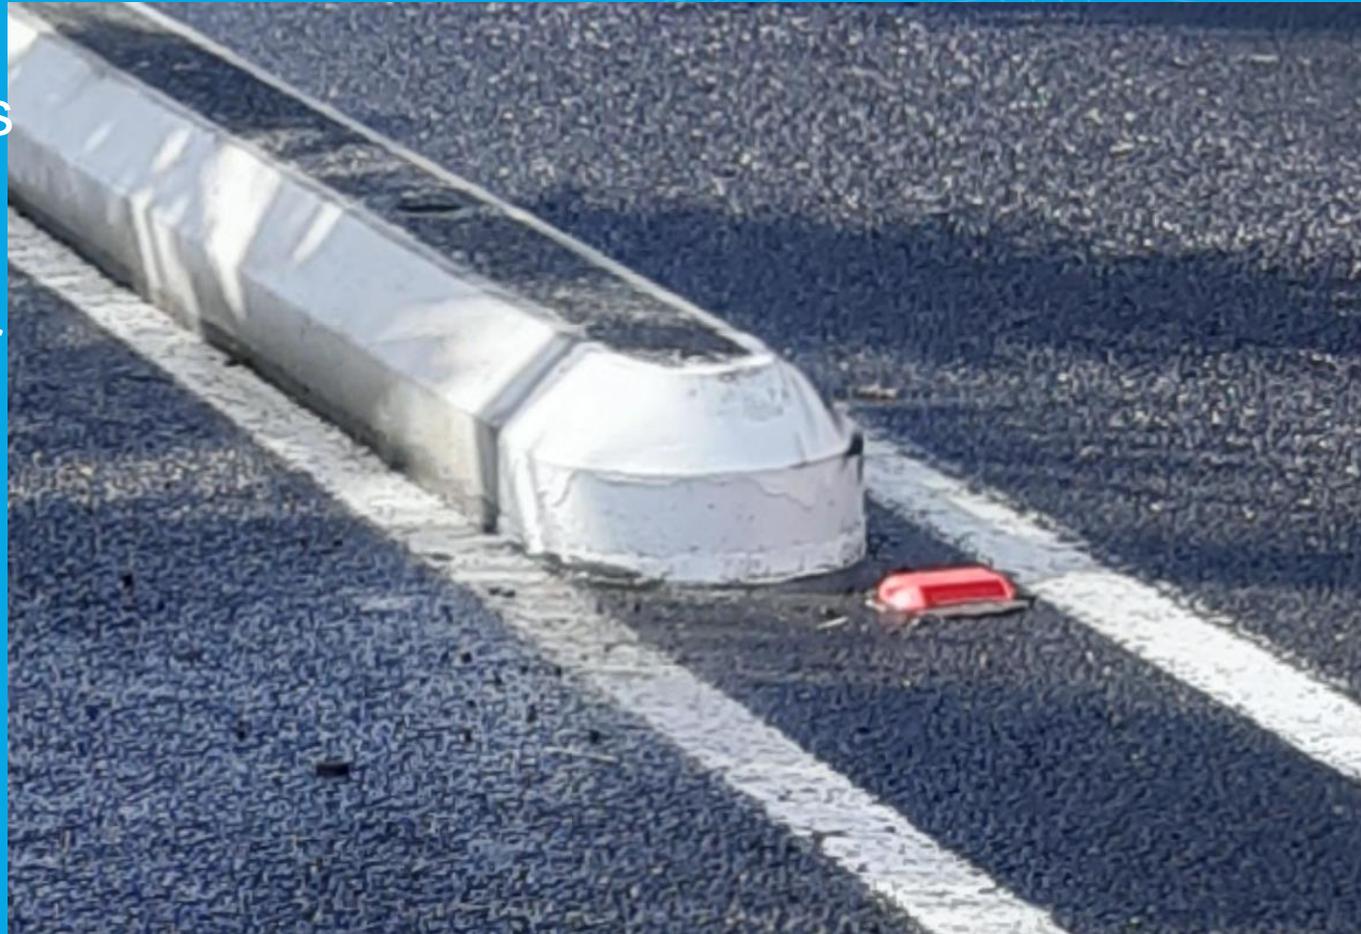
Challenges - Separator Height

- Separators placed on grout levelling base means separator is between 160mm and 180mm proud of carriageway surface.
- AC Waste Services advise 140mm is maximum height rubbish trucks can mount.
- Epoxy fixing has been used on other sites to reduce heights.

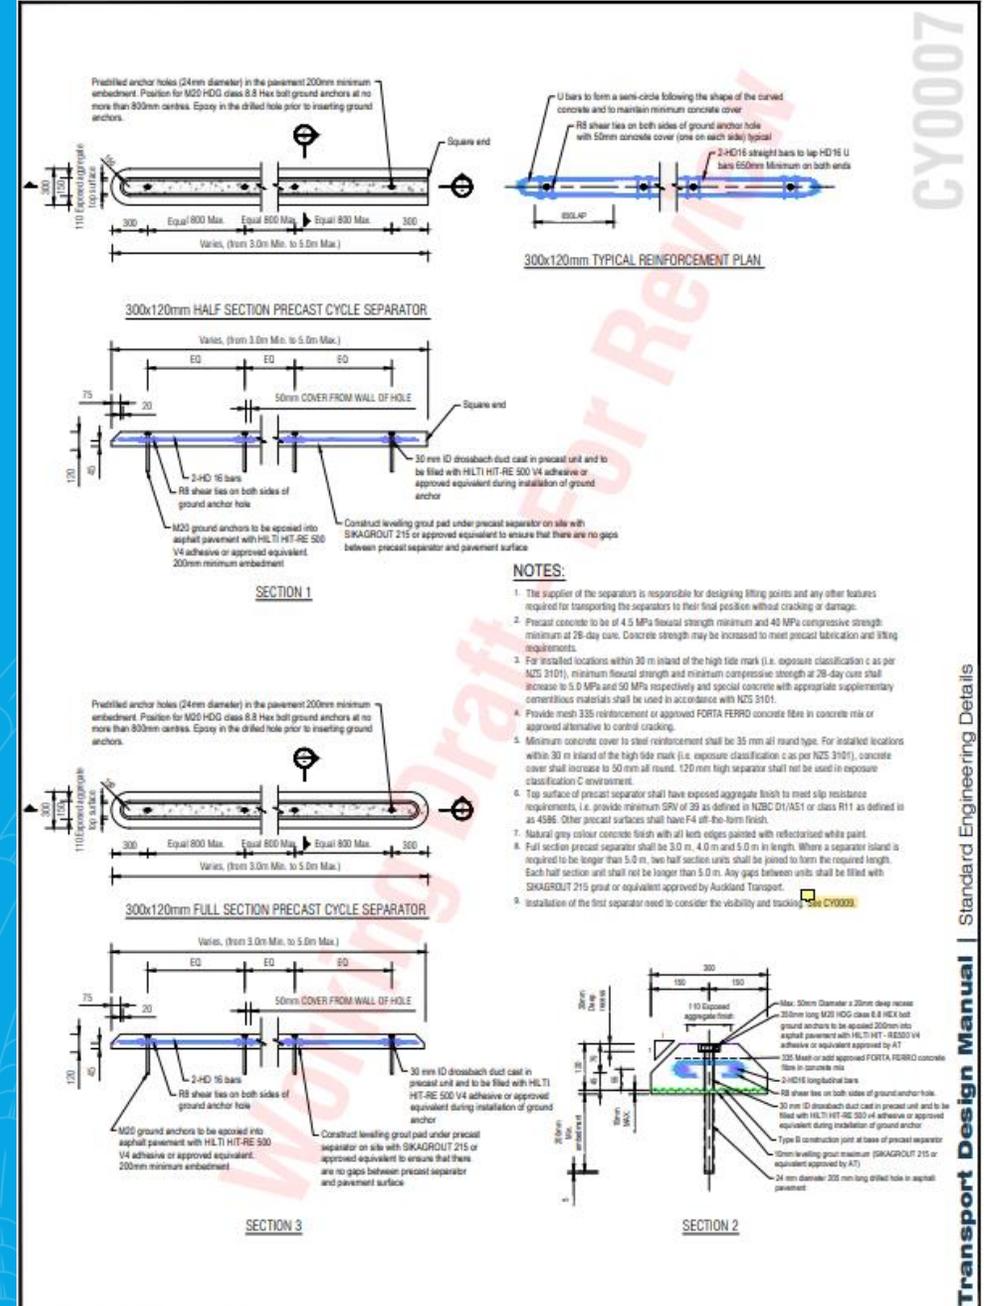
New 120mm High Separator

- 120mm high when using epoxy base.
- Allows for some wiggle room for construction tolerances or road curvature.
- Has been strength tested to ensure appropriateness for mounting and durability.
- Front end is more chamfered, minimising impact if hit front on.

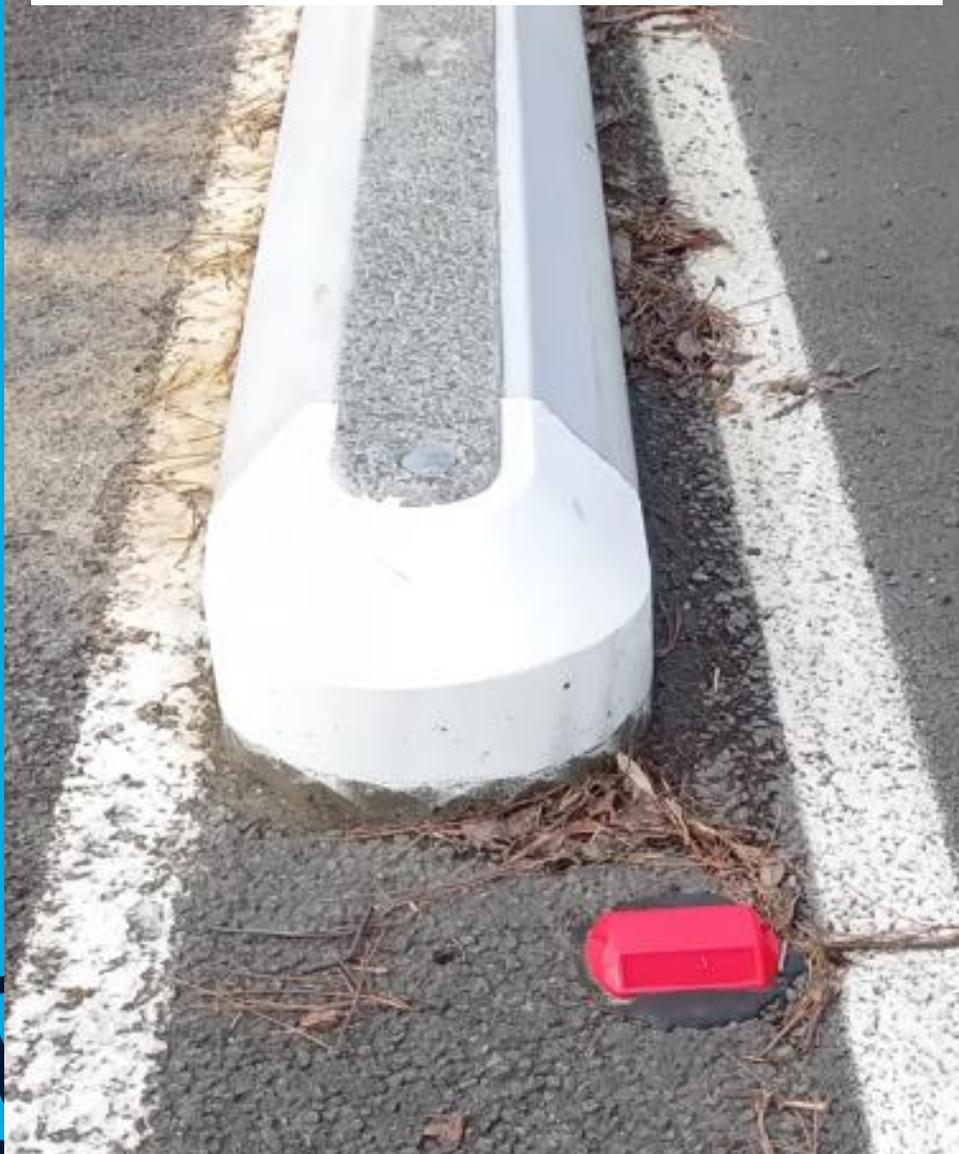
150mm on grout base

Cycle separator details (300mm Wide and 120mm High)

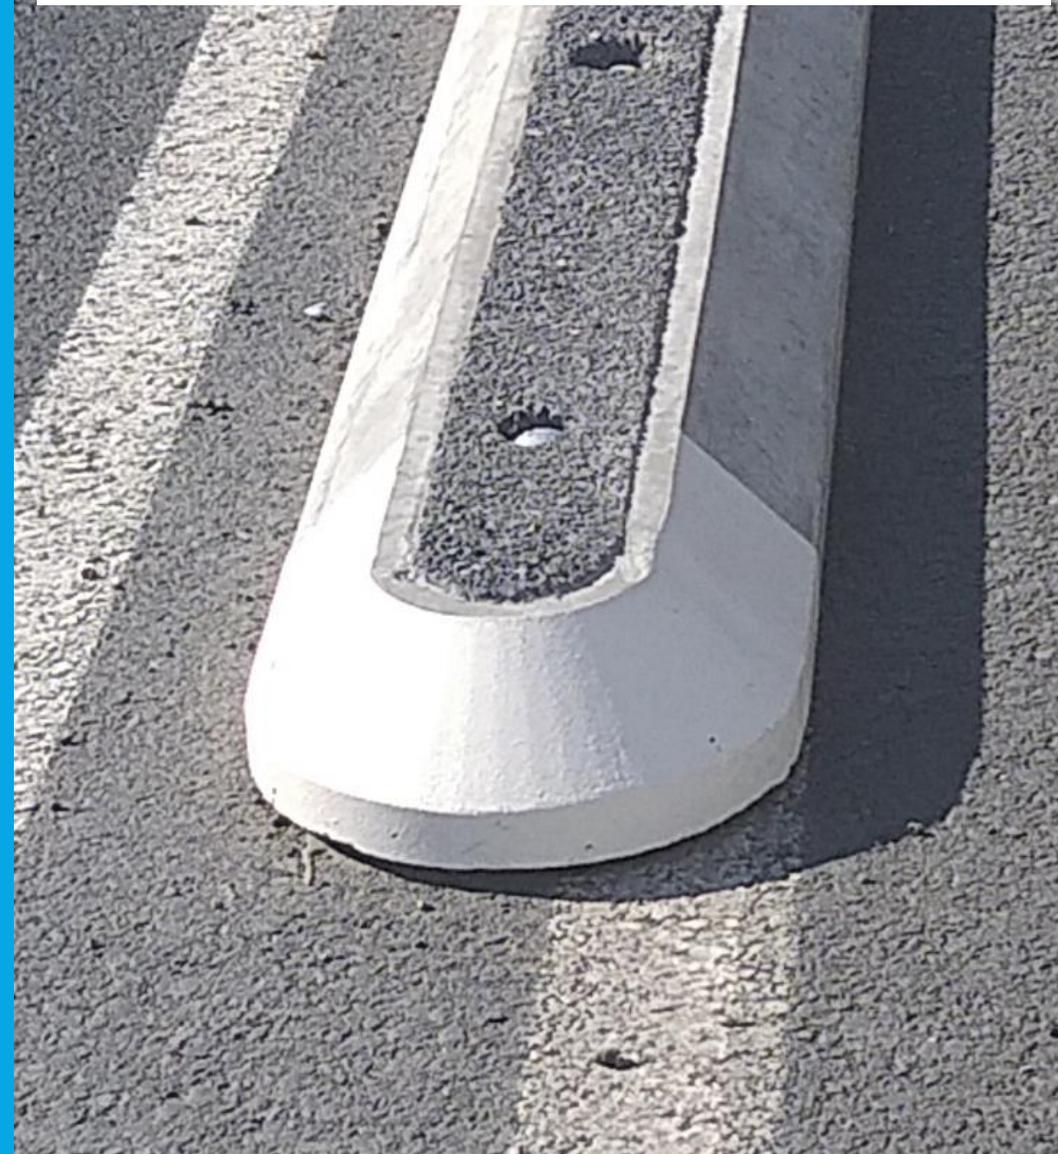
120mm fixed with epoxy

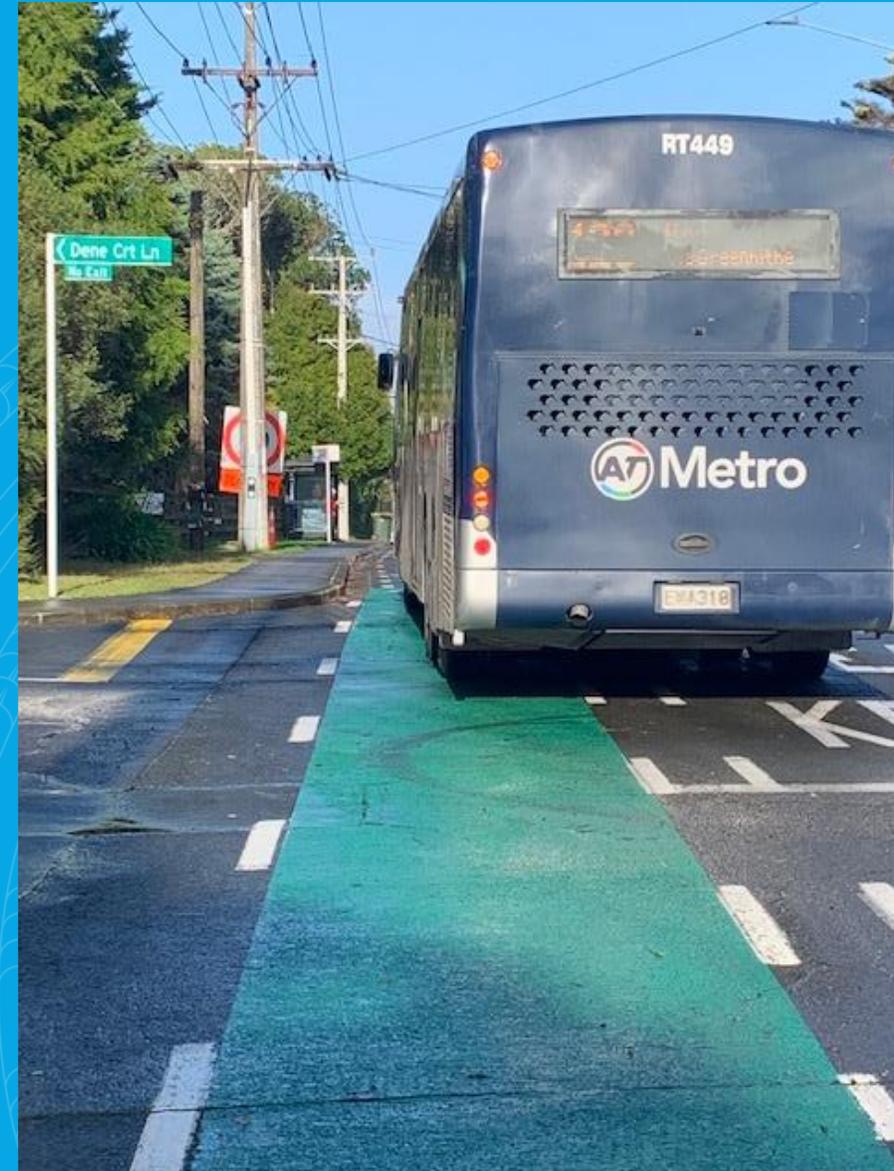
- Now difficult to turn around to stop speeding vehicle In opposite direction, can lose sight of vehicle
- When turning around near separators, difficult to see where separators are over bonnet
- Limited places to covertly undertake enforcement
- No where for vehicle to pull over and issue infringement
- Insufficient space to layout checkpoints
- No emergency stopping area - see photo

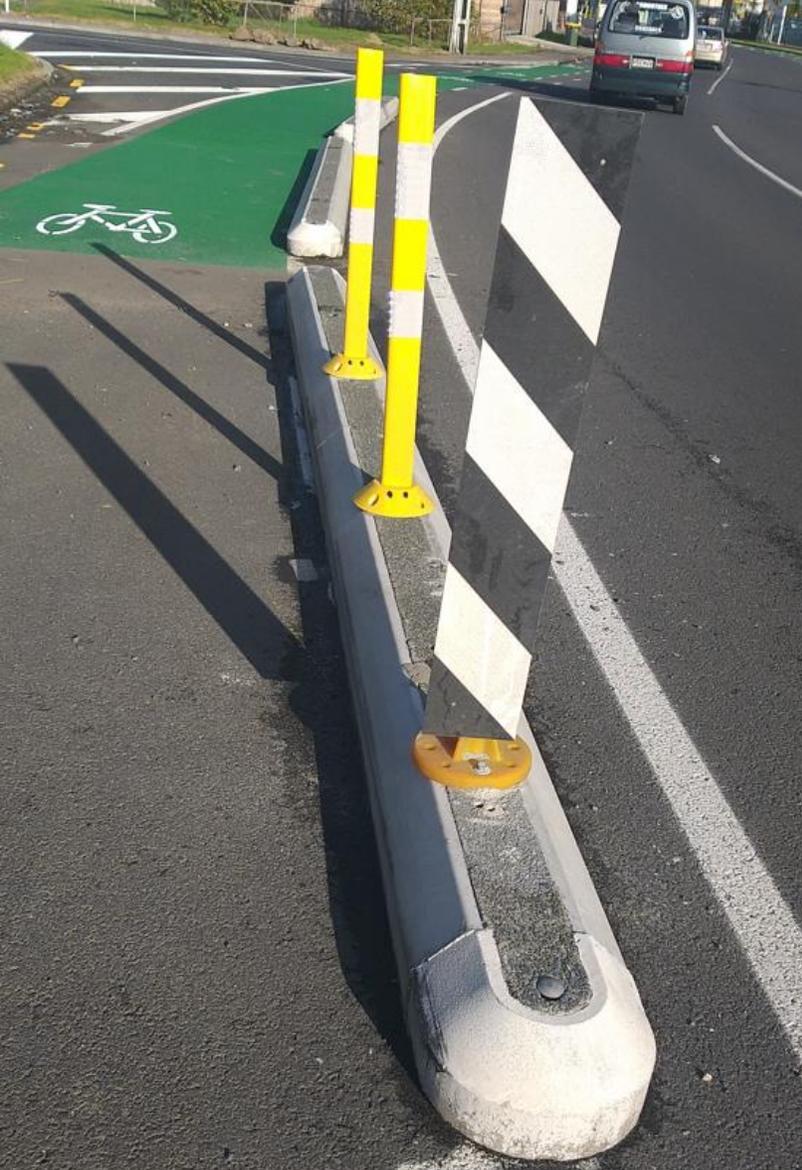
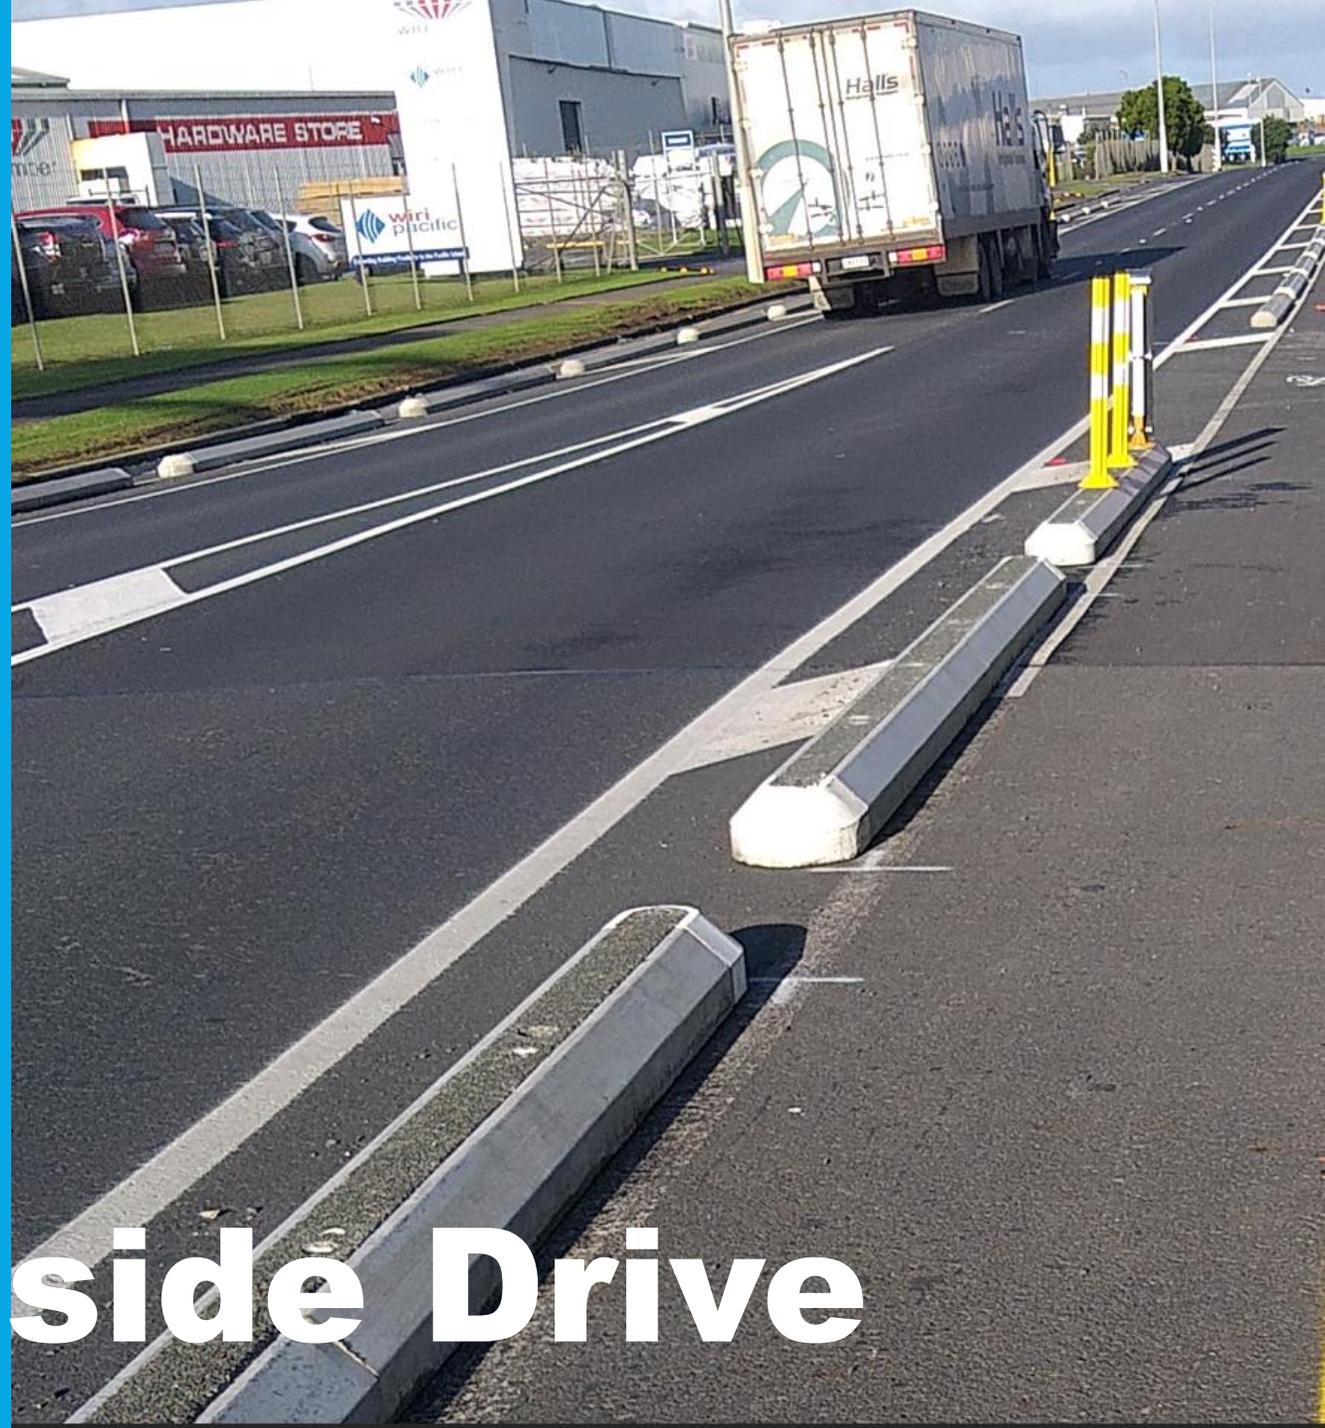
More Lessons Learnt

- Minimum buffer widths – 0.6m for 300mm separator (300mm buffer).
- Highlighting start of the separators – RRPMs, reflective paint on front ends, Bridge Marker Posts, edgeline, continuity lines.
- Construction methodology – ensure visual aids are installed at the same time as separators are installed and plenty of advanced warning is provided.
- Consultation – despite length of time taken it is best to undertake consultation as if it were a normal project.
