# Construction and Implementation of the Victoria Bridge Refurbishment

The 313m precast segmental box girder Victoria Bridge is a key Brisbane River crossing, which opened in 1969. The structure is a central link for public transport, pedestrians and cyclists within Brisbane and will be required to operate, carrying increased loading beyond its intended purpose.

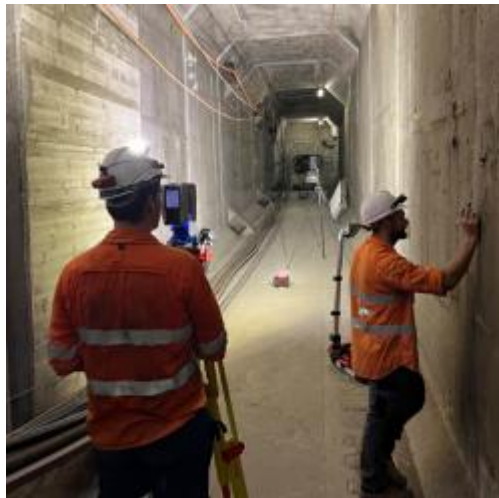
A Level 2 inspection of the bridge had already been completed on the structure by the asset owner which provided a good basis of understanding its condition. This was reviewed in detail and then confirmed if more detailed inspections were needed. For critical areas such as strengthening connection points, detailed crack mapping was undertaken before and post works. Mapping was subsequently scanned using high resolution Matterport scans.

**Figure 2 Crack mapping inside a girder**

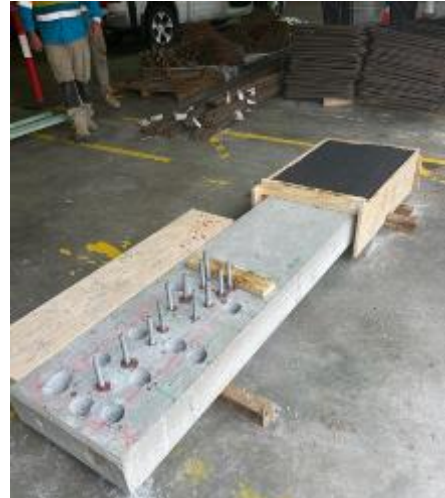
**Figure 3 Scanning trials and anchor testing**

Anchor testing was also a semi-destructive investigation method undertaken on the existing deck to prove the design load on the future anchors and the adequacy of the existing concrete to take the anchors. Concrete cores were also taken to determine the existing bridge precast concrete quality and strength.

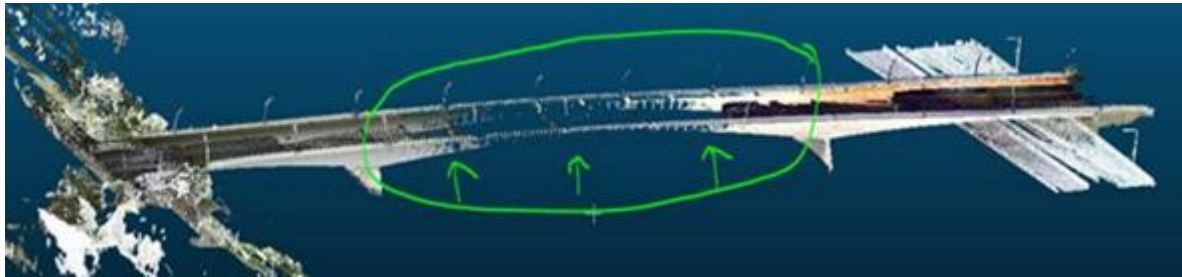
There were several types of surveys undertaken on the bridge such as external and internal LiDAR scanning. The LiDAR scanning provided accurate depiction of the position of the bridge to inform design and inform the construction team. The figure below shows the extent to which the LiDAR scanning reached when positioned on either abutment. The completed the scan brackets were installed on the piers, accessed by water vessel, to enable the centre span to be accurately scanned.

**Figure 4 External LiDAR scanning**

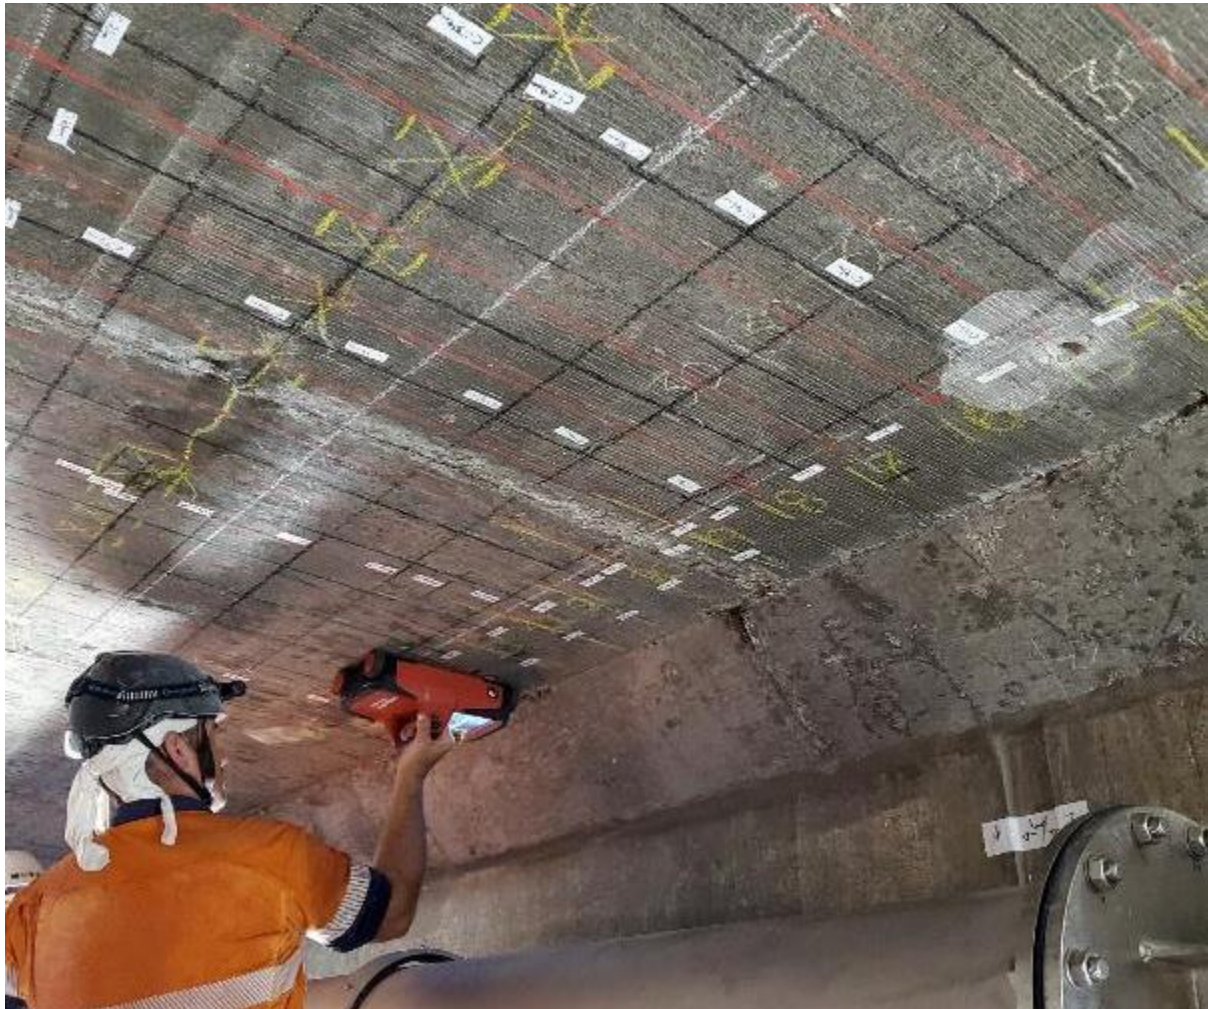
Reinforcement scanning was a critical step in identifying the location of reinforcement within the concrete. Output from the scanning can, at times, be difficult to interpret especially in areas of high reinforcement congestion. Proper trials, experience and familiarity with the scanning equipment being used is recommended.

In zones of congestion the Proceq GP8000 device was used as it provided high resolution and data that could be exported into software programs for greater interrogation. The Hilti PS300 and PS1000 were used on the project also.

**Figure 8 Reinforcement scanning and marking on the bridge soffit**

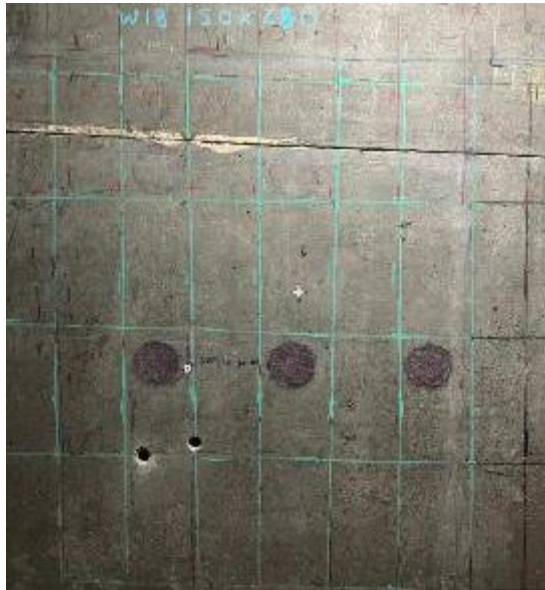
**Figure 9 Rebar marking after scanning**

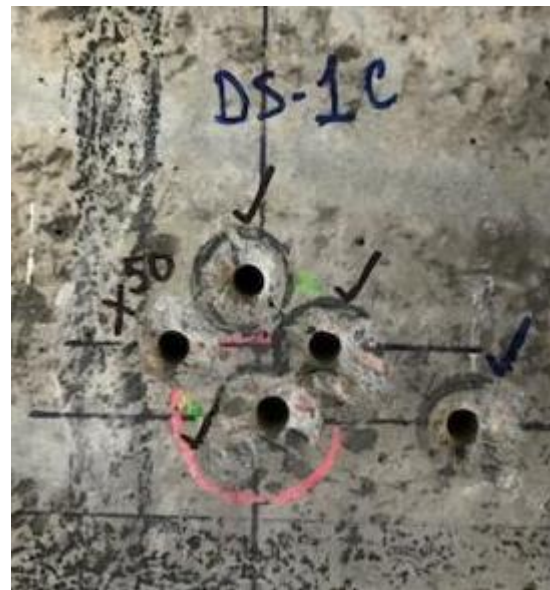
For coring works, pilot holes were used after the scanning and reinforcement marking onto the concrete in order to confirm the clear zone prior to undertaking the coring in order to ensure that the primary reinforcement was maintained. Pilot holes used 12mm masonry drill bits and with depth control measures used. Large core holes (100mm diameter) would often receive 3-4 pilot holes before confirming the position.

**Figure 10 Pilot holes after GPR scanning**

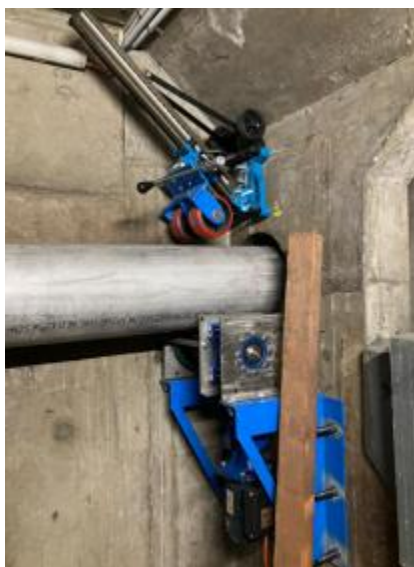
**Figure 11 Pipe pushing over the Riverside Expressway**

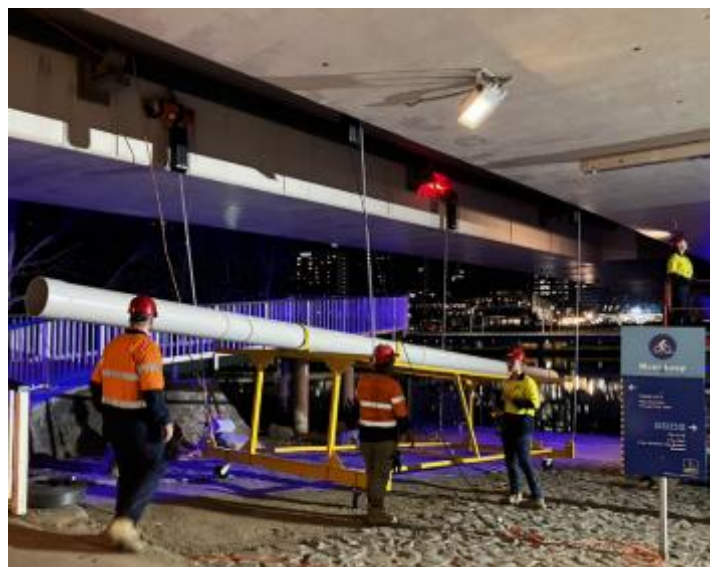
**Figure 12 Lifting frame with access from Clem Jones Promenade**

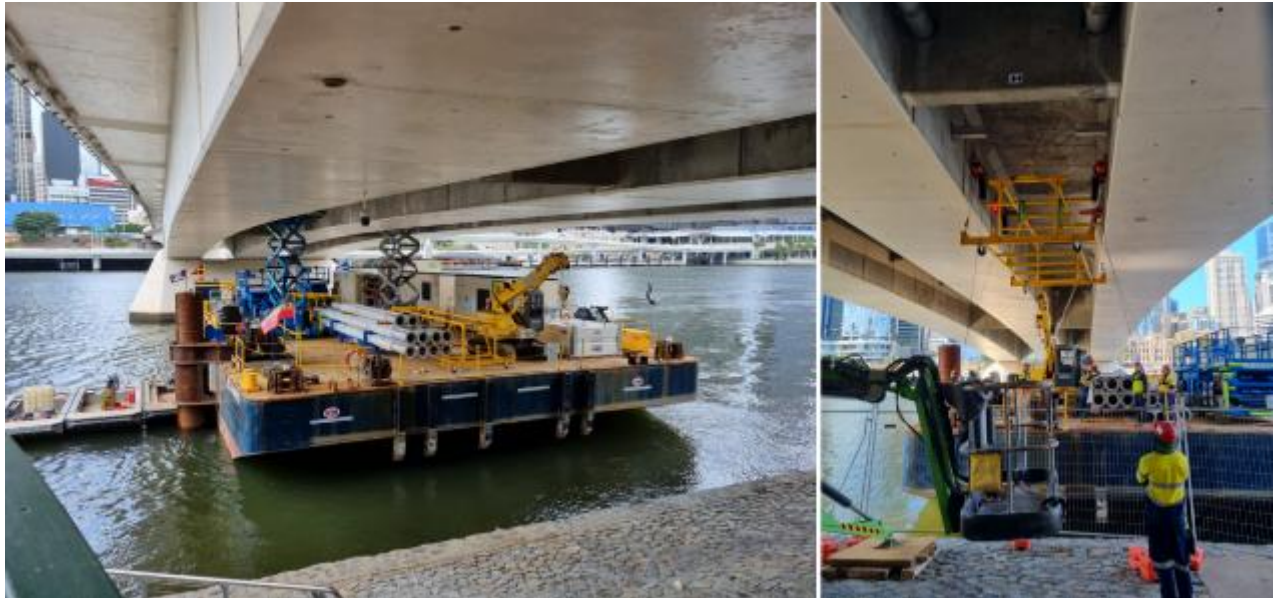
Figure 13 shows the barge setup on the river and how the lifting frame was used to raise the sections of pipe into position.

**Figure 13 Barge works with lifting frame**

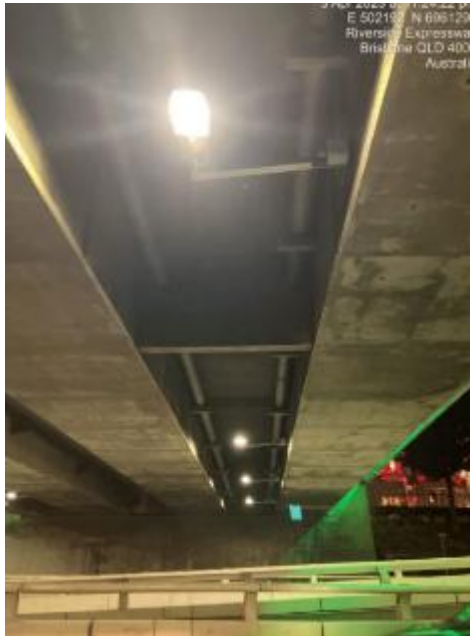
Installing lengths of pipe over the six lanes of the Riverside Expressway while maintaining access was a challenge due to traffic constraints. Works were undertaken at night under lane closures with permanent pipe brackets being installed first with temporary roller attachments. Once the brackets were installed, short three metre lengths of pipe were delivered into the abutment, welded together and incrementally pushed through the preformed holes from the inside the bridge abutment to the other team on the outside of the abutment on the Riverside Expressway under various lane closures with traffic control at night. Once enough pipe was pushed through, a new three metre length of pipe was welded on and tested for compliance. Secondary safety measures such as verification of welds and installation of over clamps were used to mitigate uncontrolled movement of the pipes while pushing to ensure the safe installation of the pipes.

**Figure 14 Sewer lines pushed through and over the Riverside Expressway**

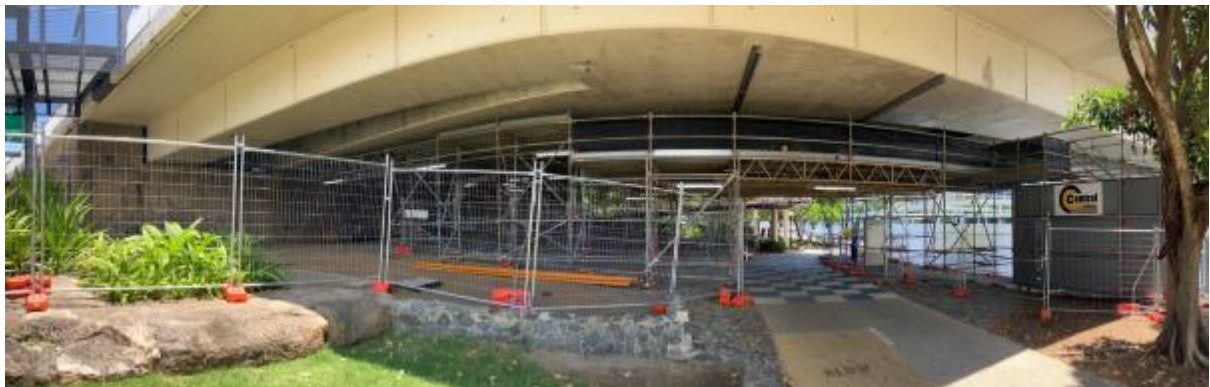
A hanging scaffold system QuickDeck was chosen for both the Southbank Precinct and Brisbane City sides as they both had to meet the requirements in maintaining access for pedestrians, vehicle traffic and river traffic. The QuickDeck system used enable connection to the bridge through pre-formed holes in the soffit of the girders and allowed it to be built incrementally from one side. All had to be constructed at night with Brisbane City side being pre-fabricated into sections and lifted into position from a barge on the river.

**Figure 16 Hanging Scaffold beneath the bridge at the Southbank Precinct side**

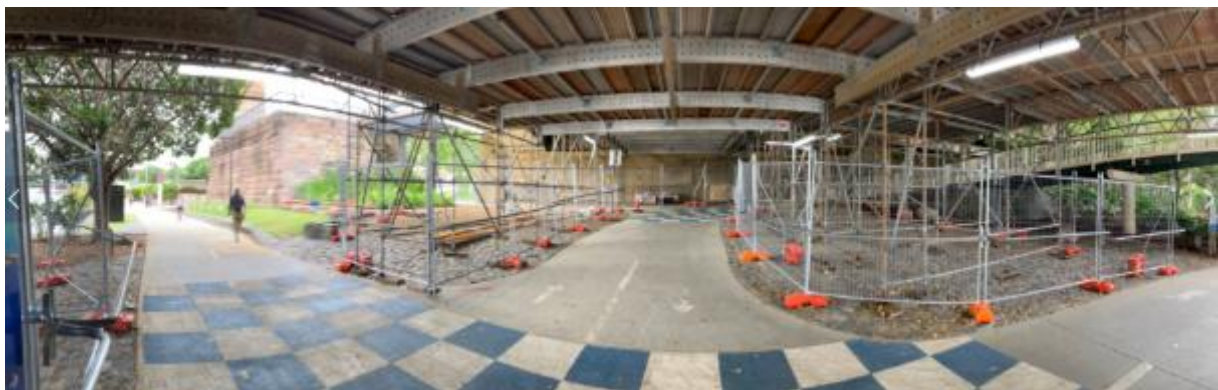
**Figure 17 Looking up at hanging scaffold beneath the bridge at the Southbank Precinct side**

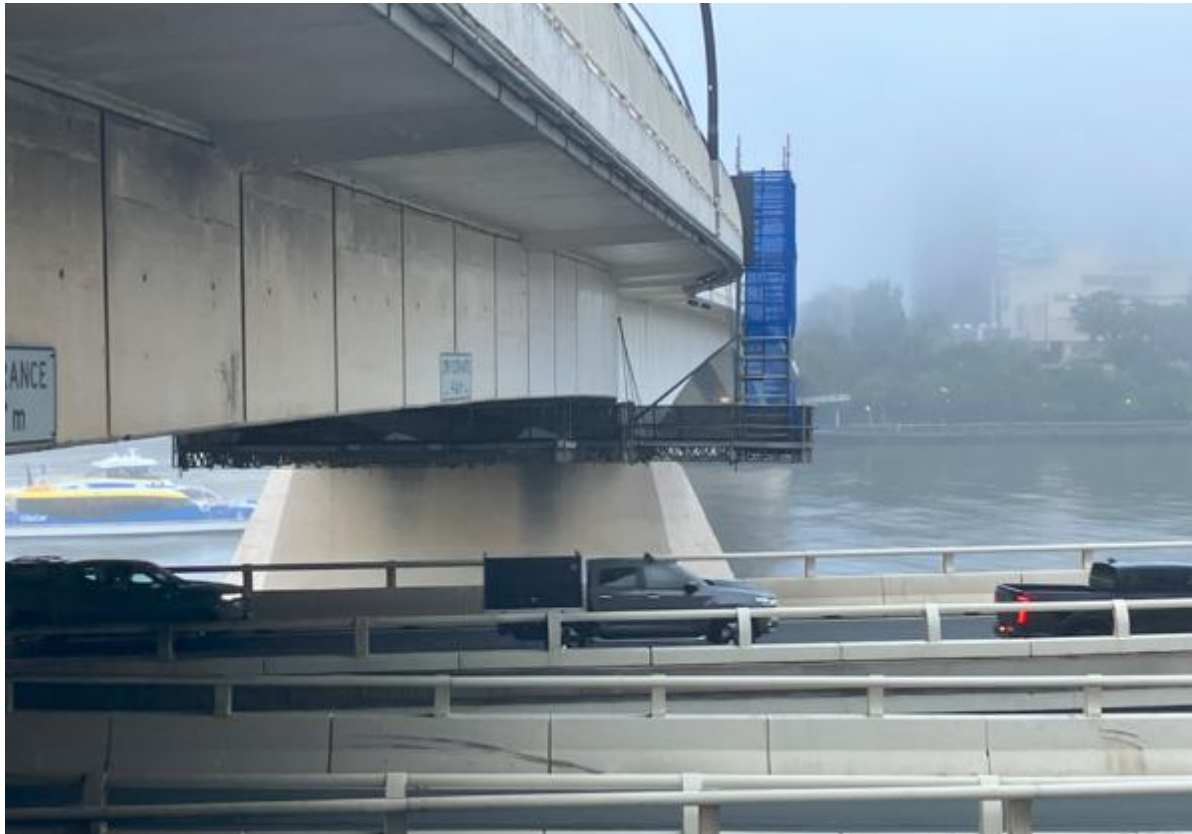
**Figure 18 Hanging scaffold at the Brisbane City side with access from above**

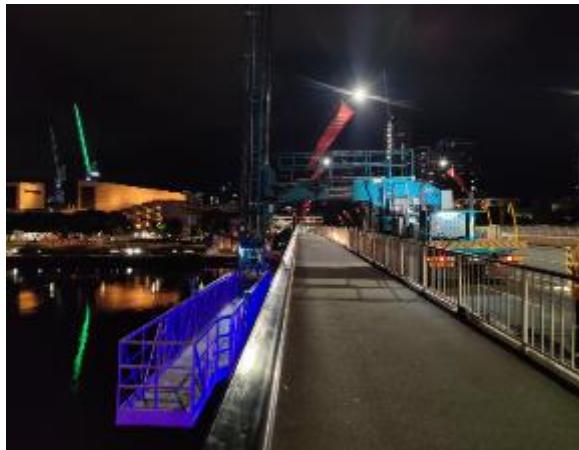
**Figure 20 Use of UBIU under lane closure**

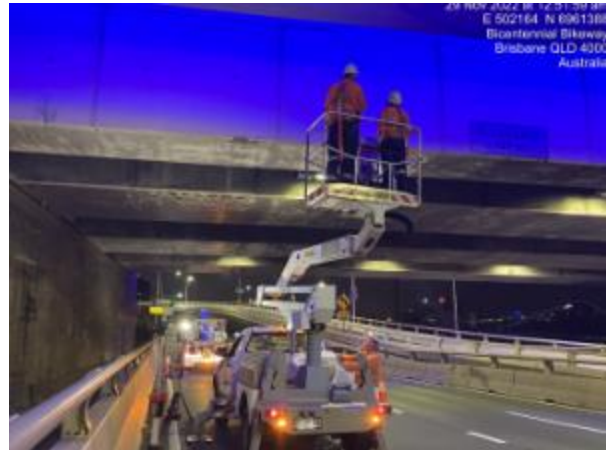
When working on the Riverside Expressway at night floating in and out conventional elevated working platforms slowed down production. The use of vehicle mounted elevated work platforms enabled quicker setup and pack up times maximising the limited working times available. Vehicles used included:

**Figure 21 Vehicle mounted EWPs**

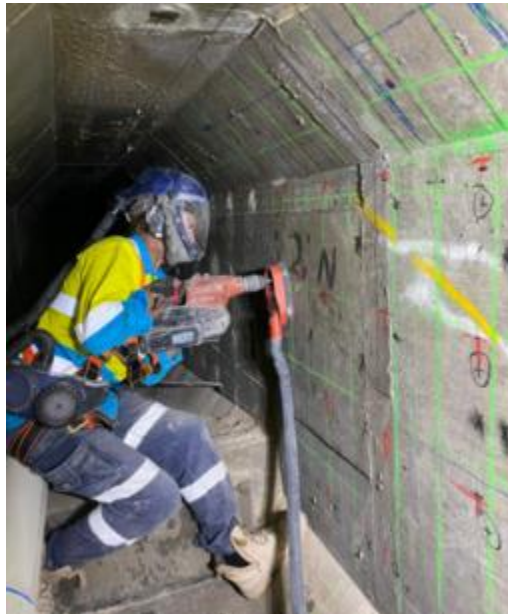
There were also several areas where confined space works were required. This required the implementation of confined space measures such as rescue plans, air monitoring, adequate lighting. Figure 22 shows the level of scanning (blue/yellow/green marks) undertaken within confined spaces and protections measures used on drilling into concrete.

**Figure 22 Confined space working**

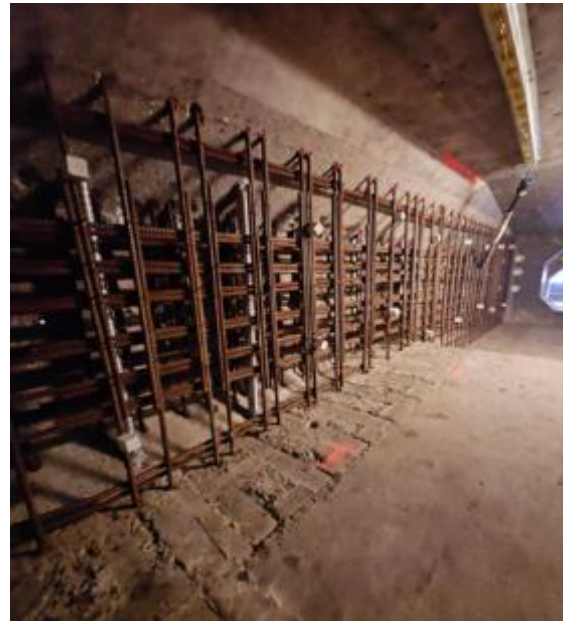
There were several concrete works inside the girders that needed to be constructed. This required thought into how formwork and the equipment could be brought into the girders and ensuring protection of services in the area. Concrete delivery was also a key consideration. Where possible delivery of concrete was made by line pump through the existing openings however in some instances, surface located core hole through the deck girder proved useful in delivering the concrete.

**Figure 23 Restricted space working**

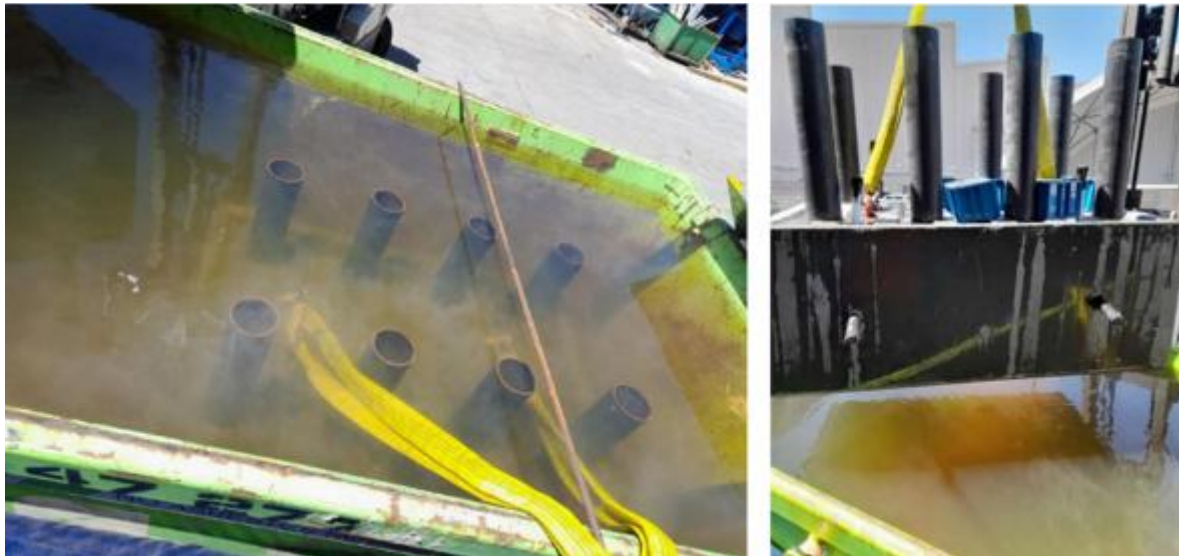
- Prototype 1 – Testing mix properties, finishes, and mixing, pouring, and casting processes
- Prototypes 2 & 3 – Confirming most appropriate forms and cast-in items and curing method
- Prototypes 4 & 5 – Use of hot water curing baths to increase strength to 160MPa + and load testing of final prototypes.

**Figure 24 Use of hot water curing baths**

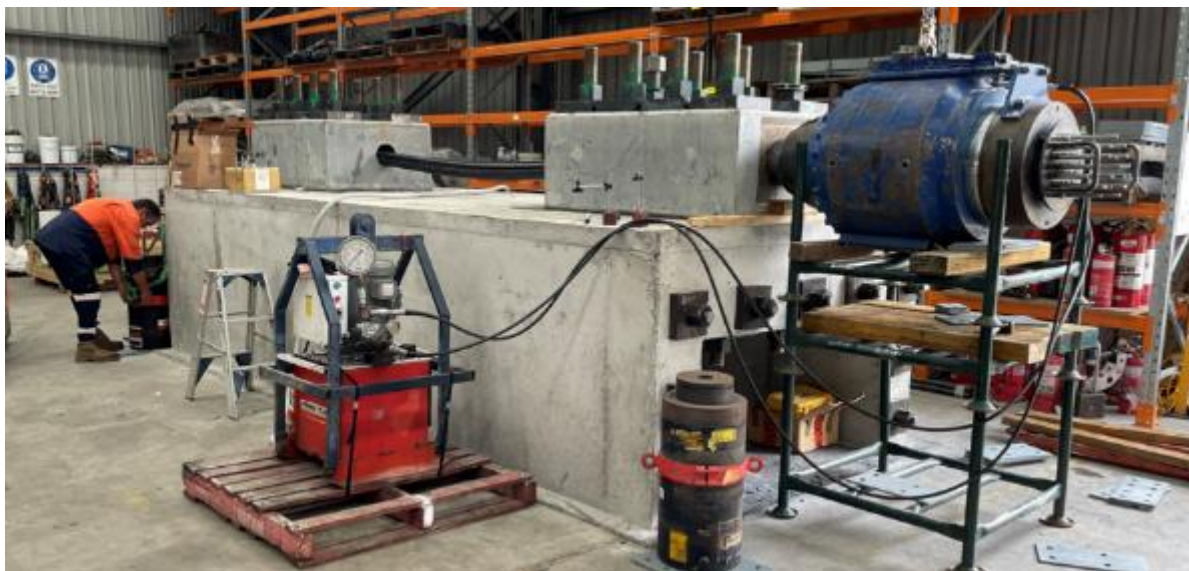
Prototype testing was undertaken on a post-tensioned concrete test bed using two UHPC anchorages tested against each other with a post-tensioned tendon threaded between the two and stressed to SLS and ULS test loads, respectively. The friction connection fixing the blisters to the test bed was installed in the same manner proposed for installation on the bridge. Stress bars were used to create a clamping force that provided the necessary friction to resist the longitudinal tendon force. The testing was completed successfully with no failure of the UHPC<sup>4</sup> observed.

**Figure 25 Prototype testing arrangement**

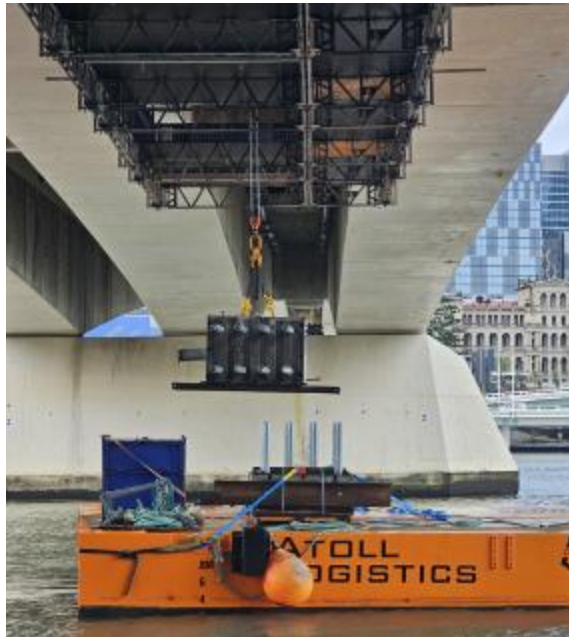
The UHPC anchorages were installed onto the bridge using lifting equipment installed between the girders to hoist them from a barge. Once in place, the interface between the blister and the girder was grouted and all transverse stress bars were stressed. The stress bars ensured adequate friction between the girder and the anchorage for transfer of the longitudinal tendon load.

**Figure 26 Blister installed from the river**

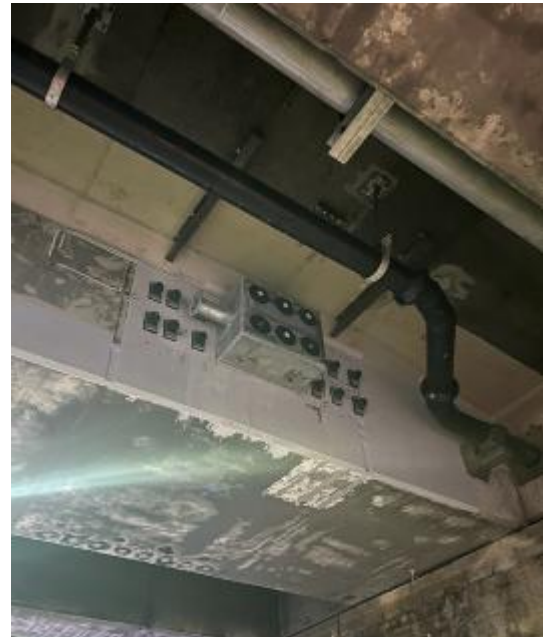
**Figure 27 Example of installed blister**

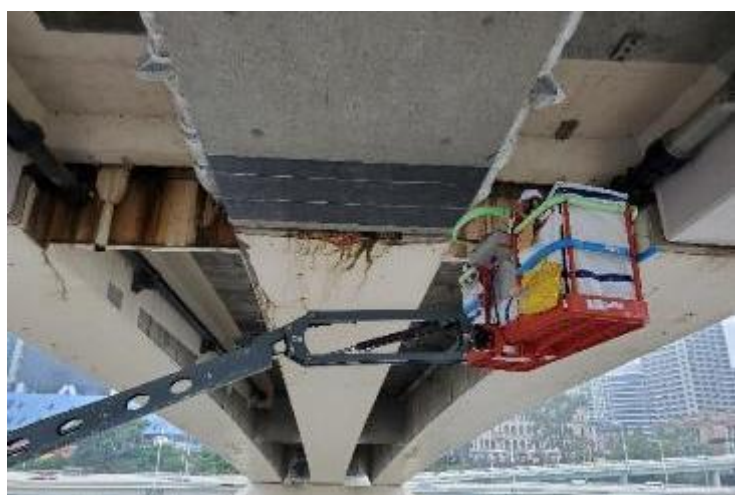
Externally bonded CFRP sheets were used for strengthening at the half joints, located at the suspended span in the centre of the bridge. Access to the joints could be achieved through two means including UBIU during night-works, or via a barge mounted elevated work platform.

**Figure 29 Installation of CFRP at Mid-Span Half Joints**

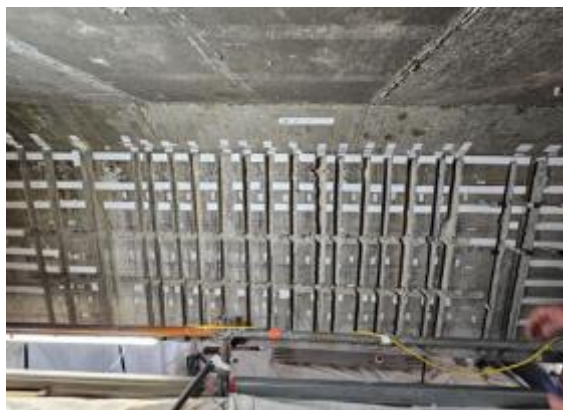
Near Surface Mounted (NSM) reinforcement was needed to strengthen the localised areas at each of the strengthening connection points. The NSM works comprised of making a groove into the concrete cover zone or at times past the cover zone using a wall chaser, breaker with joint chisel and extraction equipment. This allowed additional reinforcement to be placed, sometimes epoxied, into the groove and then surrounded with a cementitious grout (Renderoc HB70).

**Figure 30 Vertical NSM grooves in web**

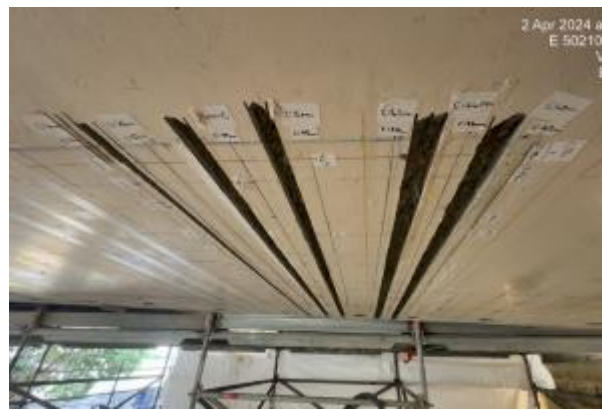
**Figure 31 Overhead NSM grooves in soffit**

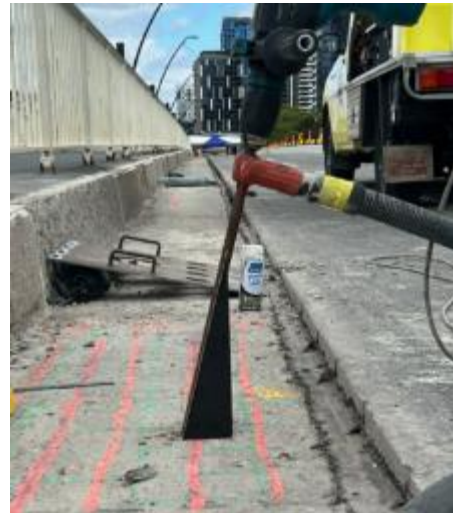
**Figure 33 Fabricated templates for bolt groups**

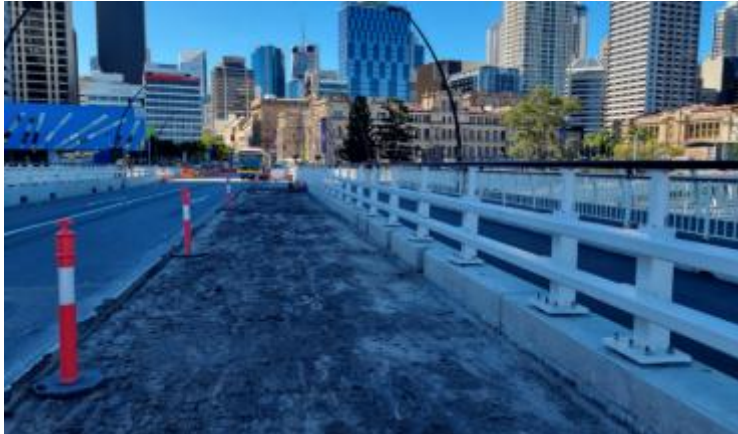
The asphalt was removed by saw-cutting along permanent lane lines and then pulled up using suitably sized rubber tracker excavators with flat blade buckets to ensure the bridge deck was not damaged. The existing waterproofing fabric membrane was then removed with a poly planer attachment to a bobcat and the surface texturized with a shot blaster, prior to the deck surface receiving prime, spray seal and then asphalt. Image below shows the existing asphalt removed with the waterproofing fabric membrane exposed.

**Figure 34 Example of lane configuration when removing asphalt wearing course**

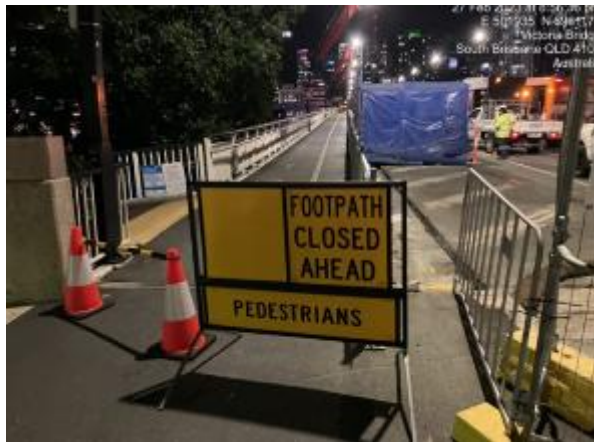
**Figure 35 Containment hoarding**

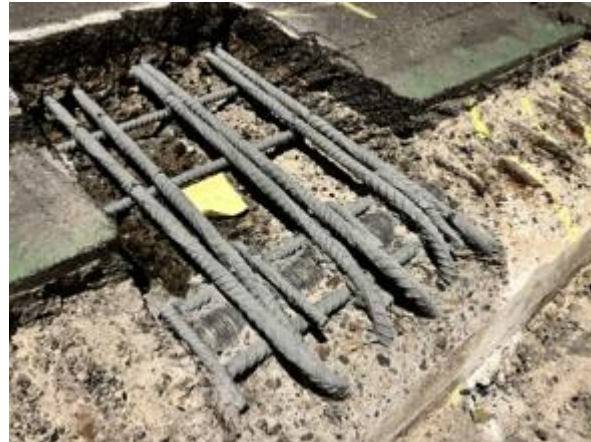
When the team were constructing the new barrier kerb, existing reinforcement with no cover (i.e. exposed) was identified. The exposed reinforcement showed signs of deterioration and was the main structural reinforcement for the cantilever footpath in this area. Once discovered, load limits were applied to the bridge and a repair method was established and undertaken. The figure below shows a blue containment screen implemented to enable high pressure water blasting (hydro demolition) of the affected areas to enable repairs to be undertaken. Due to the critical nature of the reinforcement, the works were carried out and repairs done in small sections in a certain sequence to ensure the structure was not weakened.

**Figure 36 Exposure of rebar and repair**
