AUSTROADS  
**BRIDGE**  
CONFERENCE 2025  
Brisbane | 25-27 June 2025

Peer reviewed paper

# Managing the Technical Risk with Uncoated Weathering Steel Bridges

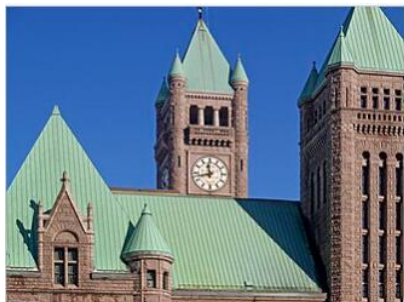
**Fig. 1. Copper patina on the roof of the Minneapolis City Hall.**

In contrast, when uncoated WS corrodes under suitable atmospheric exposure, the corrosion product has at least two distinct layers. The one on the top is relatively porous, similar to CS, but the underlying layer is denser and tightly adherent, consisting primarily of nanophase goethite [ $\alpha$ -FeO(OH)], preventing moisture and oxygen penetrating the corrosion front and thus protecting the substrate from further corrosion (Fletcher<sup>3</sup> 2005, Morcillo et al<sup>9</sup> 2019, Tripathi and Fatemi<sup>12</sup> 2024). This dense and tightly adherent inner layer of corrosion product is the protective patina. Although some other metals also form protective patina e.g. copper, the patina formed on WS has its unique colour, texture and elemental characteristics. Figures 1 and 2 show the copper and WS patinas, respectively, with different colour and texture.

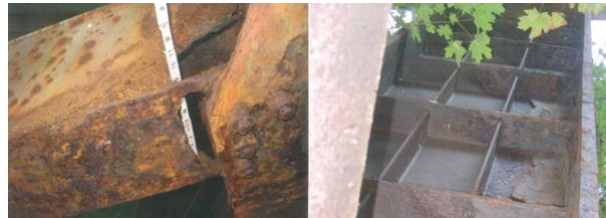
**Fig. 6. Corroded elements of Fern Hollow Bridge.**

On January 28th, 2022, an UWS bridge over Fern Hollow in Pittsburgh, Pennsylvania, collapsed due to structural failure resulting from progressive corrosion of the WS elements (Fig. 5 and 6). This progressive corrosion of WS occurred due to the non-formation of the protective patina, which was caused by prolonged wetness due to accumulated debris (NTSB<sup>31</sup>, 2023). No fatalities were reported.

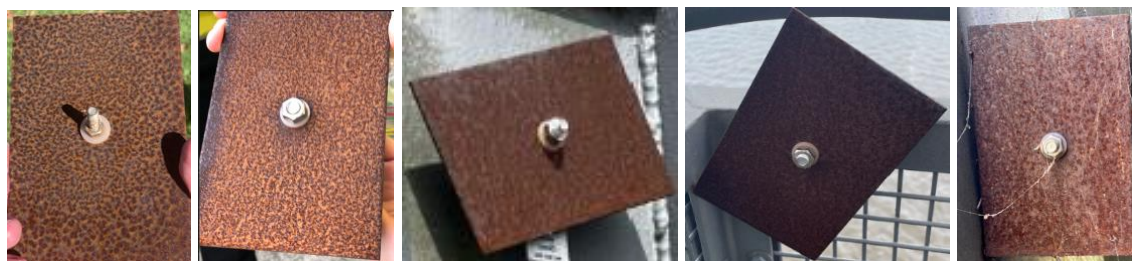
**Fig. 7 – UWS plates in different environments after 13-18 months.**

The visual appearance of patina can vary significantly, displaying different colours and textures depending on the environment and duration of exposure (European Design Guide<sup>24</sup> 2021). Colour, in particular, can be deceptive under different lighting conditions. Figure 7 below shows actual samples of WS plates, placed in environments with different corrosivities, aged between 13-18 months.
