2025 Austroads Bridge Conference – Abstract
Normanby Overpass, Bridge Strike: Assessment, Management and Rehabilitation

Normanby Overpass, Bridge Strike: Assessment, Management and Rehabilitation

Bridge Analysis, Design and Assessment

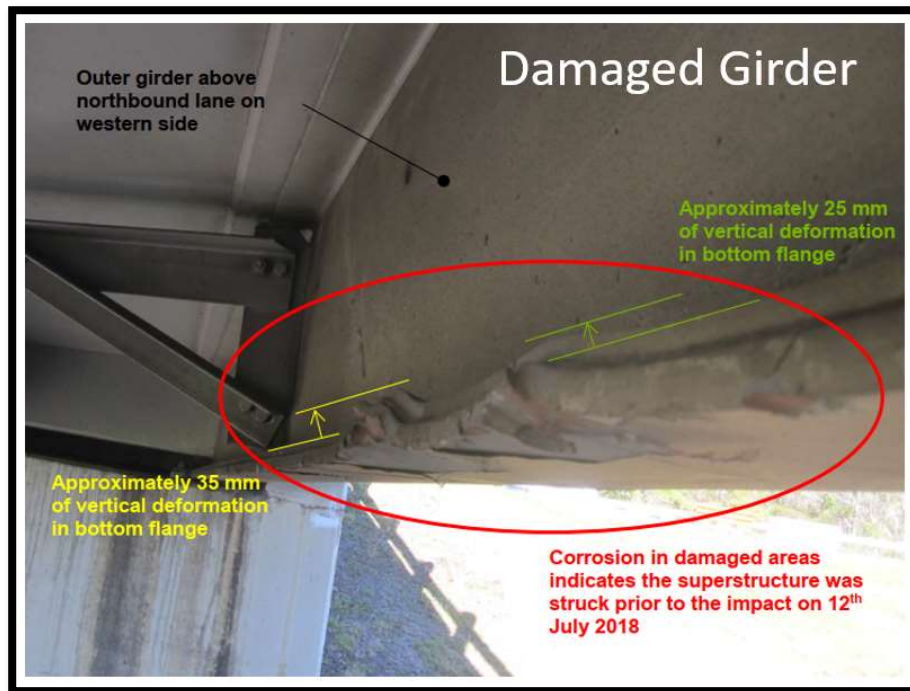
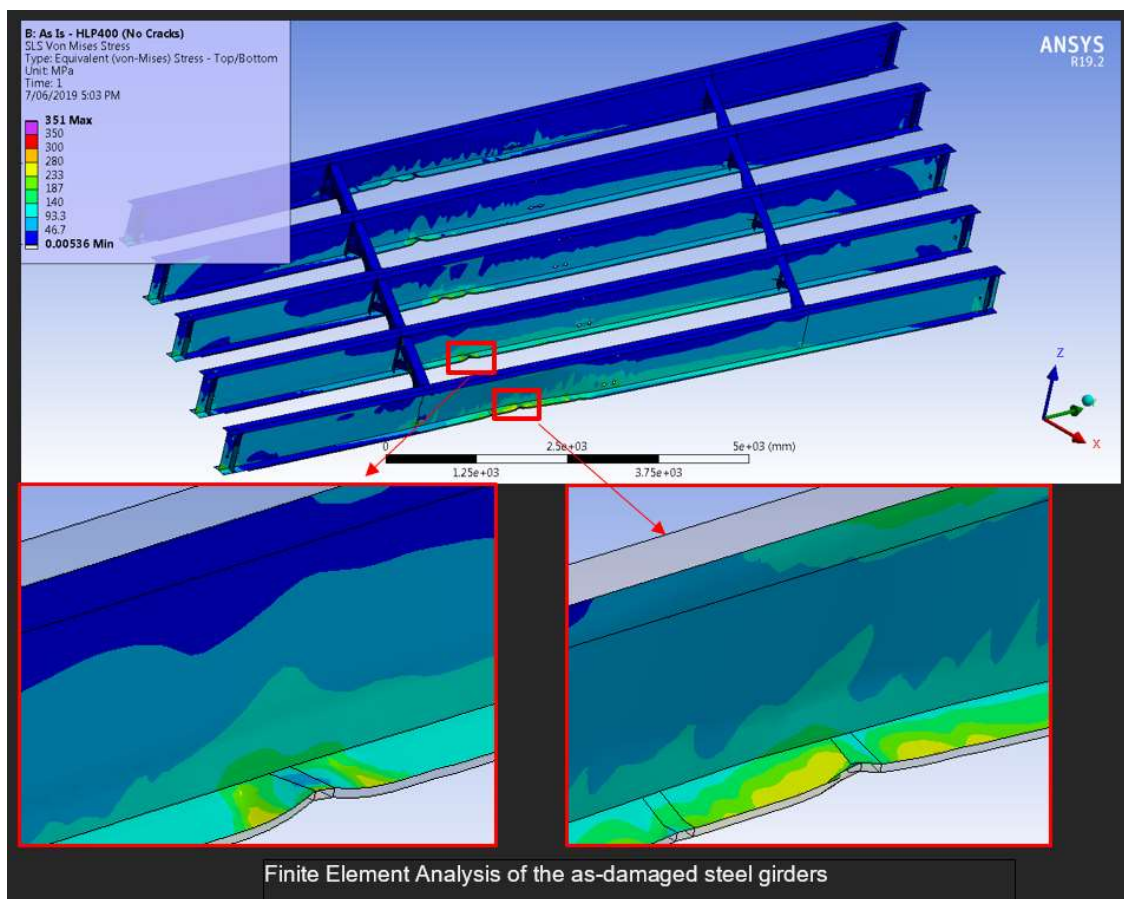
A truck carrying an over-height load travelling on Bruce Highway struck the superstructure of the Normanby Overpass in Gympie, Queensland, Australia. The overpass is a 13.5 m long single span bridge with signs attached indicating a 5.0 m clearance. The impact damaged the steel girders.

Nonlinear finite element analysis (NLFEA) was used to assess the load rating and remaining fatigue life of the as-damaged girders, and to derive repair options to carry Regulation Mass Vehicles (62.5 tonne B-Doubles) and AS 5100 design traffic loads (SM1600 and HLP400). 3D laser scan data of the damaged overpass was used to accurately model the damaged girders for the NLFEA assessment.

Despite the estimated design, construction, and future inspection cost of superstructure replacement being 50% more than the preferred repair option, replacement was adopted because:

- 100 years of design life could be achieved, compared to approximately 31 years for the repair
- design and construction of the repair were complex due to the extent and severity of the damage, and
- satisfactory site welding quality could be difficult to achieve for the repair.
