# Reliable Odour Control on a Bunnings Budget!

# The Client – Mt Isa City Council

# The Site – SPS1

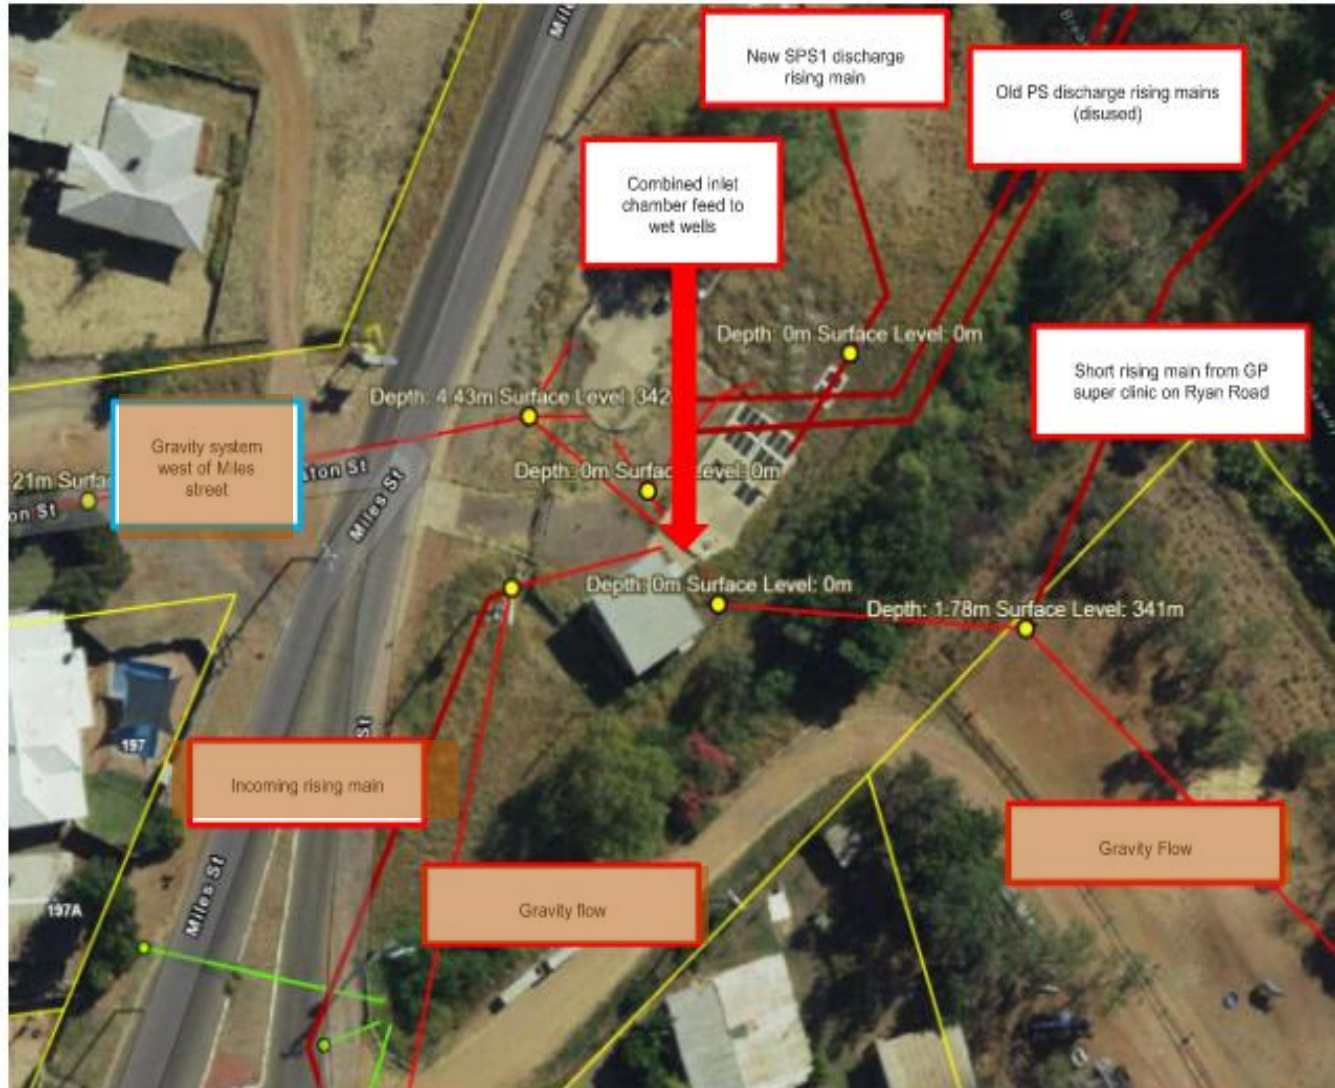
## SPS1:

- Conjunction of **four** sewers:
- DN300 rising main, and
- Three gravity sewers:
  - 2 x DN450
  - 1 x DN150

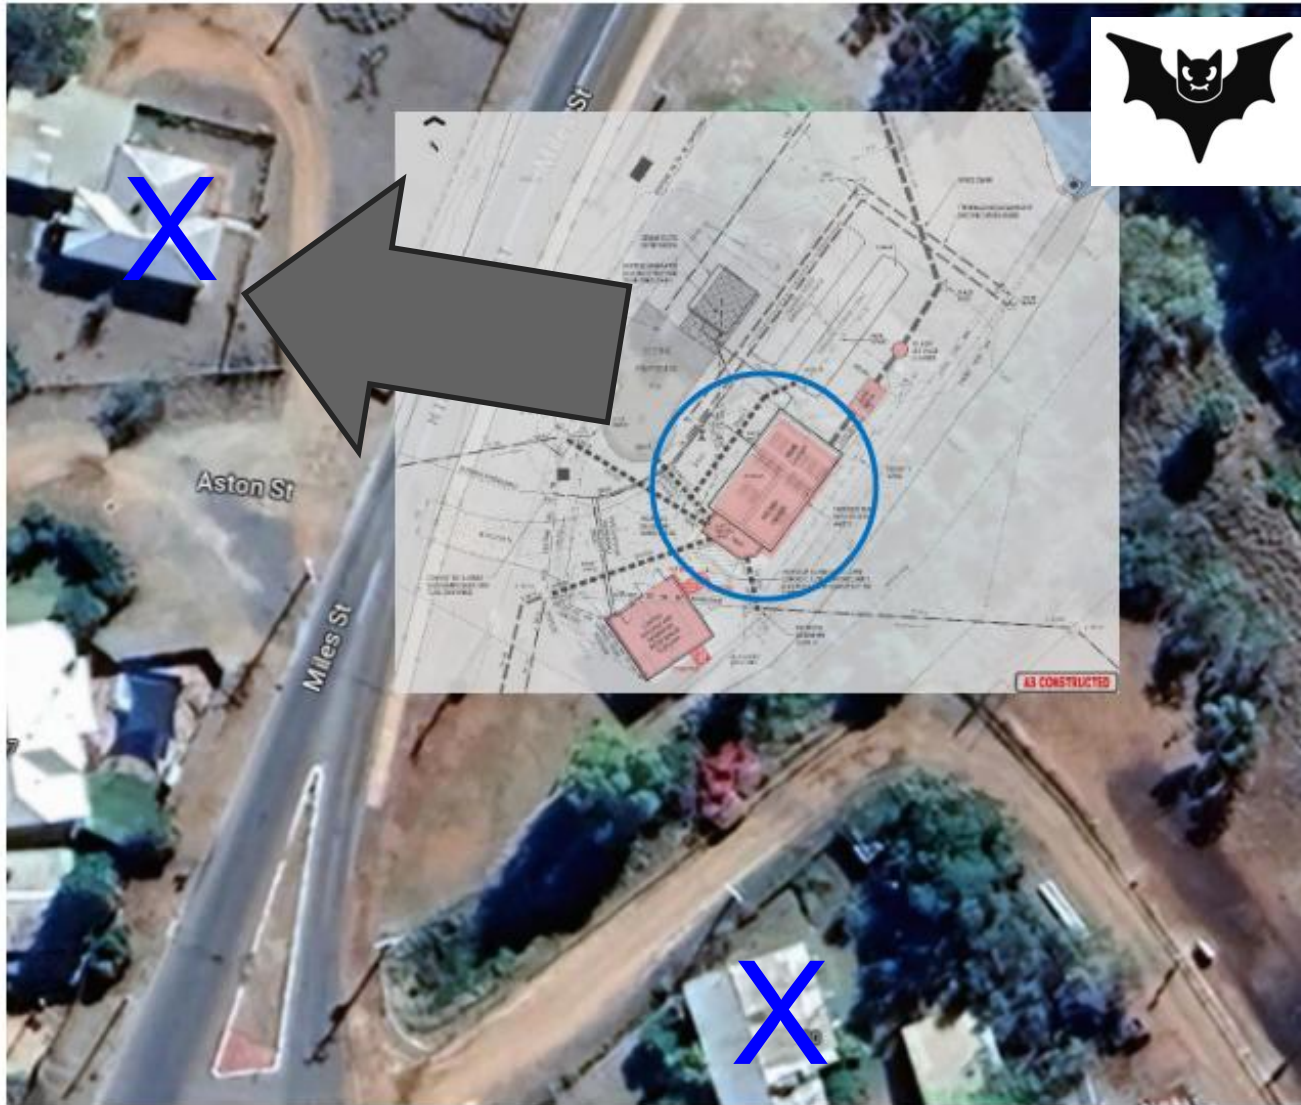
## SPS1:

- Conjunction of **four** sewers:
- DN300 rising main, and
- Three gravity sewers:
  - 2 x DN450
  - 1 x DN150

***Large bat colony  
within 100m to the NE***

***Closest receptors 30m  
west and 100m south***

***Main complaints from  
west of the pump station***

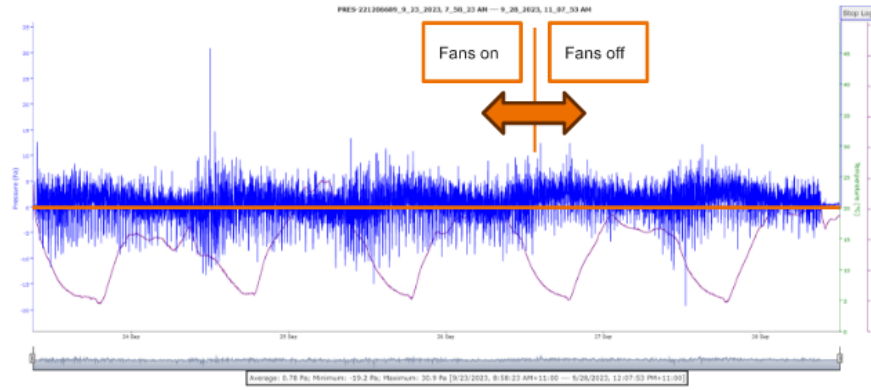
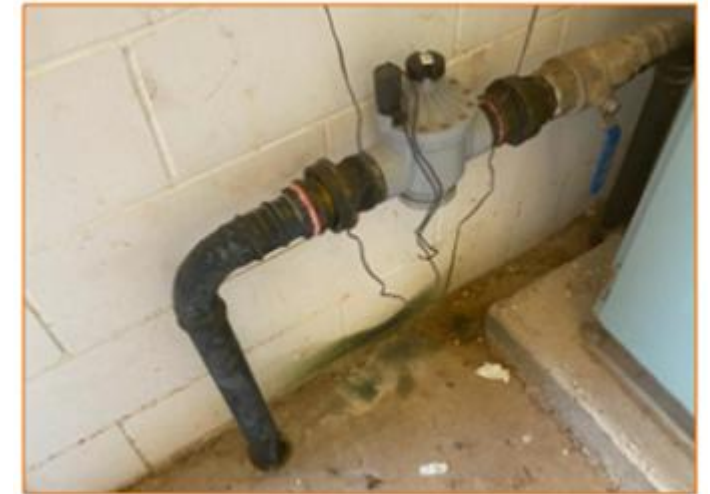
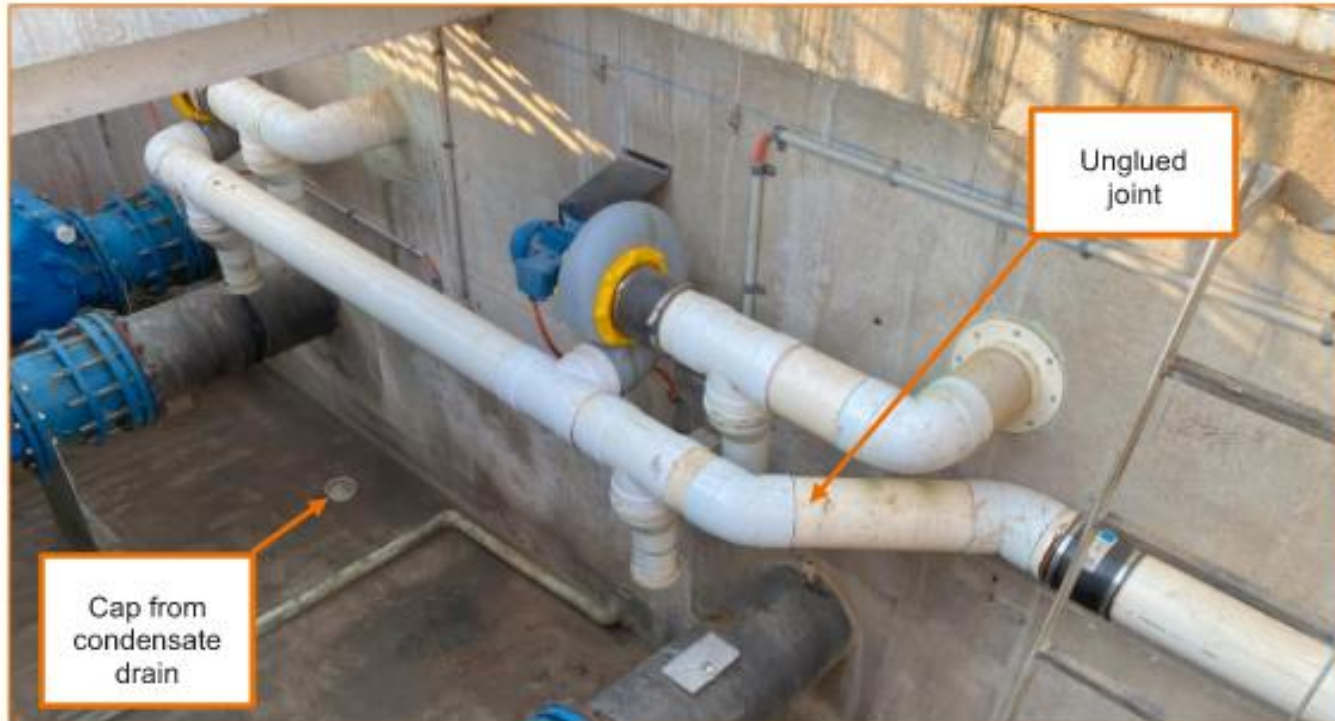
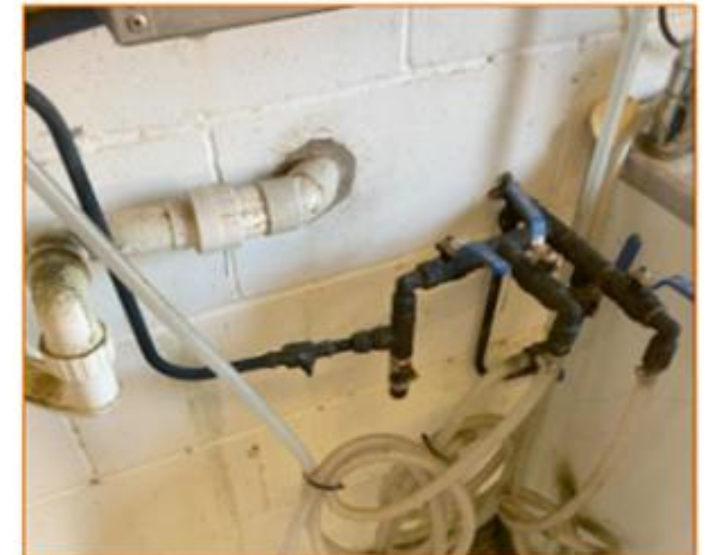
- Unlocatable air inlets
- Wet well with little to no foul air extraction
- H<sub>2</sub>S attack in switch room

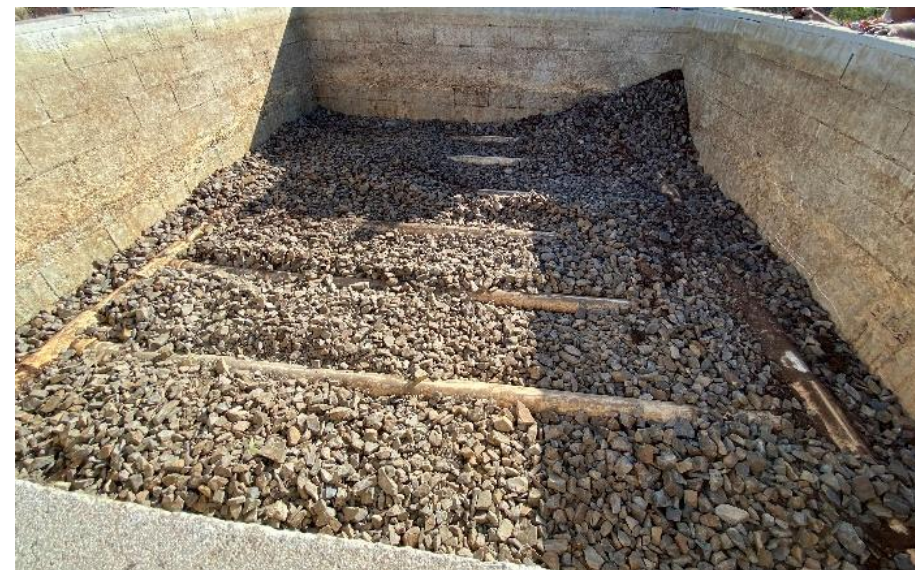
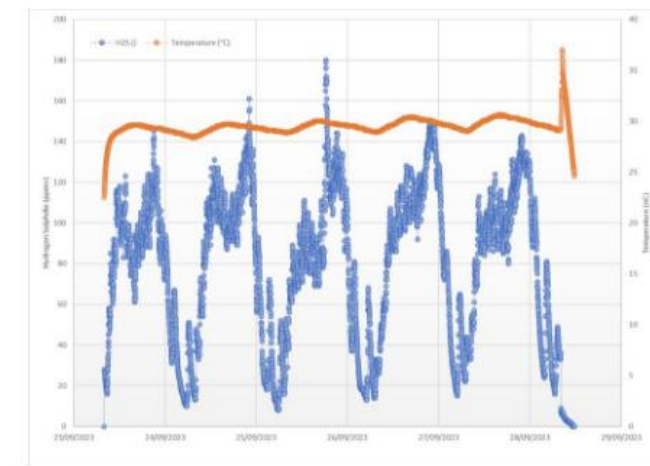
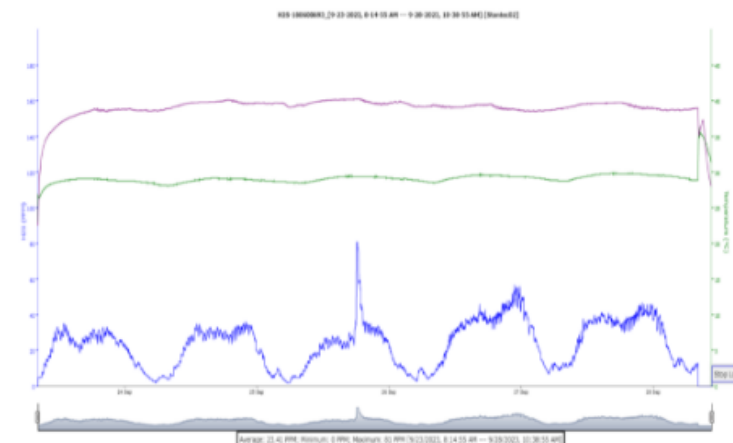
- Open bed “Bioamp 600” biofilter
- OCU increasingly unreliable and difficult to maintain
- No compliance
- Poor distribution of foul air and irrigation

- Wet well 1:
  - H<sub>2</sub>S: 78ppm avg, 180ppm peak
- Wet well 2
  - 21ppm avg, 85ppm peak

- H<sub>2</sub>S average: 73.4 ppb
- H<sub>2</sub>S peak: 1,780ppb

***Boundary levels above detectable limits – leading to odour complaints***

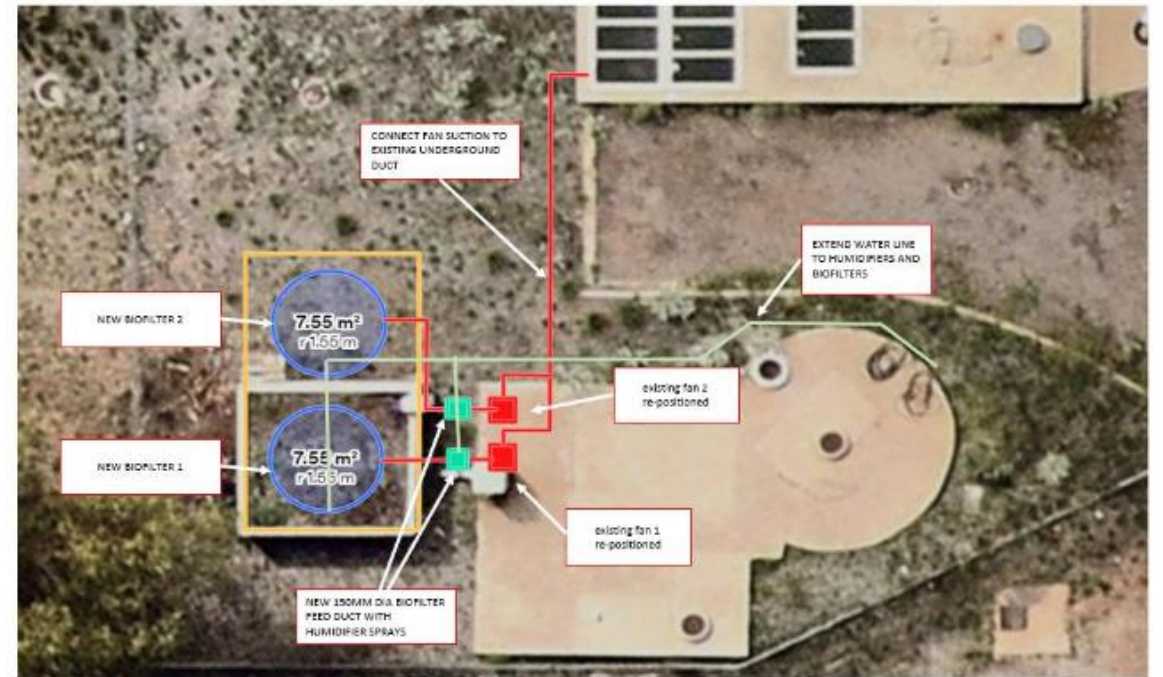
- Repair existing unit
- Rebuild like for like
- Install two above ground (poly tanks)

***Aboveground tanks were preferred***

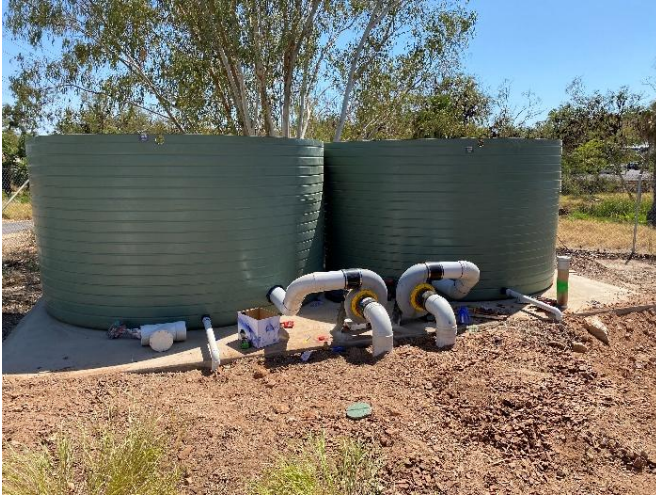
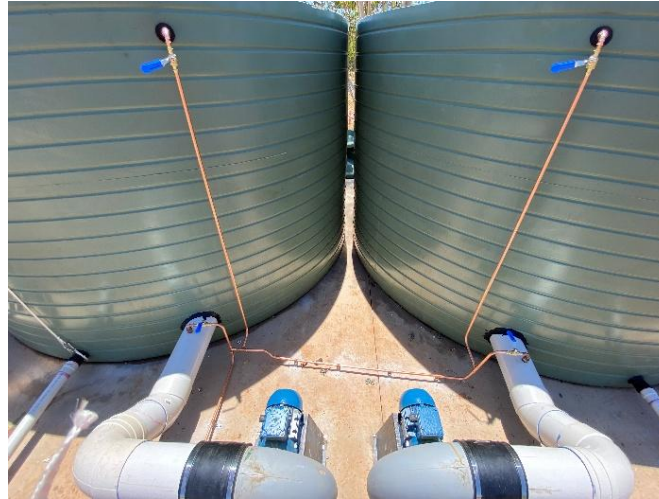
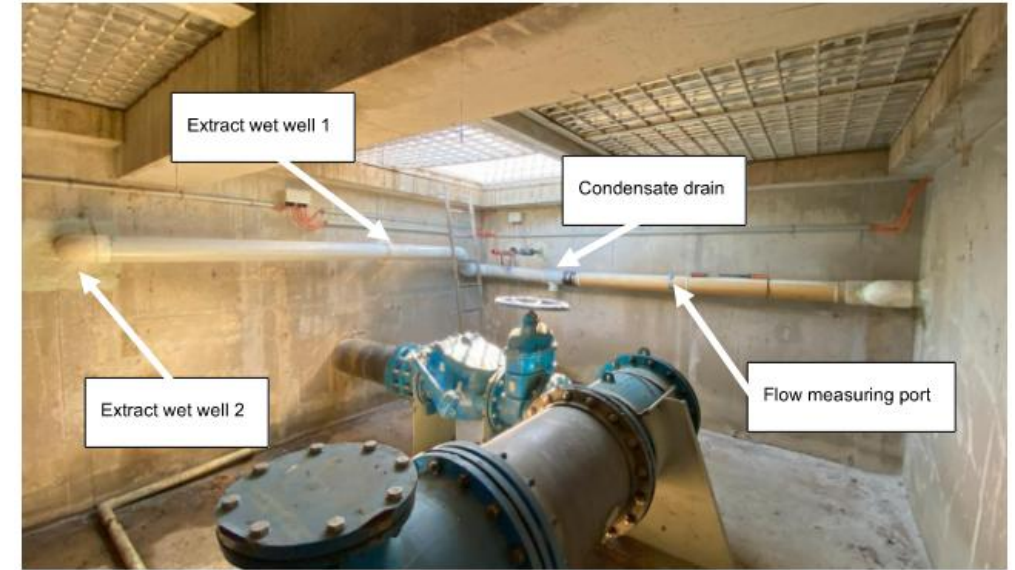
Airflow: **2,000m<sup>3</sup>/hr**

- Locate and repair air inlets
- Refurbish wet well sealing
- Refurbish extraction ductwork

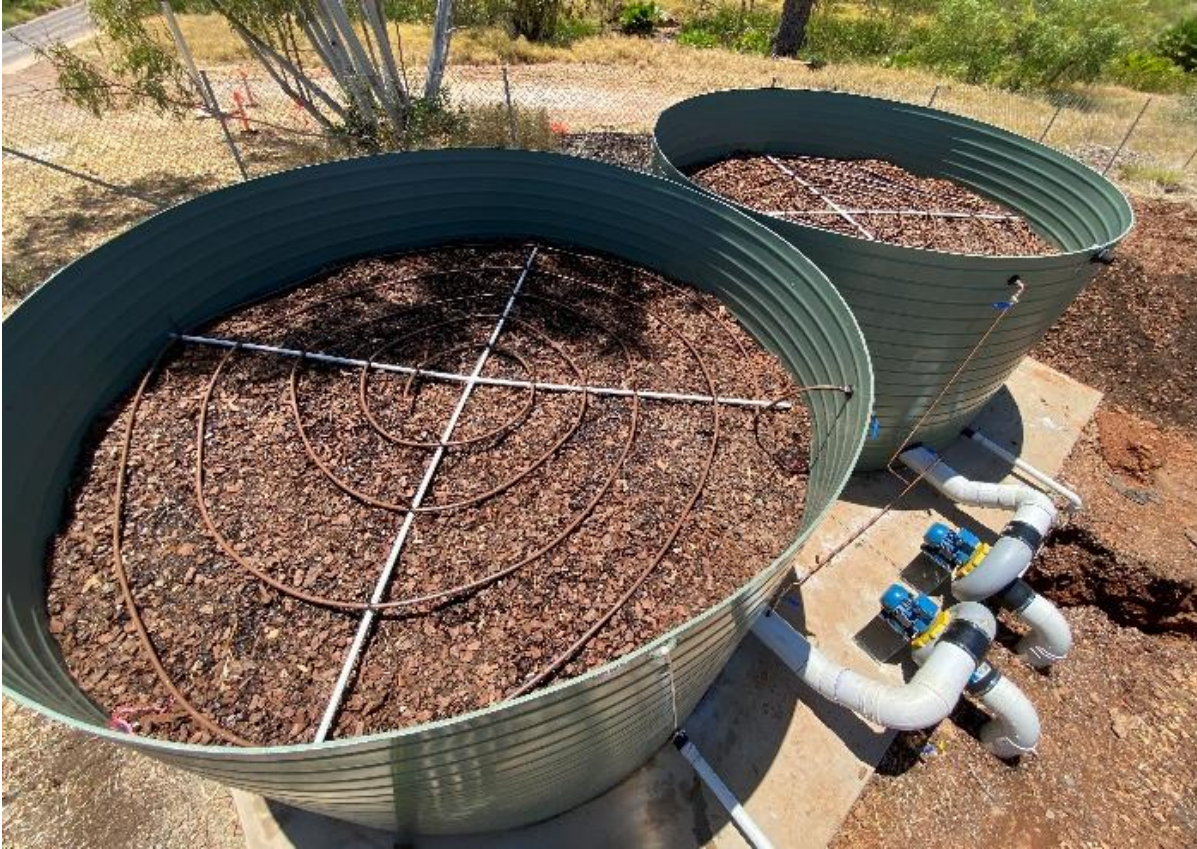
1.2m deep media comprising:

- 200mm 60/40 mix of pine nuggets and compost
- 400mm 50/40/10 mix pine chips, compost and lime
- 300mm pine chips
- 300mm pine nuggets

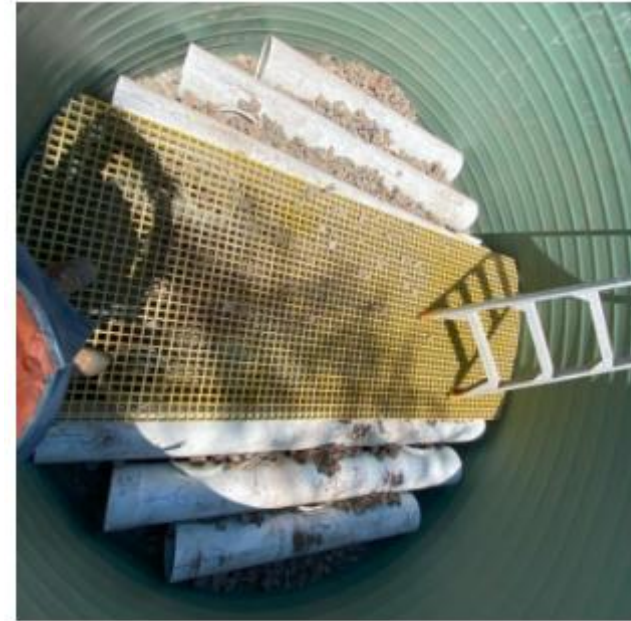
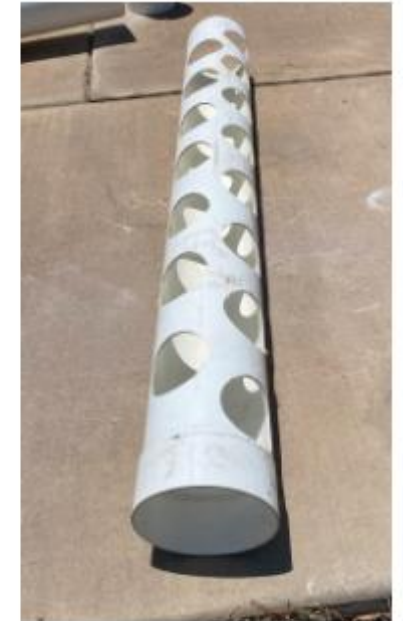
DN50 irrigation pipe with media support at 300mm

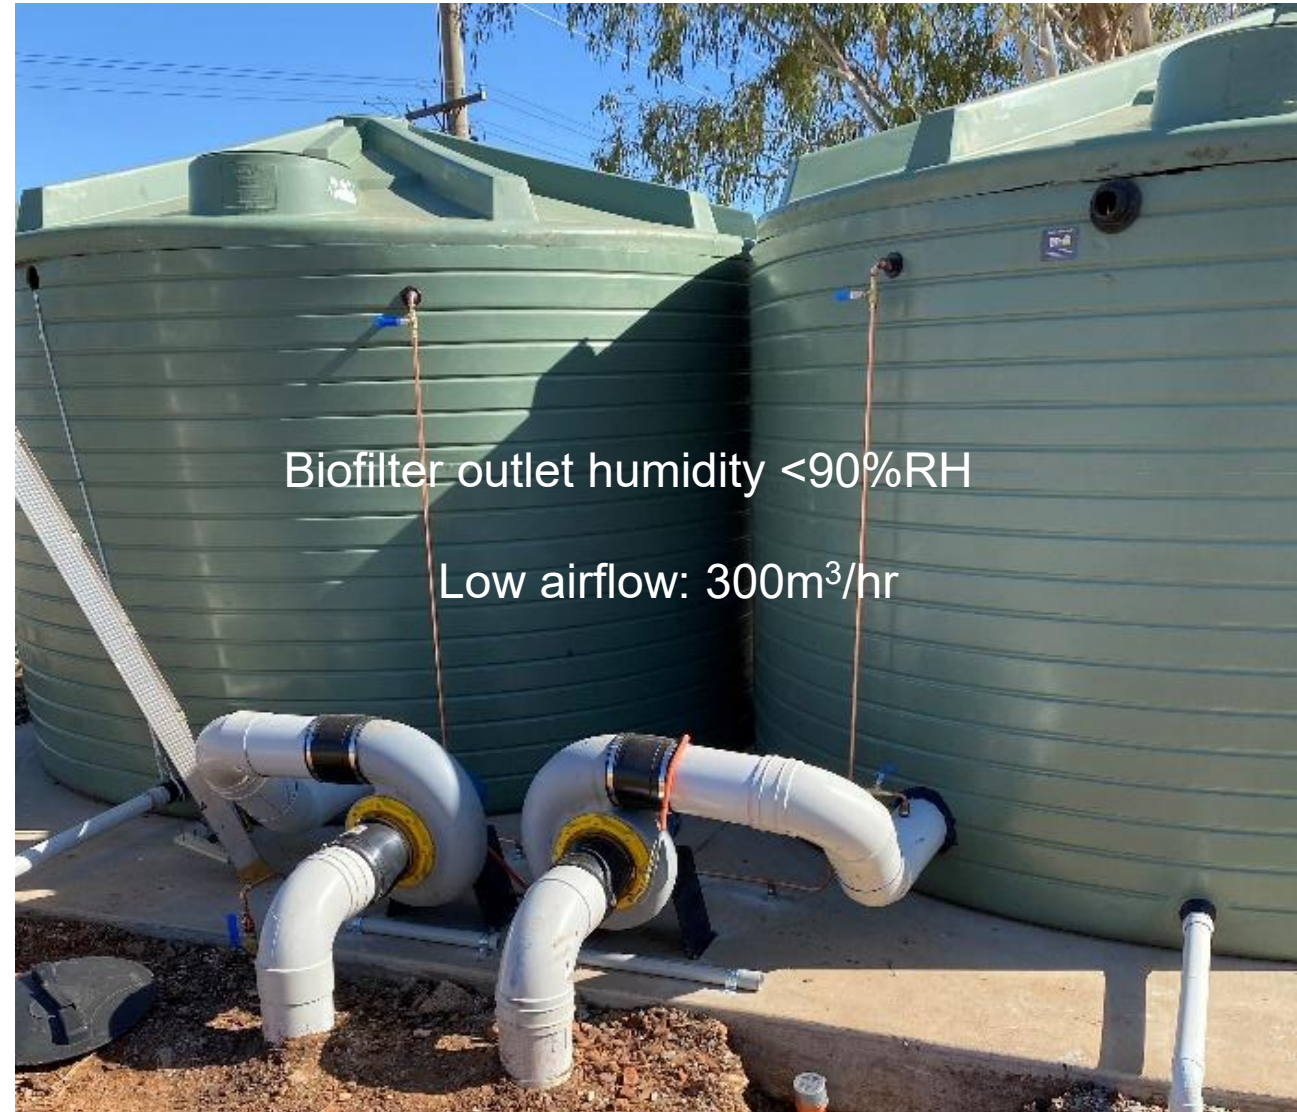
To confirm operation, testing confirmed:

- gas flowrate to the biofilters
- vacuum pressure under wet well covers
- hydrogen sulphide removal
- inlet air humidification

- ✓ Results indicated a healthy biomass of thiobacillus in 4 days
- ✓ Biomass expected to continue to improve, provided  $>90\%RH$  inlet stream was achieved
- ✓ The results demonstrated the media volume and bed constituents were suitable for SPS01

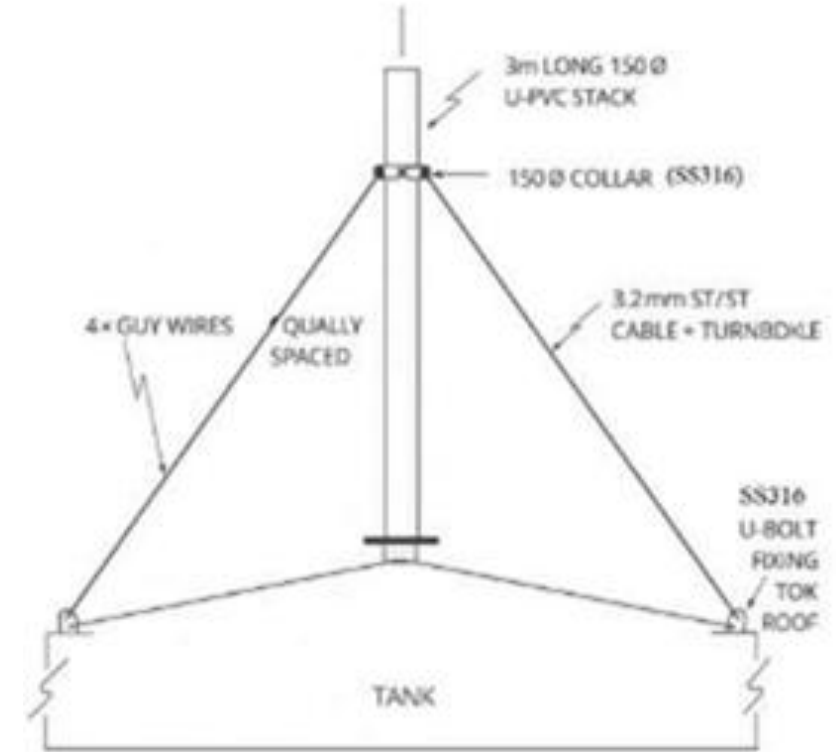
Proposed new stacks to vent off tops of biofilters

- Upgrading fans to SEAT25 units with 1.5kW motor, ensuring right hand/left hand orientations as needed
- 3m stacks to be fitted to each biofilter roofs
- Replaced spray nozzles with full cone atomization nozzles for better %RH
- Other minor items:
  - Add an aluminium slip collar to the biofilter roofs with SS316 bolts
  - Tapping and fitting of new threaded plugs for biofilter fan drains
  - Nozzle seals to be replaced with Sikaflex Tank N
  - Air inlet non return valves located and replaced
- Also:
  - Electrical conduits sealed with expanding foam
  - Sewer smoke testing
  - Structural condition assessment of wet well
