When Cracks Appear: Resilience for Gympie

Luke Maher, Specialist Water Industry Operations, Gympie Regional Council
Emma Fisher, Manager Water, Gympie Regional Council

Century-old, failing infrastructure, and the resilience behind regional water supply

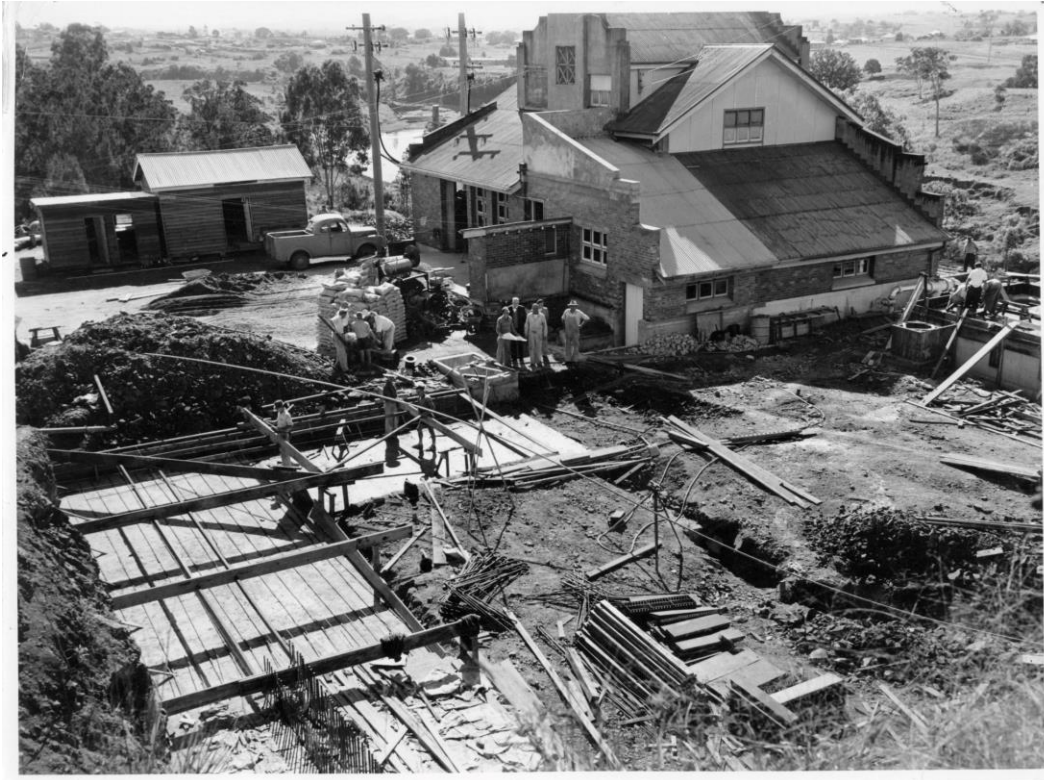
In the early 1960s, the sedimentation tank was poured (Figure 2). It was rectangular, robust, and built to last — or so it seemed. At the time, it was a proud example of engineering for the needs of the era. What it didn't have were features we now consider essential: no redundancy, no bypass, no isolation valves, no drainage. The treatment process relies on this single tank. If it fails, the town's drinking water supply stops.

Figure 2 - Construction of sedimentation tank, early 1960s

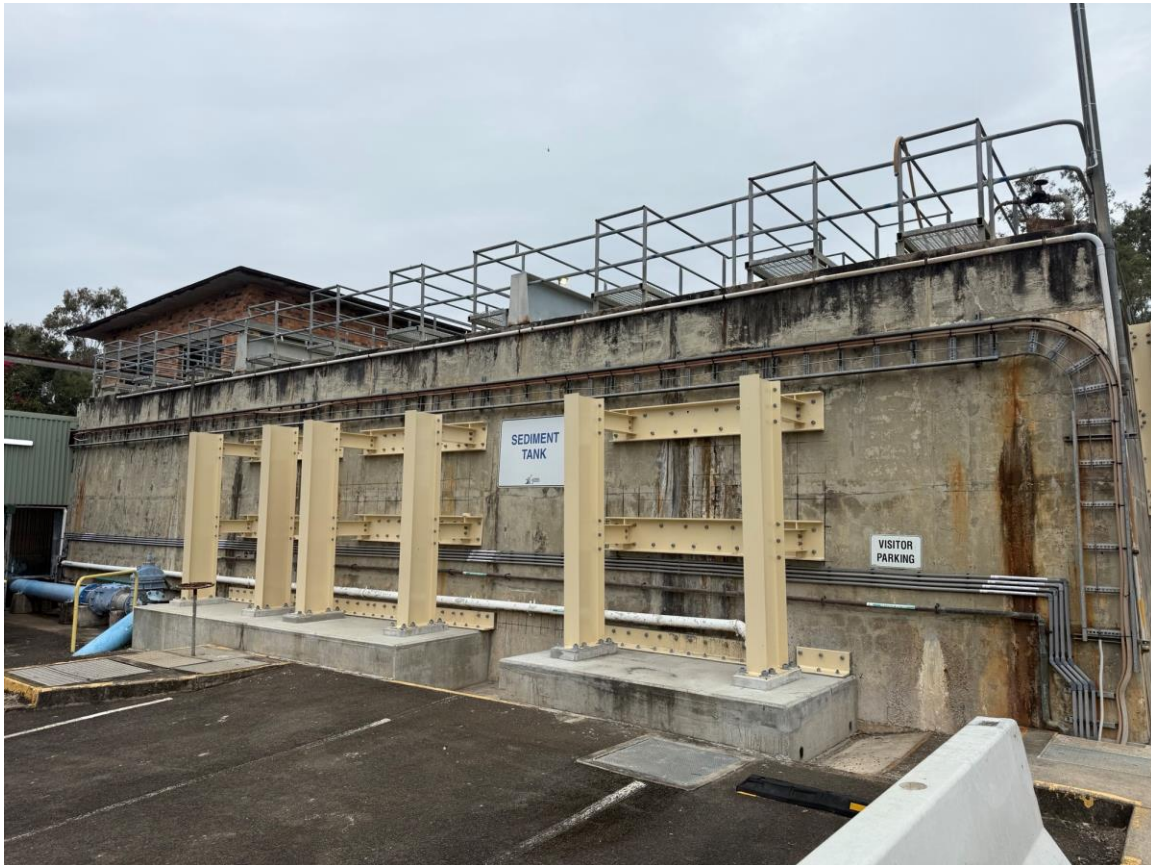
- Crack monitoring and survey regime.
- Exclusion zone for staff safety.
- External buttresses installed along the most vulnerable walls (Figure 4)
- Emergency bypass design from flocculation to filtration — once considered unworkable.

Figure 4 - Sedimentation tank buttressing
