Glenorchy field trip

LaRGE Landslides Conference | 28 April 2026

This field trip provides an overview of the natural hazards and resilience in the head of Lake Whakatipu area, including recent natural hazard and risk investigations, and collaborative work completed to develop a natural hazards adaptation strategy.

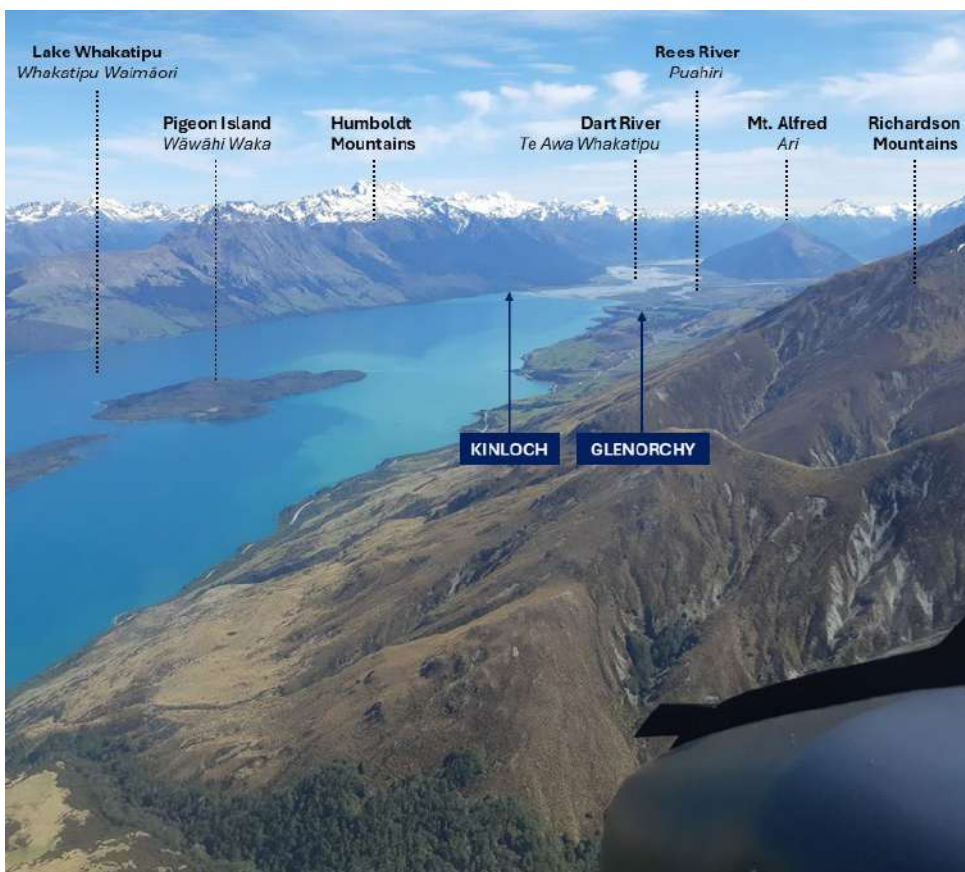
Figure 2: View northwards towards the head of Lake Whakatipu, showing the Dart-Rees floodplain and delta formed in the glacially-carved valley between the Humboldt and Richardson mountain ranges. The settlements of Glenorchy and Kinloch are located adjacent to the eastern and western margins of the Dart-Rees delta, respectively.

Lake Wakatipu (Whakatipu Waimāori) occupies a large glacially-carved basin, lying between the Richardson Mountains to the east and the Humboldt Mountains to the west (Figure 2). The lake has a maximum depth of 380m, with its lake-bed being up to 70 metres below sea level, but the bedrock trough is much deeper — containing a depth of at least 400 metres sediment fill in places (Coursey and Mountjoy, 2022).

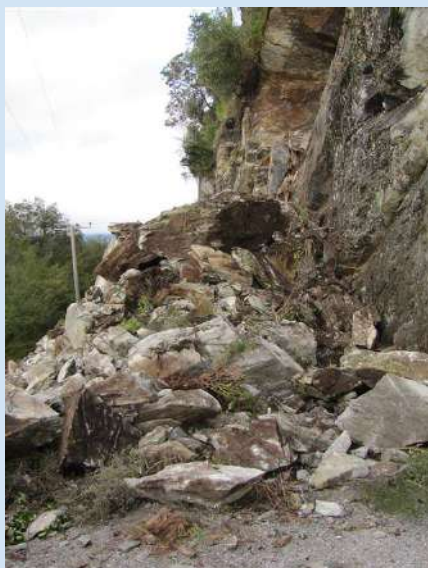
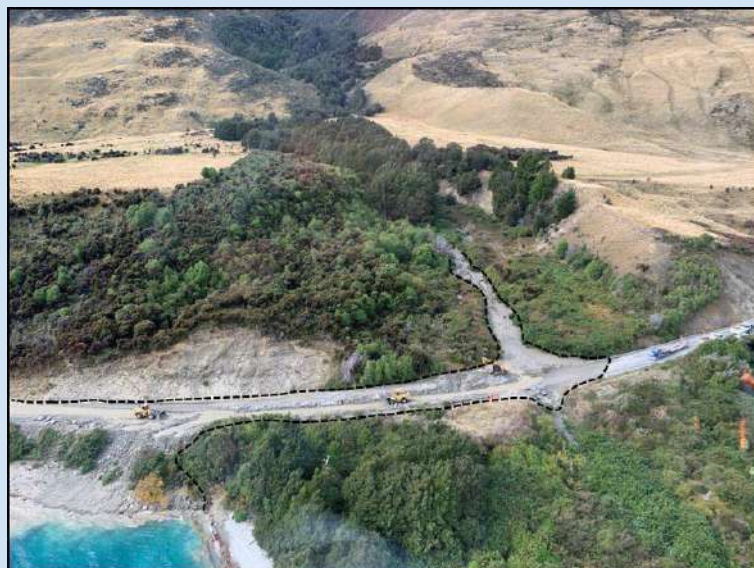
Figure 3: Left: May 2010 rockfall at the Narrows (photo: ODT). Right: Aerial view of debris flow impacts at the Queenstown-Glenorchy road, annotated to show the approximate extent of debris deposition (photo provided by Maddi Phillips, WSP Ltd).

Figure 3 shows the example of a debris flow which occurred at Shepherds Hut Creek in April 2022.

This event caused a road closure of 36 hours and required clearance of ~3400 m³ of debris (Shaw, 2022). The existing culvert at this location is planned to be replaced with one of larger capacity to improve roading resilience.

The May 2010 rockfall in Figure 3 occurred in a section of the road known as the Narrows, and was estimated at 1500-2000 tonnes.

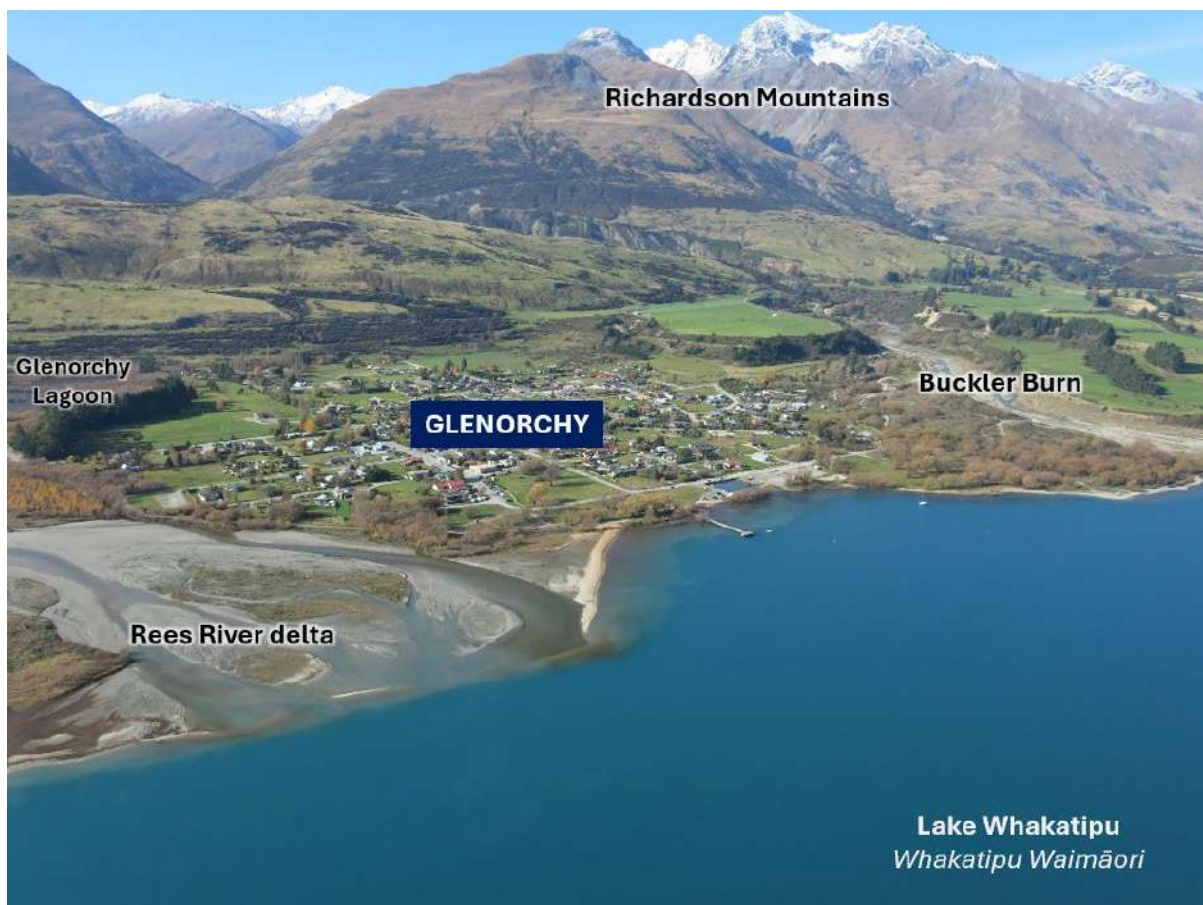
Figure 4: Overview of Glenorchy township.

Glenorchy township is located on a low-elevation alluvial fan landform formed by the Buckler Burn at the lake margin, between the Rees River and Buckler Burn

drainages, and adjacent to the actively growing Rees delta and the Glenorchy Lagoon and wetland (Figure 4).

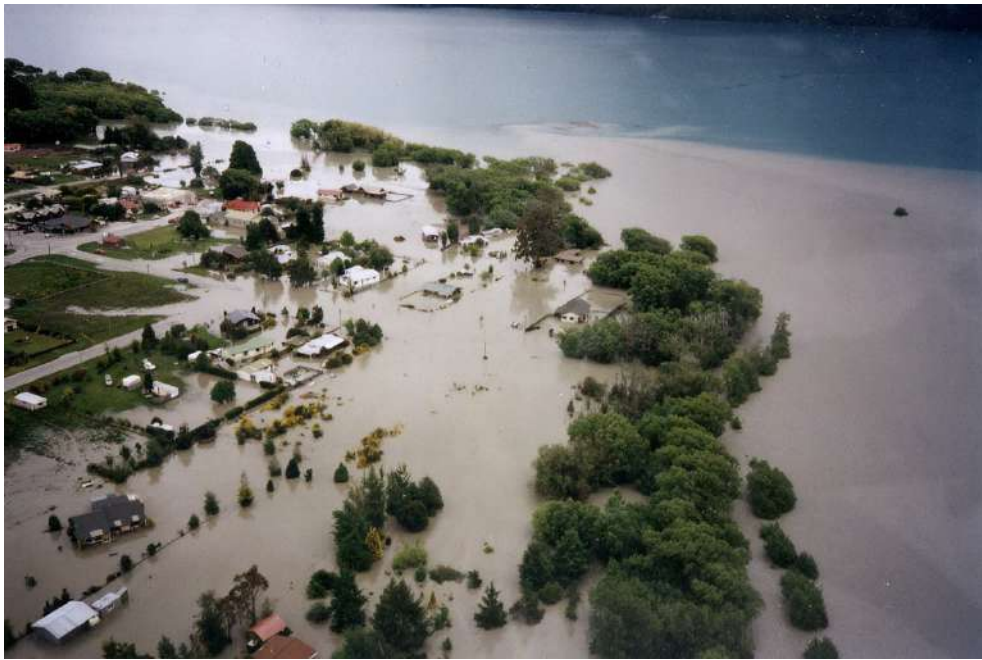
Figure 5: Flooding of Glenorchy township residential area, due to highest water levels on record in Lake Whakatipu (November 1999).

The township is exposed to potential flooding hazards from sources including high flows in the Rees River (e.g. Figure 6), Buckler Burn and Bible Stream, high-water levels in Lake Whakatipu (e.g. Figure 5), or combinations of these sources. ORC has investigated flooding hazards through 2D hydraulic modelling and flood hazard analysis for the Dart-Rees Rivers (Gardner, 2022) and Buckler Burn (Gardner and Beagley, 2023).

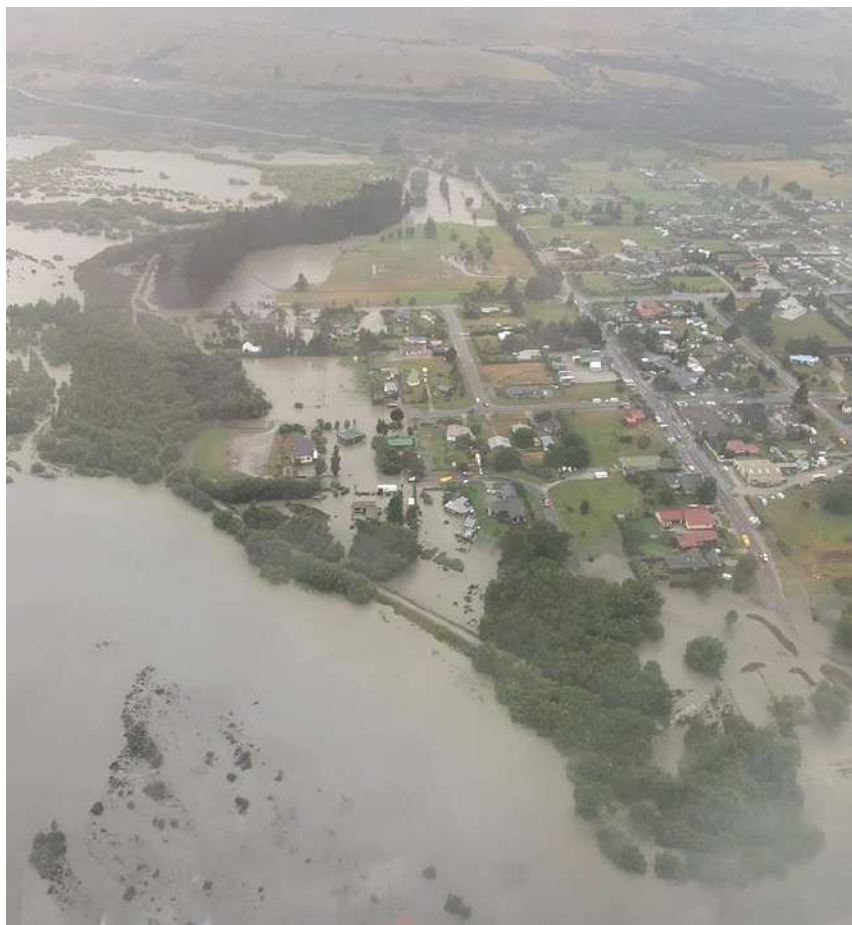
Figure 6: Flooding of Glenorchy township residential area, due to high Rees River flows causing overtopping of a section of the Rees-Glenorchy floodbank (February 2020).

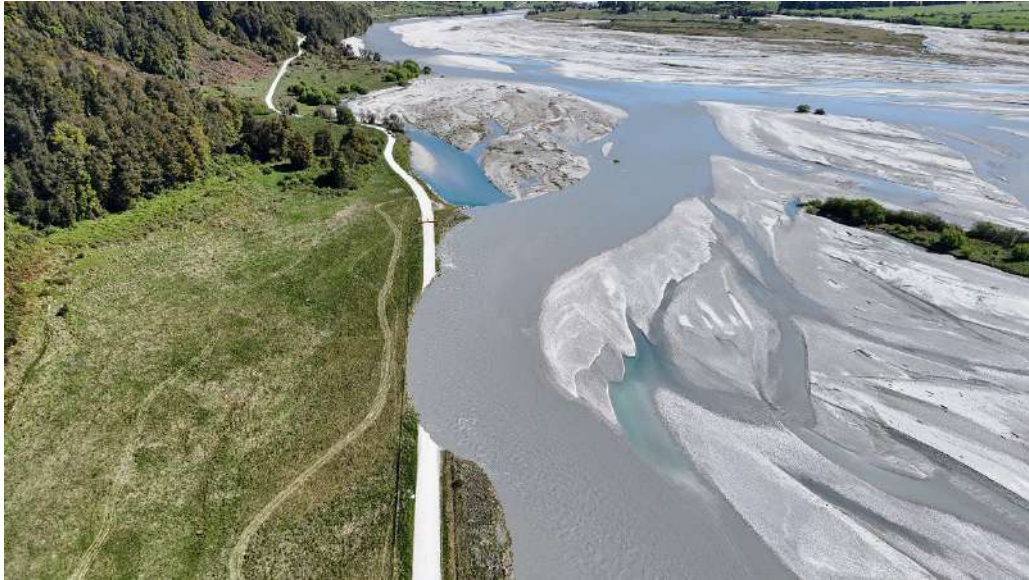
Figure 19: Erosion damage to Kinloch Road on the right bank of the Dart River (November 2024), this damage was repaired by realigning a short section of the roadway slightly inland from the river channel.

The road access to Kinloch is located on the Dart River floodplain and is prone to closure due to flooding (e.g. Figure 20), often on multiple occasions per year. Additionally, the road is threatened by ongoing westwards bank erosion (e.g. Figure 19), requiring increasing frequency of mitigation and repair.

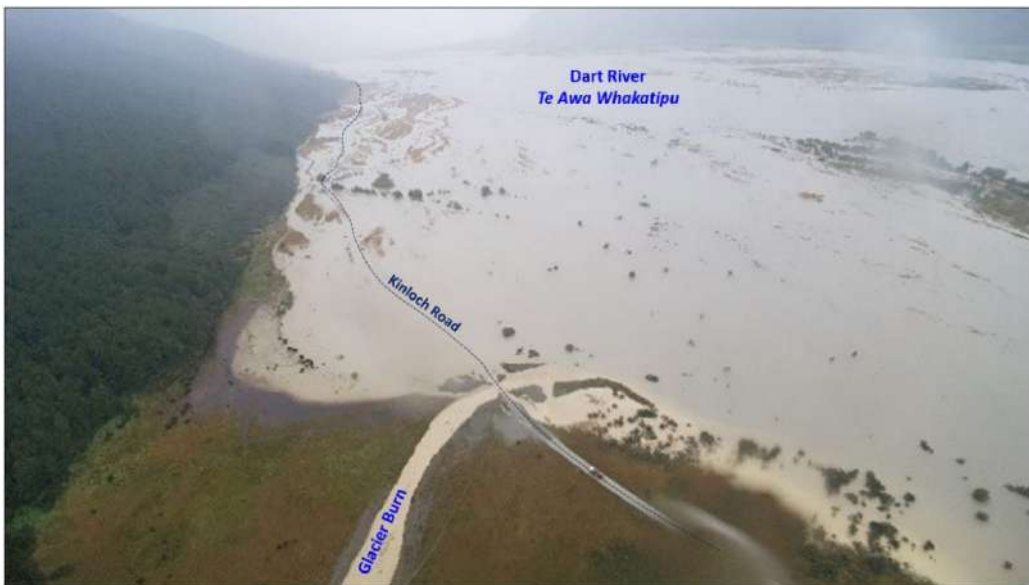
Figure 20: Flooding of Dart floodplain, showing inundation of Kinloch Road (March 2019).
