# The Challenges of the first NATM Highway tunnel of Romania

**ABSTRACT:** Romania's first motorway tunnel was built using the New Austrian Tunnelling Method (NATM) - the 1,350 m long Momaia Tunnel on the A1 motorway between Sibiu and Pitesti. The project forms part of the TEN-T corridor and was delivered under a design-and-build contract. The twin-tube tunnel was excavated in highly variable sediments of the Dacian Basin. Actual ground conditions, consisting of heterogeneous clay, silt, and sand layers with low cohesion and local landslide features, differed significantly from the initial geological forecasts and resulted in demanding excavation conditions. These challenges were successfully managed through adaptive excavation and support strategies tailored to the observed ground behavior. Despite elevated geological risks, the tunnel was completed safely and on schedule, demonstrating that NATM can be effectively applied under complex soft-ground conditions when combined with strong technical expertise and proactive risk management.

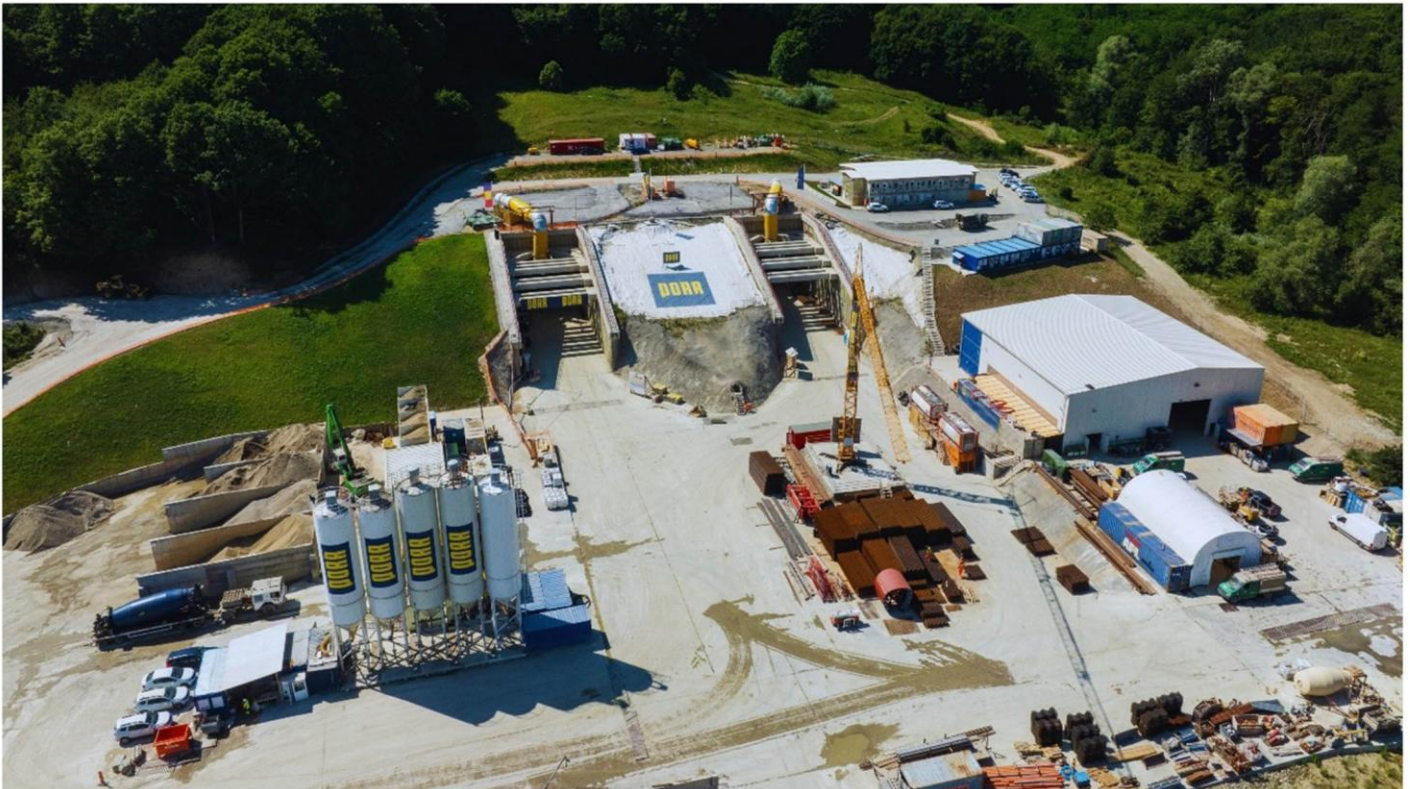
Figure 4: Portal Situation with site installations

The result of that research campaign was that only surface slides in depths up to 30 meters are encountered. As well it was found out that the mass movements are nearly parallel along the tunnel axis. For that reason box shaped portals had been designed that are founded with heavy reinforced piles. That piles act like an anchor in the stable – not moving – stratigraphic layers.

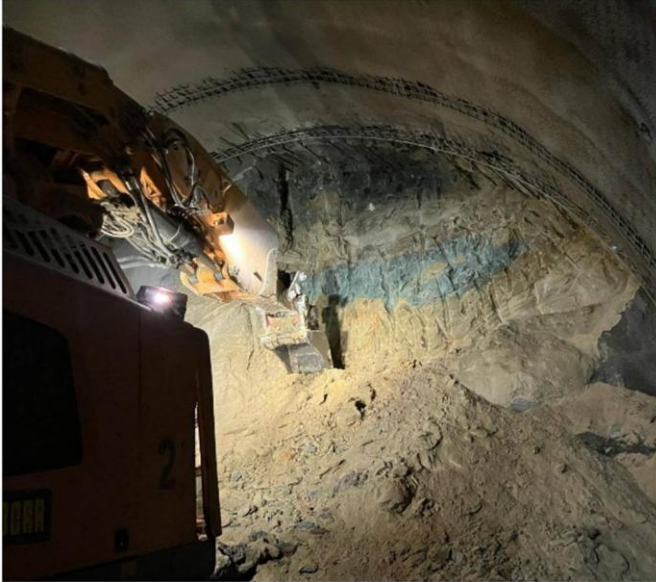
Figure 5: Top heading excavation in sand and clay

The concept planned a rapid ring closure [Figure 3] with a short trailing invert for the excavation works. For the advance a Liebherr L950 tunnel excavator with a ripper [Figure 5], bucket [Figure 6], optional road header and hydraulic chisel was used. Shotcrete application was executed with a Putzmeister Wetcret 5 shotcrete manipulator and a two-arm Sandvik DT922i drilling rig was used for all drilling works like fore poling and anchoring. The concrete was supplied by a construction site concrete mixing plant located near the portal. For the spraying and securing works a shotcrete C30/37 J2 with an alkali-free accelerator was applied. Both tunnel tubes were excavated in parallel in a 24/7 shift operation, with the excavation start having an offset from approximately one month in order to maintain the minimum distance of 25 m. Work was carried out in two shifts with a designated tunnel excavation crew with a

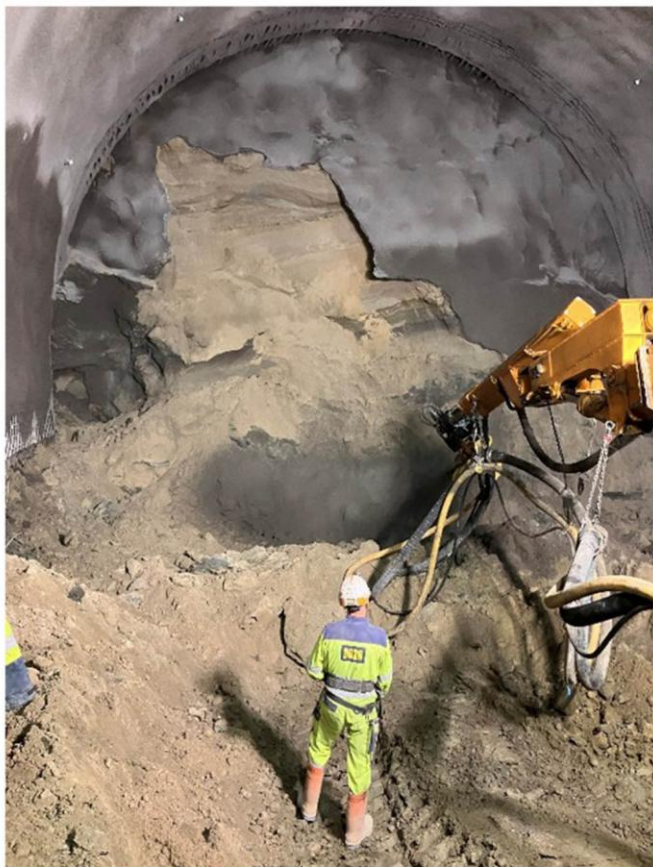
Figure 7: Face collapse due to sand during excavation of the bench

During excavation, it became apparent that the sand layers were significantly thicker than predicted – up to full face conditions – and significantly more heterogeneous and less compacted than assumed. In particular, the narrowly graded, dry and almost binder-free sands caused very unstable face conditions [Figure 7] and breakthroughs in the crown and top heading areas.

As an immediate measure, the excavation length was reduced, the face was subdivided into smaller sections and full-face support consisting of reinforced shotcrete with 15 m long anchors was installed. Unavoidable overbreak's were filled with shotcrete as far as possible, additionally, to avoid possible cavities and to ensure that the primary lining was firmly attached to the mountain, injection drillings have been carried out subsequently in the back.

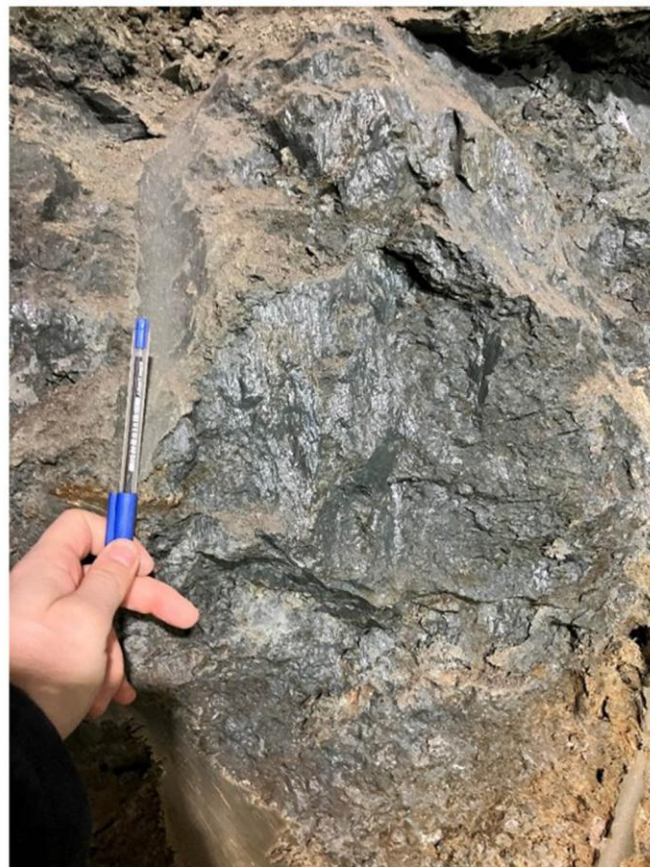
Figure 8: Slickensides in the face under clayey conditions (height of 45cm and a width of 30cm)

The clay and silt layers were described in the investigations as compact, cohesive soils of stiff to firm consistency, and in higher overburden also as clay/siltstone. In situ, irregular separation surfaces exhibiting slickenside structures [Figure 8] were frequently encountered, particularly in the Dacian sediments. The occurrence of slickensides led to a total loss of cohesion and to varying degrees of collapse behaviour of the excavation face. The cause of the slickensides is not of tectonic origin; it is assumed that they were caused by the swelling of clay minerals. Due to their relatively small size and irregular orientation, the structures could not be identified in the exploratory drillings.

The countermeasures were based on the thickness of the affected layers and included, in addition to a concentrated arrangement of face anchors with a minimum length of 15 m, the full-face securing with the reinforced shotcrete, as well as the reduction of the round length and excavation in smaller subdivisions.

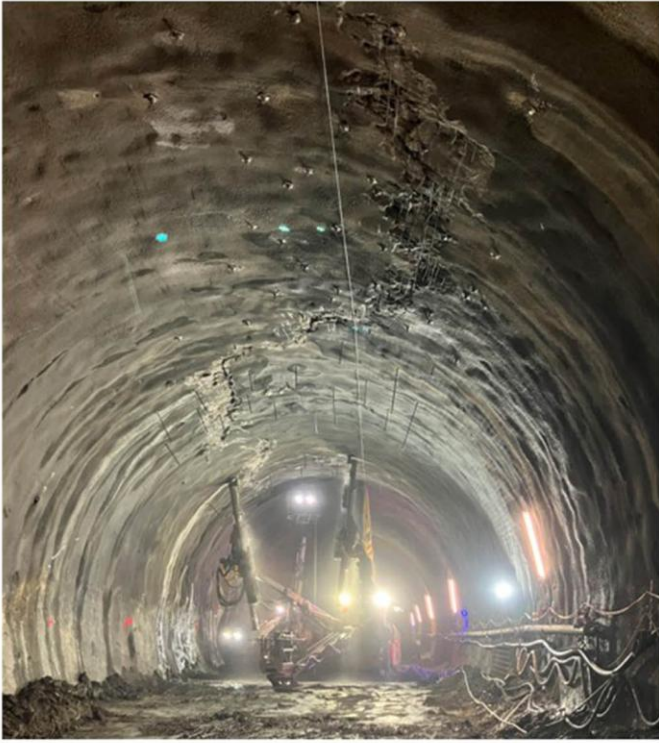
Figure 9: Repair work after the crack

In an ad hoc meeting with the foreman, supervisor, site manager, project management and the geotechnical engineer, it was decided to take immediate action and bring both tunnel drives to a controlled stop. At the same time, all preparations were made for large-scale anchoring in a 1.5 m grid with self-drilling injection anchors with a minimum length of 12 m throughout the entire top heading. Within 36 hours, approximately 3,500 running metres of anchors were drilled and injected using two drilling rigs, thus preventing further spread of the crack [Figure 9 and 11].

In the following days, after a damage analysis and several rounds of consultation with the designer and the geotechnical engineer, it was decided to install shotcrete ribs to stabilise the broken outer shell. The ribs were designed to be approximately 100 cm wide, reinforced in three layers, connected to the outer shell with shear dowels and installed at intervals of 7.5 m all around. In addition, a repair concept for the outer shell between the ribs was developed and implemented. The ribs were only gradually removed immediately before the inner shell was installed.

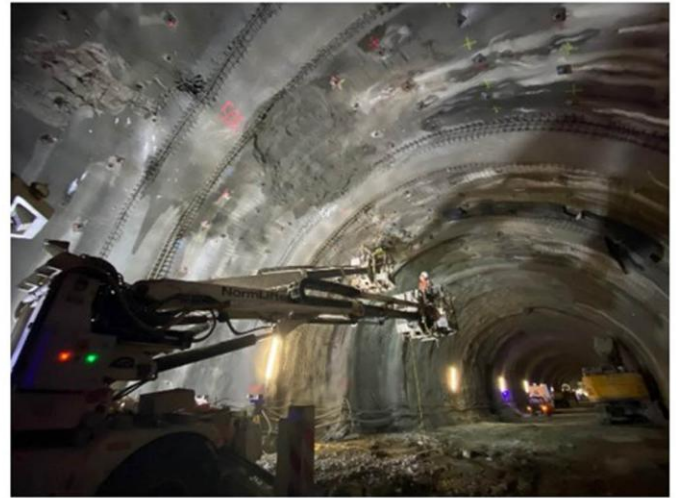
Figure 10: Crack spreading in the top heading area

After a period of stabilisation, on the evening of 6 April 2024, the crack extended from approx. 10 m to approx. 65 m within a short period of time [Figure 10] and the displacement also increased significantly. The cracking of the shotcrete was acoustically detectable and led to larger pieces of shotcrete breaking off.
