# **INFLUENCE OF STRUCTURAL AND OPERATIONAL CONSTRAINTS ON THE EFFECTIVENESS OF BLOCK BACKFILLING: FINDINGS FROM WATERPROOFING OF A DEUTSCHE BAHN TUNNEL**

**ABSTRACT:** The “Große Wendlinger Kurve” (engl.: Wendlingen Large Curve) is a single-track railway tunnel with a length of approx. 770 m. The tunnel, which was excavated over approx. 660 m using the new Austrian Tunnelling Method (NATM), has a pressure-retaining waterproofing system, which consists of sheet waterproofing membranes (SWM), protective layers, external joint seals, and an in-situ concrete inner lining. A grouting system was installed over a length of around 225 m, which was used for a systematic block backfilling of the tunnel lining prior to the rise of groundwater level. The same waterproofing system was installed in the remaining 435 m of the tunnel, but in these sections, neither the installation of a grouting system nor the systematic block backfilling was carried out. In this case only crown gap grouting was carried out, which allows a direct comparison of the two approaches.

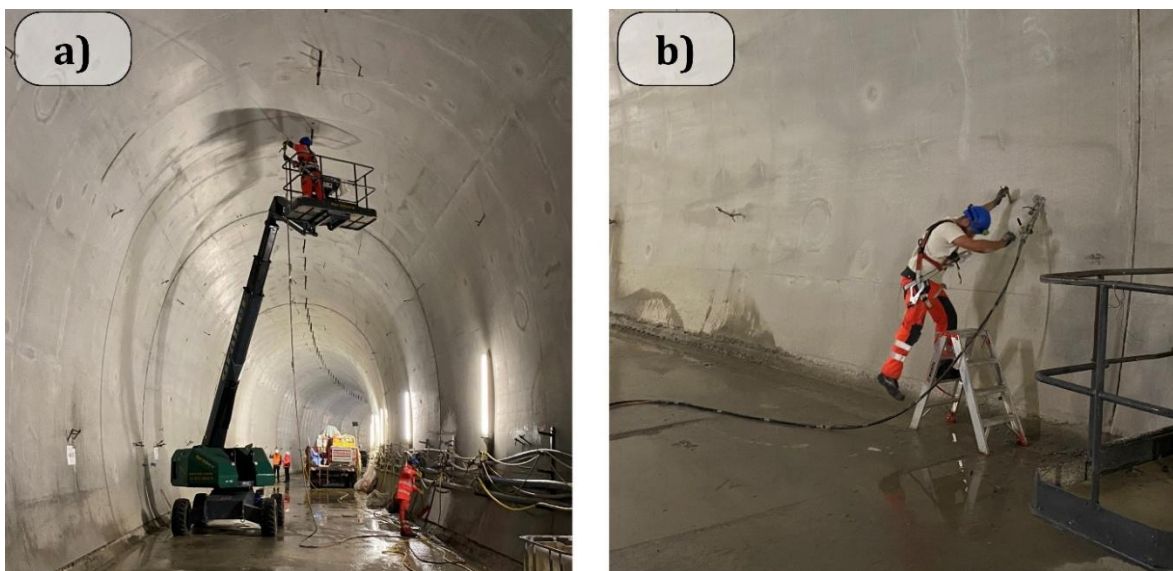
Figure 4: Execution of the CGG (a) and SBB (b) on the WLC (source: IB Kirschke)

Based on the current regulations in Germany, a CGG must be carried out by default after 28 (7) or 56 (8) days before the original groundwater level is restored. This procedure targets the filling of the cavity in the crown (crown gap) caused by the concreting process and technology. For this, a low-shrinkage grout (cementitious mortar or slurry) is used. Requirements for the material properties can be found in ZTV-ING Part 3, (10) Section 5. The grouting is carried out through the “spy holes” remaining after the fresh-in-fresh concreting along the crown line (Image4 a).

known as “systematic block backfilling” (SBB, Figure 4 b). SBB also covers the crown gap, so that it already includes the CGG required by the regulations.

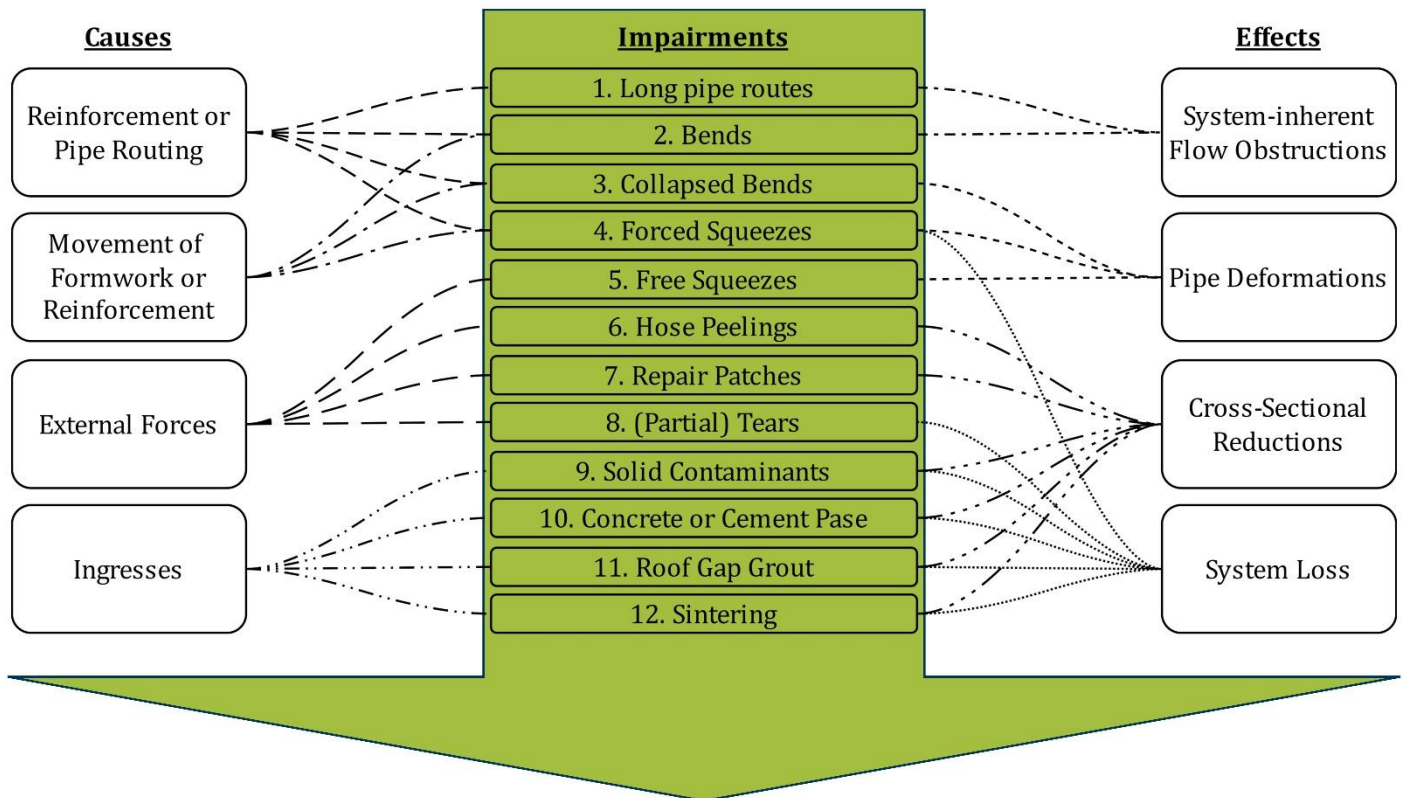
Figure 6: Heuristic classification system for cataloguing possible impairments to the functionality of individual grouting devices (top centre) with their causes (top left) and effects (top right), along with examples for every impairment covered by the catalogue (bottom) in the order which they are listed

The following impairments were used for quantification and evaluation from the catalogue presented in section 4.1.2 by Figure 6:

- bends (2.)
- collapsed bends (3.)
- forced squeezes (4.)
- free squeezes (5.)
- hose peeling (6.)
- repair patches (7.)
- ingress of solid contaminants (9.)
- ingress of concrete or cement paste (10.)

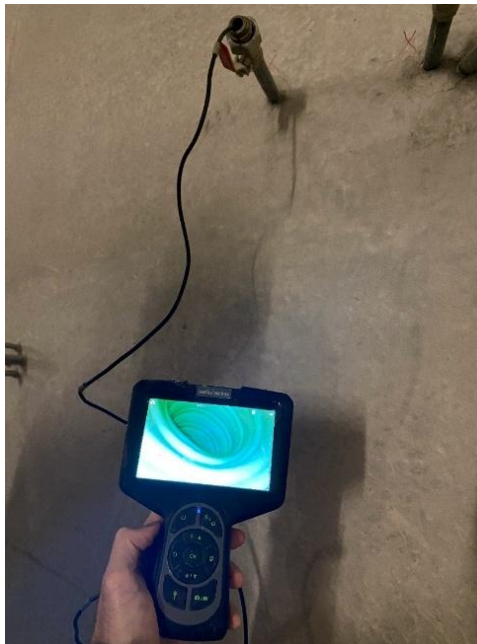
Figure 7: Conducting a video inspection through a grouting packer (source: Camós-Andreu)

Data was collected using a waterproof handheld pipe camera (see Figure 7) with HD resolution (1080 P), integrated LED lighting, a frame rate of 30 frames per second and a camera diameter of 8 mm. The length examined was tracked using markings on the camera cable.

To obtain as comprehensive a sample as possible of both the grouting devices of the standard type grouting system and the two experimental variants, a total of four block sections were systematically examined. Two of these sections were equipped with the standard grouting system (sections 31 and 32) and one section each with the system with fabric hoses (section 34) and the system with corrugated pipes and angled connections (section 35) in the sidewalls and crown. In these four selected block sections, depending on accessibility and without disrupting the construction process, all 24 grouting devices installed were examined from the formwork unit before and after placing concrete for sidewalls and crown. This systematic recording was supplemented by random samples of individual, randomly selected grouting devices in randomly selected block sections. These random samples comprise 25 examinations, which were carried out during the preparation of the grouting through the already installed grouting packers, as shown in Figure 7.

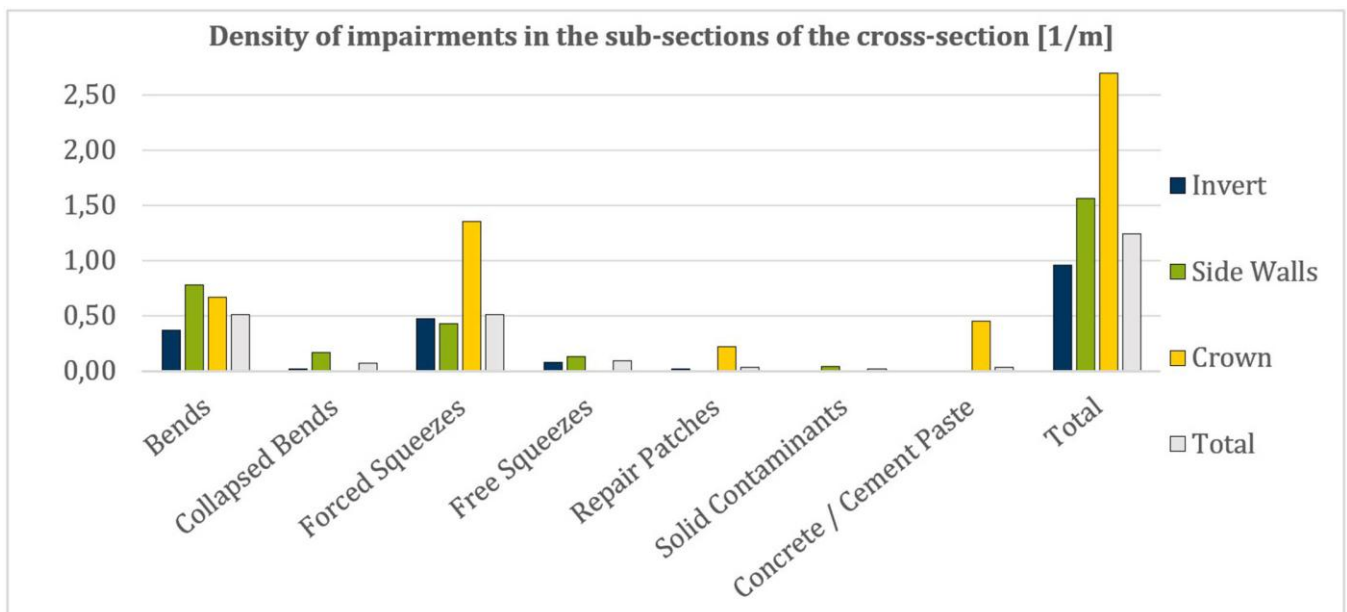
Figure 8: Density of the impairments observed in different sub-sections of the cross-section

To assess the impairments causing the total distribution shown in Figure 8, the proportions of the total density distribution and the distributions per sub-section were analysed. This analysis shows that the total distribution (Figure 8, "Total") is significantly influenced (more than 41 %) by bends and forced squeezes. Looking at the individual cross-sectional sub-sections individually, bends dominate in the invert and the sidewalls with proportions of ~ 39 % and ~ 50 %, respectively. In the crown, on the other hand, forced squeezes have the biggest influence by ~ 50 %.

These types of impairments not only account for high percentages but also show significant variation between the cross-sectional sub-sections. This explains the observed distribution of the total density (invert < side walls < crown).

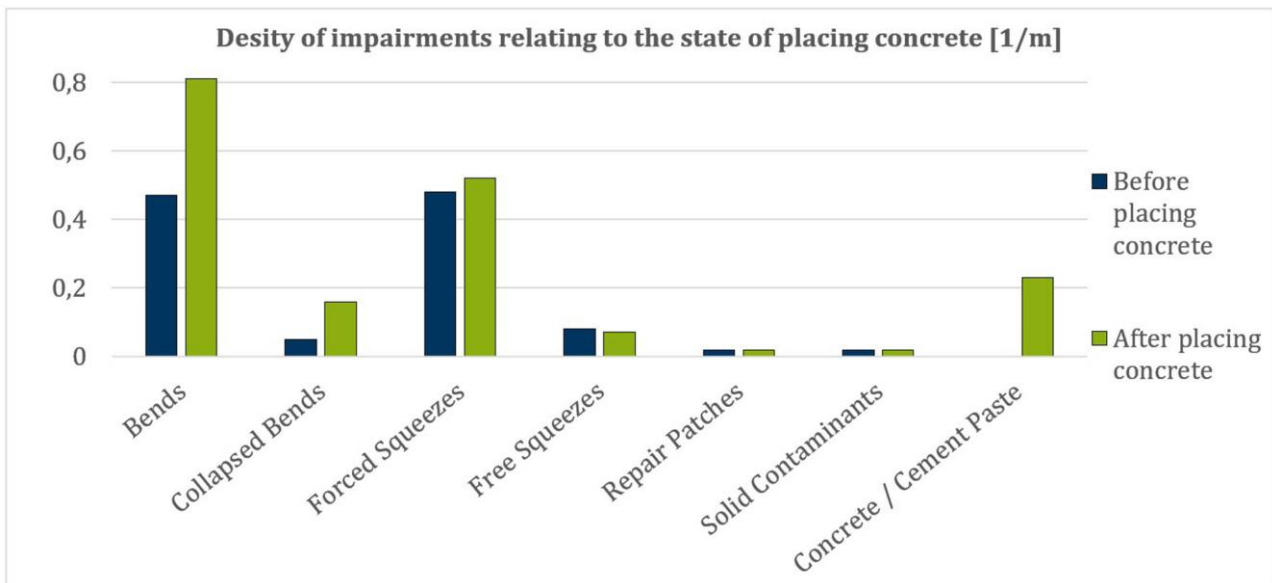
Figure 9: Density of the observed impairments before and after placing concrete in the sidewalls and crown

As a result of placing the concrete in sidewalls and crown, there is a significant increase in the density of bends and collapsed bends. Overall, the density of all impairments increases from 1.10 1/m before to 1.84 1/m after placing concrete. As to be expected, concrete or cement paste deposits are only visible after concreting. These show a density of 0.23 1/m. The values from Table 3 are illustrated by Figure 9.

Reviewing Figure 9, it is evident that, placing concrete has an overall impact on the impairments to the grouting devices. However, based on the assessment presented, it is not possible to identify any influences from previous and subsequent construction stages. Still, it can be assumed that these may also impair the functionality of the grouting devices. For example, compared to the systematic examination, the density of solid contaminants increased significantly in the random supplementary examinations during the preparation of the grouting (0.05 1/m compared to 0.02 1/m). Furthermore, hose peelings, which were not encountered at all during the systematic examination, occurred in the supplementary random samples with a density of 0.08 1/m. This value, which appears low at first glance, is due to the long investigation distances. In fact, peelings that are not distributed over the pipe route but only occur once per grouting device were found in 72 % of the grouting devices examined as part of the supplementary sampling.

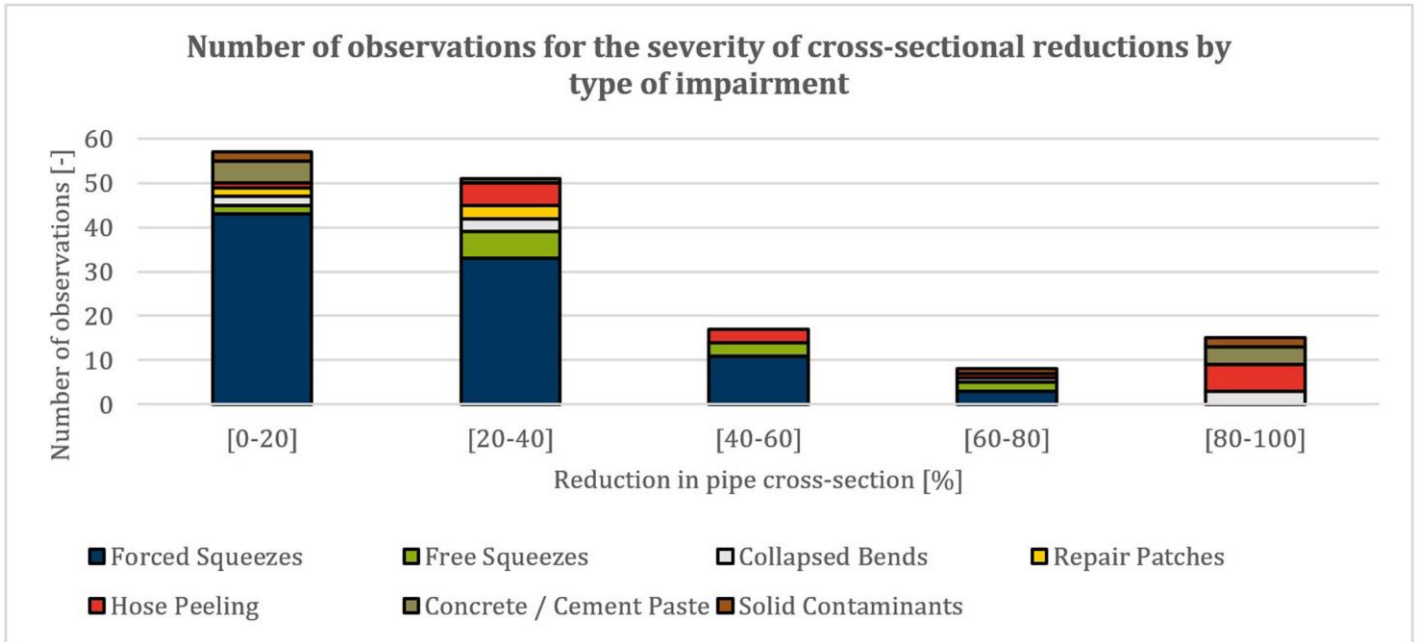
Figure 11: Histogram of the number of observations for the groups of percentual reduction of the grouting pipes cross-sections

The results of these analyses are shown in the histogram in Figure 11. In accordance with the procedure, these are strongly influenced by the number of observations. For the procedure described, only those screenshots were used in which the respective impairments were visible frontally and in full, showing the entire pipe cross-section. This could not be ensured in equal numbers for all types of impairment, which is why the relative distribution of the observed impairments must be evaluated individually for each type of impairment under the specific number of observations for further analysis.

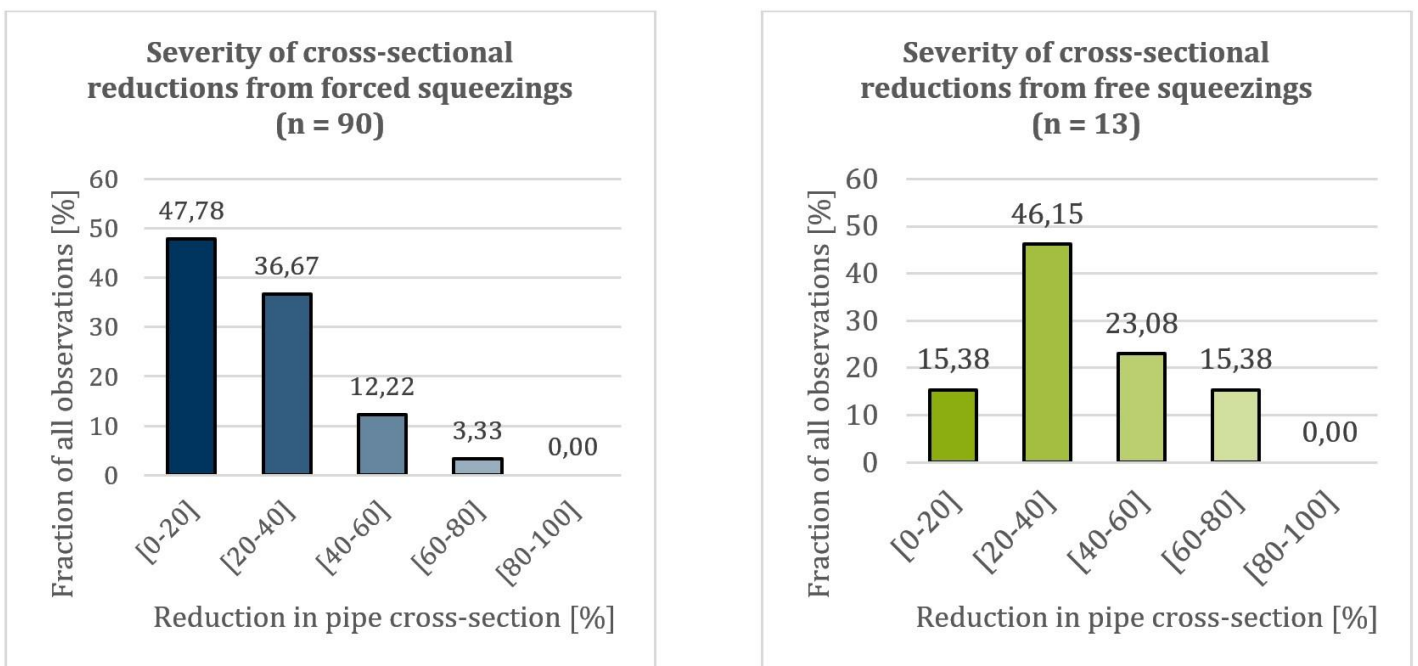
Figure 12: Histograms for the relative reduction in grouting pipe diameters observed for forced and free squeezes

Figure 12 therefore shows examples of the histograms of the relative number of observations for the different severity groups in histograms for the impairment types 'forced squeezes' and 'free squeezes', which occurred most frequently in the study described (see Section 4.2.2) alongside the bends that cannot be quantified here. For these types of impairment, the majority of the individual observations that occurred resulted in only a relatively small cross-sectional restriction of up to 40%.
