# FORENSIC ENGINEERING IN TUNNELLING

J.-M. Hohberg

IUB Engineering AG, Berne, Switzerland

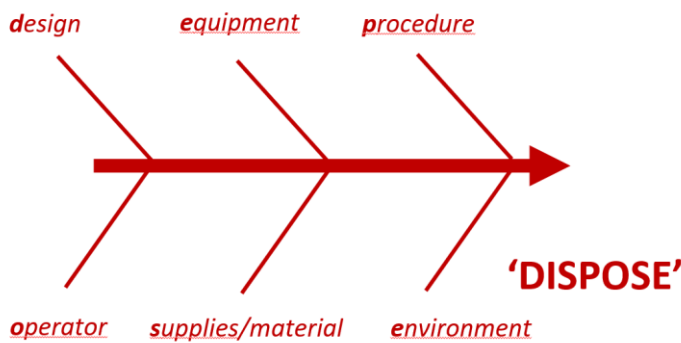
Figure 2: Fishbone diagram as schematic failure tree in engineering (like creeks sending water downstream in a flooding event)

A rather different attitude is learning to advance the state of the art – for instance, the construction of increasingly robust tunnel boring machines, coping with a variety of unexpected ground conditions to avoid blockage of the TBM e.g. by an erroneous prognosis of fault zones. Back analysis of failures and the improvement of modelling techniques is a particular aspect, pursued for concrete mechanics in fib's Forensic TG 3.5, with a certain tradition in dam engineering, but also in tunnelling (e.g. Barton 2016). Nonetheless, inadequate education and training, misguided cost-cutting (incl. ground exploration), unsuited contract models, negligence and hubris may contribute as well. Such a broad socio-economic perspective is taken by IABSE's Forensic TG 5.1. It is included in the contributing factor 'environment' of Ishikawa's fishbone diagram, in both a physical and organisational interpretation (Fig. 2).

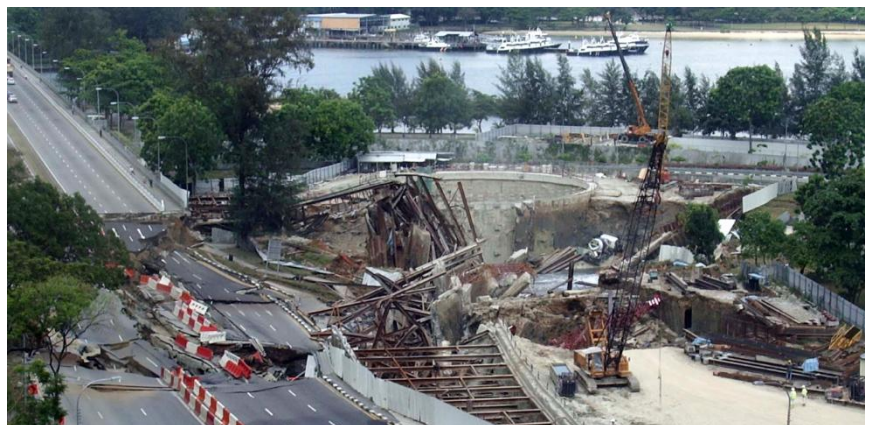
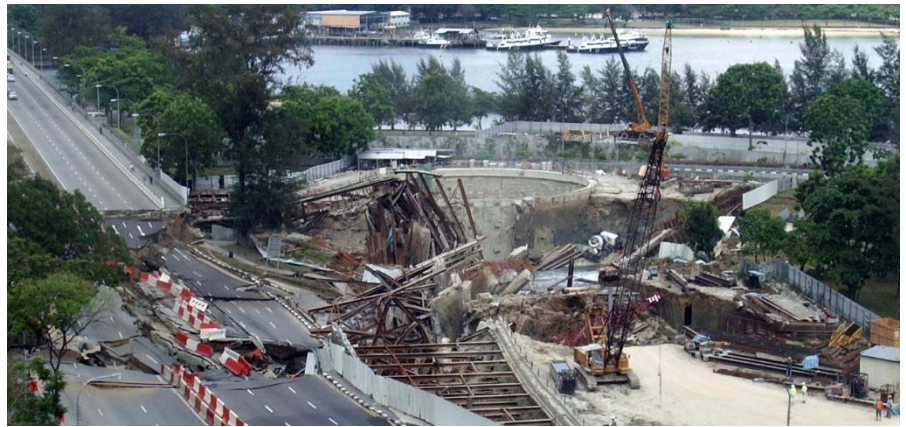
Figure 3: Collapse of metro construction pit due to buckling of struts in Singapore 2004 (Source: Hee Yang Ng, Structure Magazine 2021)

A well-documented case is the access ramp to a new metro tunnel in Singapore in 2004, known as the Nicole Highway Collapse (named after the road affected by ground failure), Fig. 3. It is very illustrative in terms of soil mechanics errors as well as problems in structural detailing and flawed management decisions. Since this failure does not concern the tunnel proper, it will not be discussed here. However, a cut-and-cover tunnel is taken as first case study.

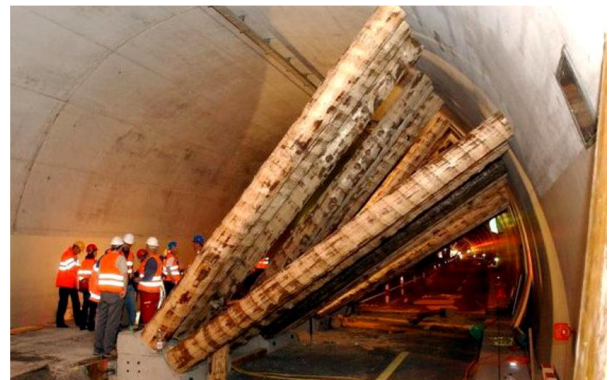
Figure 4: Temporary propping of the gallery to stabilize the flexural shear crack

In an emergency response the gallery had to be stabilized by wooden props (Fig. 4), the overburden was removed to grout the cracks and an additional 20 cm thick inner r/c lining was cast, reducing the clearance of the tunnel by sacrificing the bicycle lane. Closer examination of the expert from EPF Lausanne revealed that not the 40 cm settlement of the peat had caused the cracking, but that the earth pressure was grossly underestimated by the 2D finite element analysis. Because the modelled width of 45 m was too small, the lateral overburden and the inclined thrust on the wall could not fully develop. (Fig. 5)

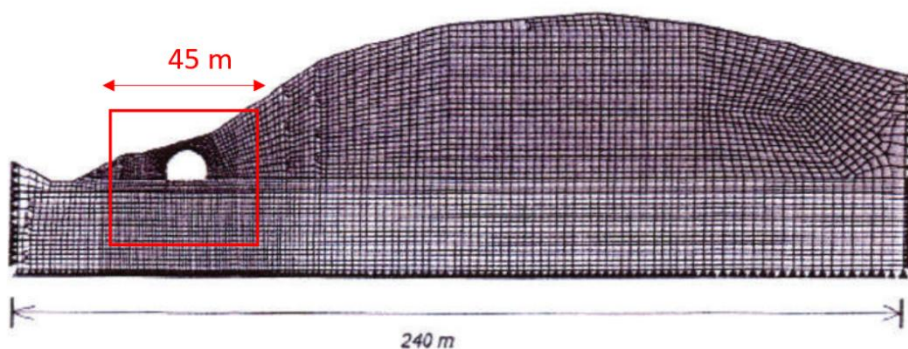
Figure 5: Insufficient width of the modelled domain in FEM analysis to give a realistic estimate of the unilateral earth pressure

Instead, the roller bearings on the vertical boundaries, mimicked a symmetry condition (i.e. invisible identical galleries adjacent to the left and the right side of the model boundaries).

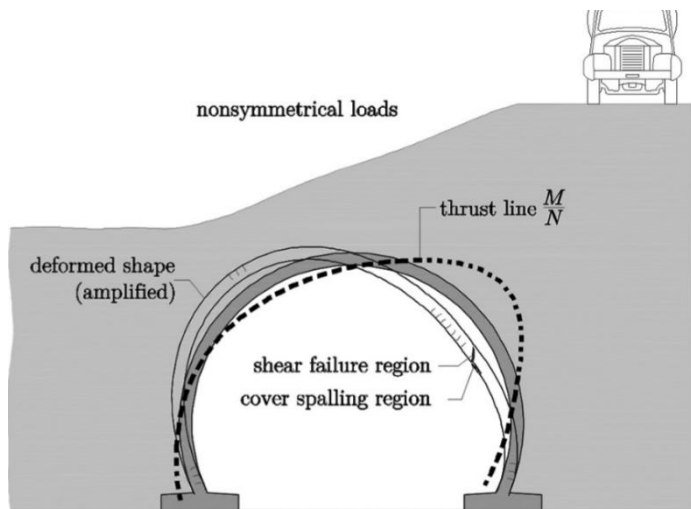
Figure 6: Failure of arch-shaped member in combined bending and shear under non-symmetrical load

insufficient ductility of concrete shells without shear reinforcement. This was further investigated in shear tests at EPFL (Campana 2014), (Fig. 6), and resulted in a guideline of the Swiss Federal Office of Roads (OFROU) stipulating input

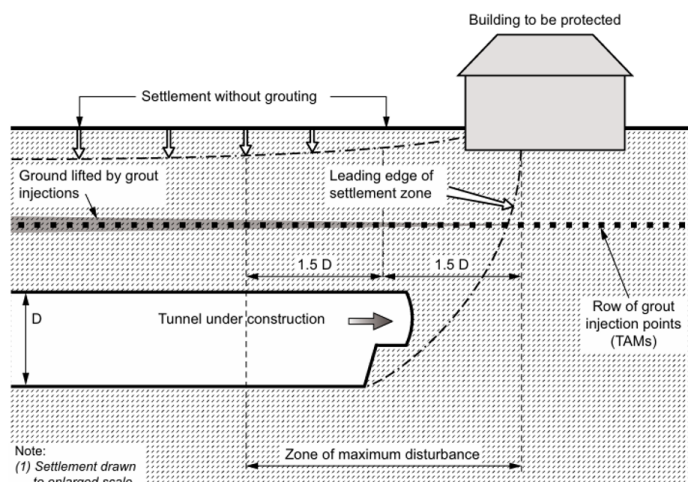
Figure 7: Principal concept of compensation grouting (left) and situation with sequence of tunnel collapse (right); in orange the excavation state at the time of collapse

The three tunnel tubes (two single track platform tunnels with a concourse tunnel in between) were designed with 21 m of overburden and horizontal grout injection pipes (tube-à-manchette) at half height, 10 m above the tunnel crown (Fig. 7 left), as an option to compensate any settlement of buildings, incl. an airport fuel depot. The concourse tunnel was excavated first from an access shaft, followed by the platform tunnels, excavated with an advance side gallery ('eye') followed by a three-step enlargement (crown / bench / invert) with gradual demolition of the temporary shotcrete partition (Fig. 8).

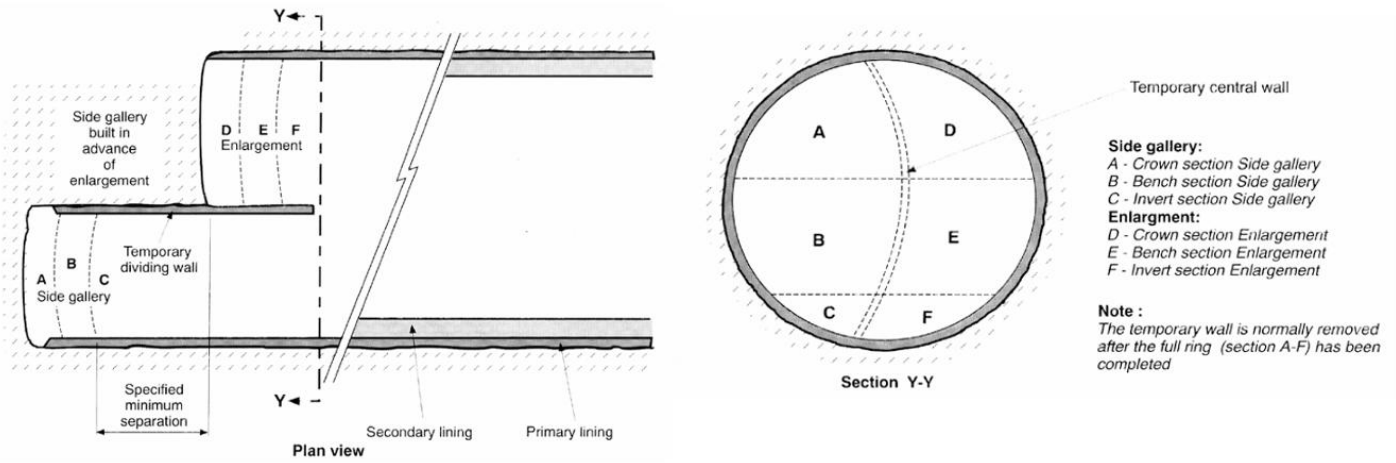
Figure 8: Excavation sequence with advance side gallery and following enlargement

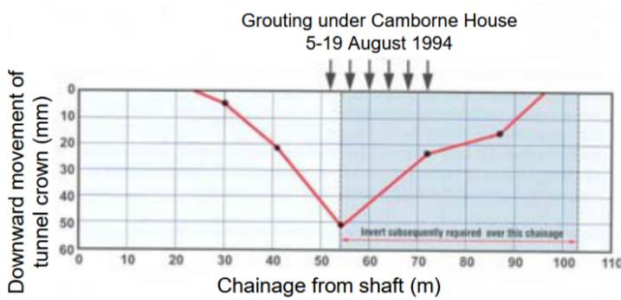
Figure 9: Downward movement of concourse crown due to compensation grouting

When in July 1994 the settlement limit of 25 cm was reached, compensation grouting began and produced a 50 mm deep depression trough in the concrete lining over a length of 72 m (Fig. 9), accompanied by downward and inward movement of the shotcrete shell and cracking of the invert. However, only about 50 m – the dark blue area in Fig. 9 – were repaired (Clayton 2008). The concrete quality of the invert was poor due to considerable shotcrete rebound, and the curvature of the invert had been reduced further by the overall tunnel settlement (Fig. 10).

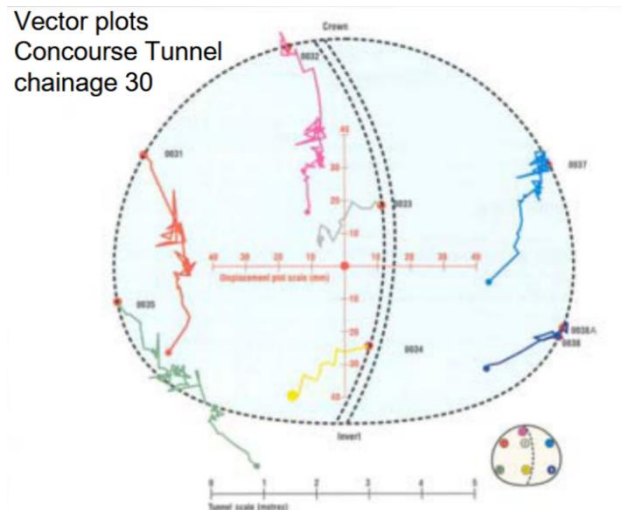
Figure 10: Reflector measurements showing overall downward depression of shotcrete shell

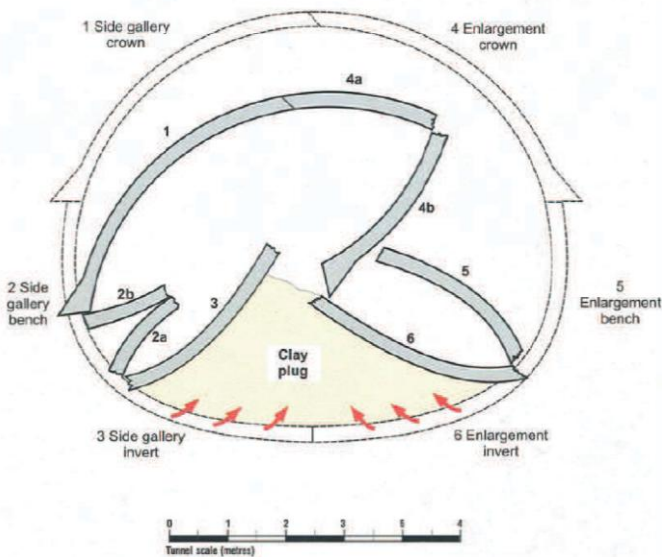
Figure 11: Debris of the concourse tunnel

Apparently, the cold joint in the invert between the side gallery (#3) and enlargement (#6) failed first (Fig. 11), where the reinforcement detail had been changed by the contractor (Clayton 2008). With the ground moving inwards through the invert, the side gallery bench (#2) failed, and the side gallery crown (#1) came down, followed by a crack in the enlargement crown (#4).

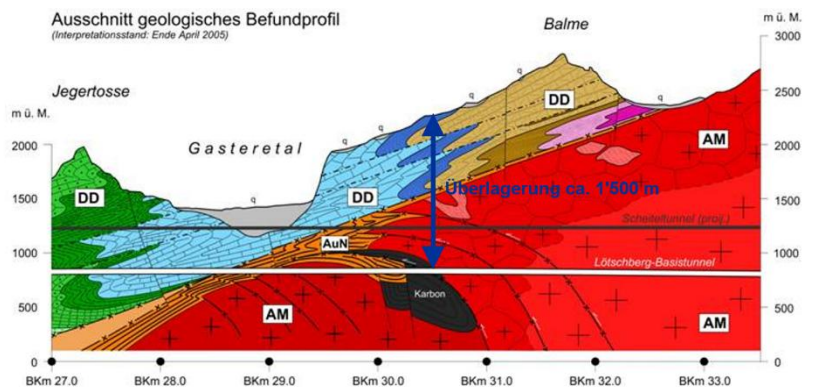
Figure 12: Geological profile (as amended 2005), anthracite in black

In March 2004 an unpredicted carboniferous rock was hit at chainage 30.2 km with 1,500 m overburden (Fig. 12).

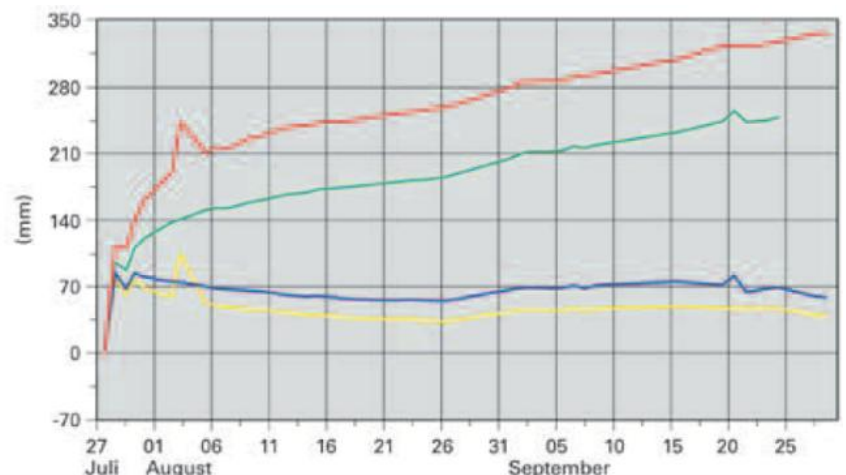
Figure 14: Geological face mapping with typical development of radial deformations (geodetic reflector measurements)

The problem was that large radial deformations developed in an asymmetric manner, with no apparent asymptotic trend (Fig. 14). To protect the shotcrete shell against crushing, several techniques from the mining industry were tested: sliding joints in the steel profiles, spring pots, and precast crushable concrete blocks – the spring pots tilted due a substantial longitudinal displacement against the direction of the tunnel drive, whereas the high-yield concrete blocks remained stable and controlled the shotcrete stresses effectively (Fig. 15). Still, the radial inward displacements continued to grow up to 70 cm.

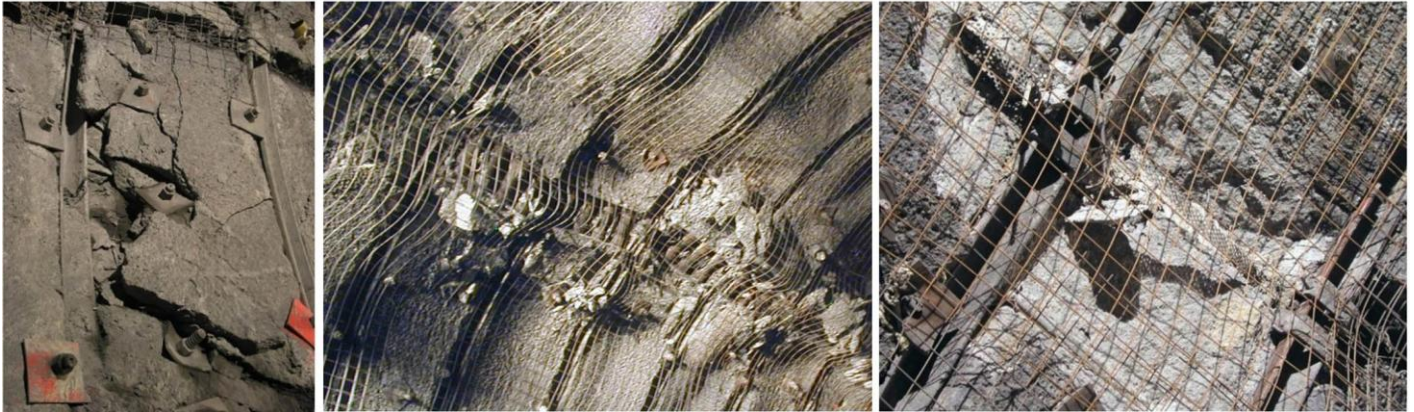
Figure 15: Behaviour of convergence slots – sliding joints (left), spring pots (centre), crushable concrete blocks (right)

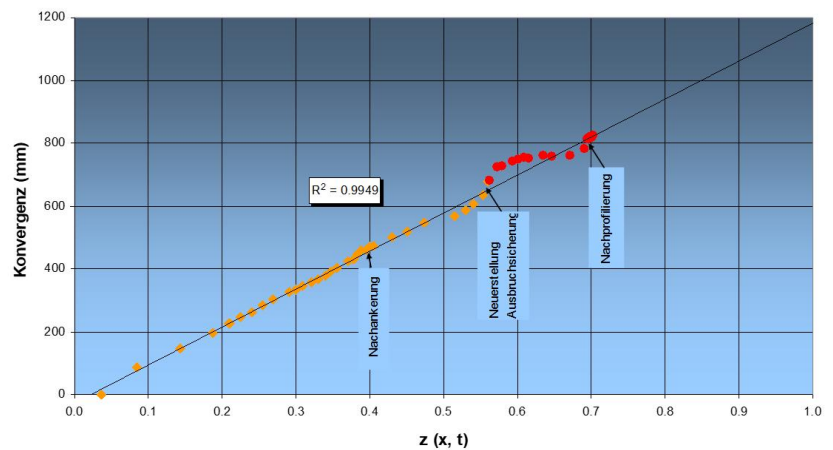
Figure 16: Logarithmic development of convergence

The formula by Sulem & Panet (Sulem 1987) was fitted to the measurements against space and time and served to estimate the expected convergence (Fig. 16). The tunnel was reprofiled to a circular shape with longer rock anchors, and the additional lateral space was used to cast a thick concrete inner lining. The crown thickness could not be increased without removing the overhead protection and was kept as 50 cm. Till October 2004, several cross-sections had to be refurbished more than once (Fig. 17).

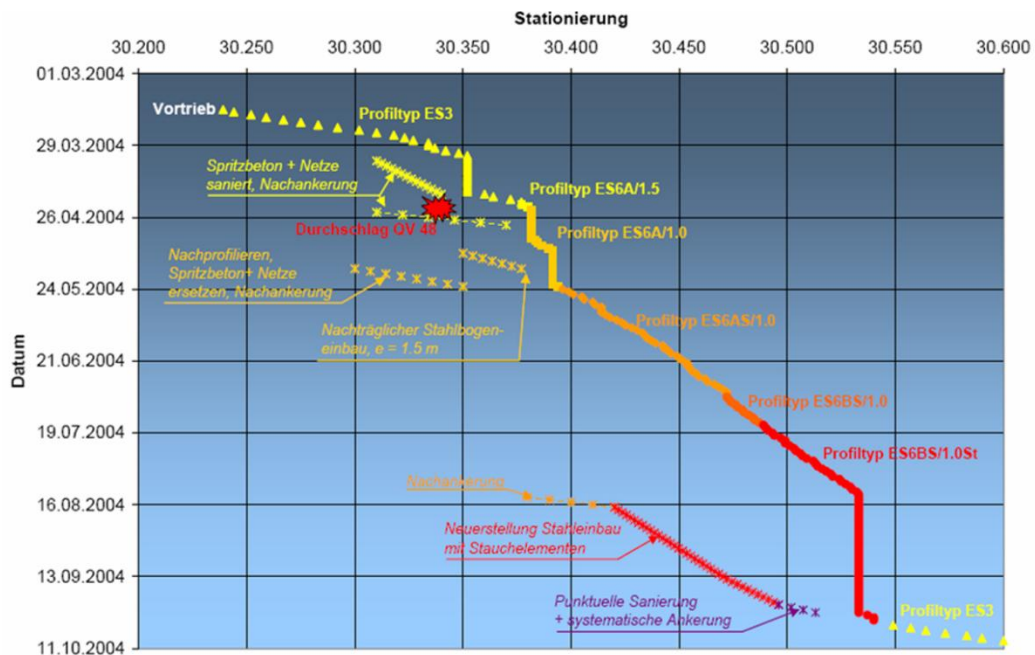
Figure 17: Overview of strengthening measures with reprofiling, additional anchoring and convergence slots

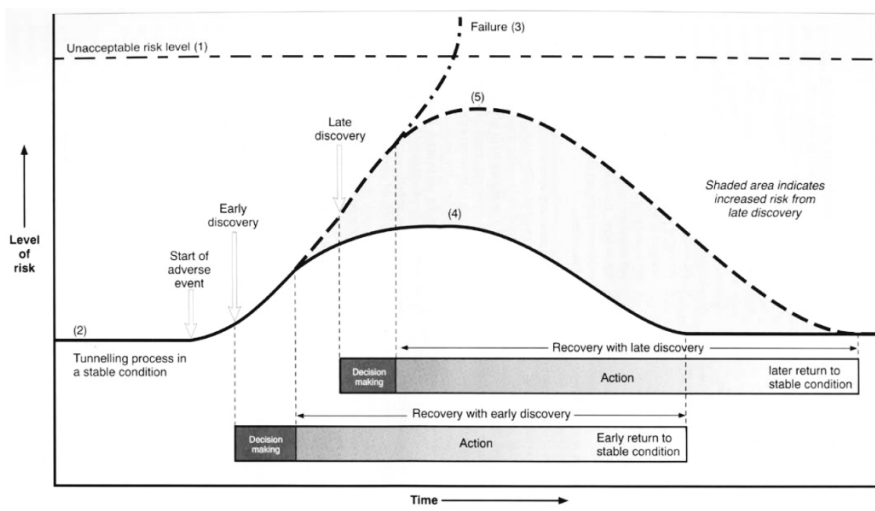
Figure 19: 'Discovery - recovery' model of timely intervention (HSE 2019)

The crucial factor is time for analysis and reaction (Fig. 19).
