FEDRO'S TUNNEL RENOVATION METHOD FOR MOTORWAY TUNNELS UNDER LIVE TRAFFIC

G. Balbi & J.-M. Waeber

FEDRO Swiss Federal Roads Office

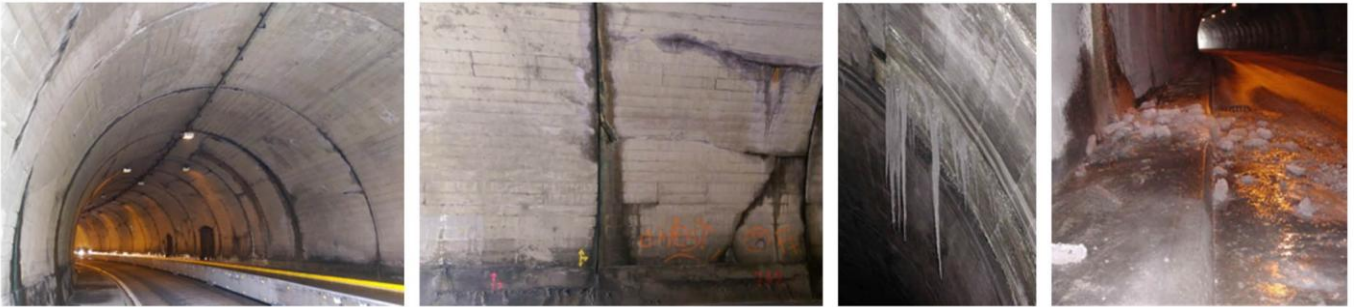
Figure 1: Deterioration of the existing tunnel lining leading to water ingress and ice formation in the traffic area

Water ingress can severely disrupt traffic, particularly when it results in the formation of hazardous icicles in the tunnel arch or ice patches on the carriageway. The non reinforced concrete arch of these tunnels was cast in place directly against the rock, without any waterproofing system having been installed beforehand. In such situations, the conventional approach consists of removing the inner concrete ring, installing a waterproofing system and subsequently casting a new lining in place. Crack grouting or curtain grouting would not provide a durable solution, as the long-term performance of these measures has not been proven and the cost benefit ratio is not always favourable.

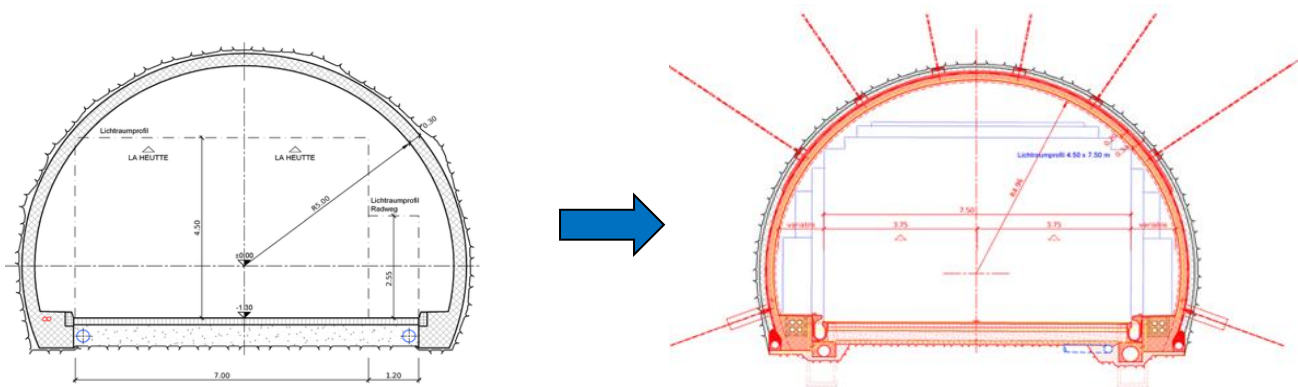
Figure 2: Cross-sections of tunnel T3 before and after renovation

The renovation of the 196-metre-long tunnel T3 on the A16 motorway represented the first application of this renovation methodology and involved the use of an innovative approach under previously untested conditions, making this project a world first. The arch of tunnel T3 consisted of 5-metre-long non reinforced concrete rings that had been cast in situ directly against the rock, that is without any waterproofing system. Tunnel T3 crosses the Portland limestone segment of the Twannbach Formation. Stratigraphic discontinuities and tectonic cracks result in potentially unstable rock formations, which may impose additional loads on the tunnel arch. The estimated volume of unstable rock formed the basis for the structural analysis of the temporary reinforcement measures and for the dimensioning of the new lining.

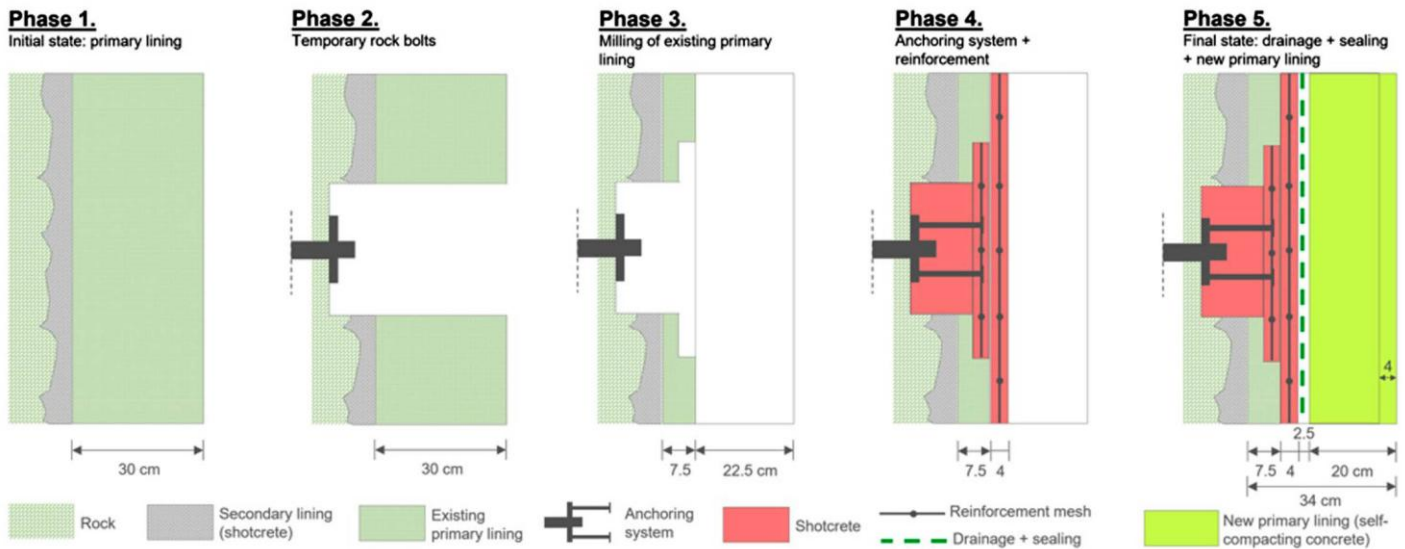
Figure 3: Sequential phases from existing lining to final inner shell

The renovation procedure involved the following steps:

- Installing an anchoring system
- Milling the non-reinforced concrete arch
- Installing a drainage layer over the entire surface

Applying a new waterproofing system
Casting a new inner ring.

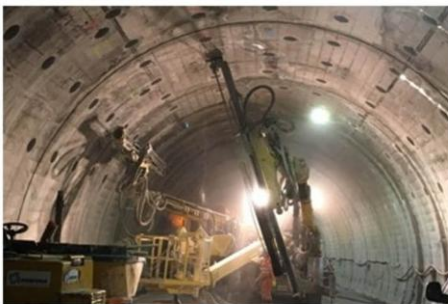
Figure 4: Installation of temporary rock bolts to stabilise the tunnel arch after milling

Temporary passive rock bolts were first installed along the full length of the tunnel to stabilise the arch, thereby enabling the subsequent milling of the existing lining to be carried out safely. The bolt layout, including number, length and diameter, was adapted to the degree of fracturing of the limestone massif identified during the geological investigations. These measures reduced the load transferred from the surrounding rock mass to the milled arch.

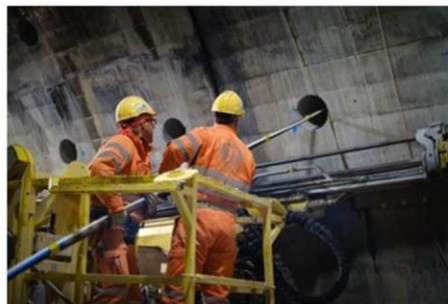
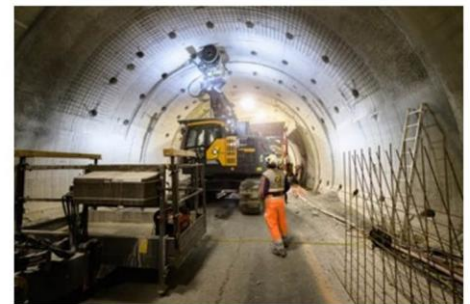
Figure 5: Controlled milling of the non-reinforced concrete tunnel lining

The non-reinforced concrete lining was then removed in a controlled manner using specialised milling machines, ensuring precise execution and a uniform surface finish suitable for subsequent layers. The average advance rate was approximately 2 m per night. At tunnel portals, where the lining consisted of reinforced concrete, removal was carried out using hydro-jetting.

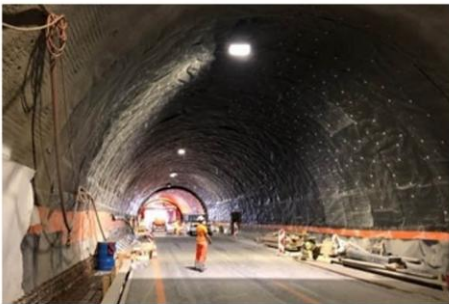
Figure-6:-Drainage-System

The main deficiencies of the existing structure of tunnel T3 were largely attributed to water ingress through numerous cracks in the lining. Consequently, the primary objective of the renovation works was to ensure effective drainage of the surrounding rock layers. For this tunnel, a conventional drainage system applied over the entire surface of the arch, combined with a full-face waterproofing system, was selected.

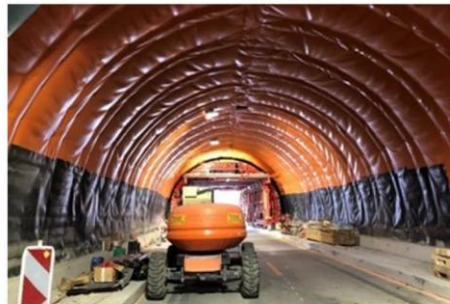
Figure-7:-Conventional-synthetic-waterproofing-system

Two waterproofing technologies were tested: conventional synthetic waterproof sheeting installed over one half of the tunnel, and a spray-applied waterproofing system applied over the other half. The spray-applied system was initially favoured due to its advantages in installation speed and logistics. However, as the project progressed, it became apparent that conventional synthetic sheeting provided a better overall result as well as faster execution. This was mainly due to the difficulties associated with applying the liquid spray on waterproofing evenly to a rough surface while meeting the required quality standards.

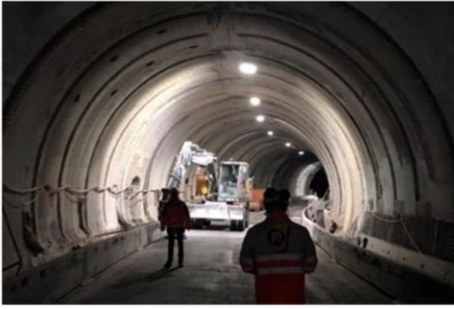
Figure 13: Night-time works inside the tunnel during renovation

To ensure a high level of safety during construction, the existing lining was first stabilised by installing a system of temporary rock bolts. This preliminary reinforcement allowed the subsequent milling of the inner shell to be carried out safely. A mobile crash deck was installed to protect the carriageway from falling debris. During the most critical phases of inner shell installation, the available clearance was temporarily reduced to 6.0 m × 4.2 m and the speed limit was lowered to 60 km/h.

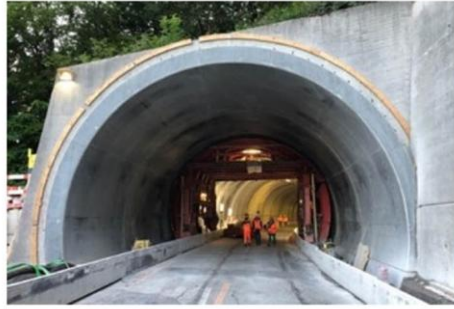
Figure 14: Completed inner lining after renovation

Once the waterproofing system had been installed, a new 20 cm thick arch of self-compacting concrete was constructed to provide permanent structural support to the tunnel. The new arch was cast in place in a single operation during nighttime closures, using a mobile formwork system. Special anchors were installed at the base of the formwork to counteract the pressure exerted by the fresh self-compacting concrete during casting. These anchors made it possible to minimise the dimensions of the tunnel formwork, which would otherwise not have allowed two lanes of traffic to pass through the tunnel during daytime. The construction of the new inner shell required a total duration of seven weeks, with a production rate of one 5-metre-long block per night.

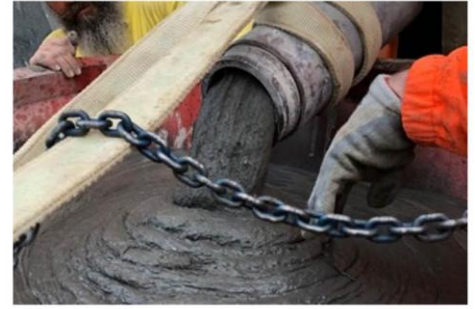
Figure 15: Fresh UHPFRC consistency during casting

During and after construction, the behaviour of the UHPFRC lining at tunnel T5 was closely monitored. A key initial concern was whether a complete and homogeneous filling of the tunnel arch could be achieved in a single casting operation, given that the material had to be pumped and placed against an overhead curved surface with variable thickness, unlike typical gravity-based UHPFRC applications. Despite these challenging conditions, the entire lining ring was successfully filled without voids or major execution-related difficulties.

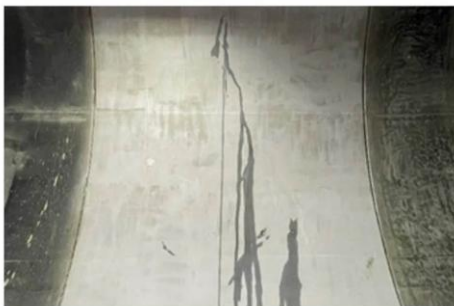
Figure 16: Cracking of the UHPFRC inner lining after casting

However, the subsequent performance of the lining did not fully meet the initial expectations. Cracking was observed shortly after casting, in some cases extending through the full lining thickness and locally leading to water ingress. As a result, the intended waterproofing function was not fully achieved. Various corrective measures were implemented during construction, including adjustments to casting procedures and curing conditions, but these did not result in a satisfactory improvement. The observed cracking was therefore attributed to a combination of factors related to material behaviour, construction conditions and application-specific boundary conditions rather than to a single isolated cause.

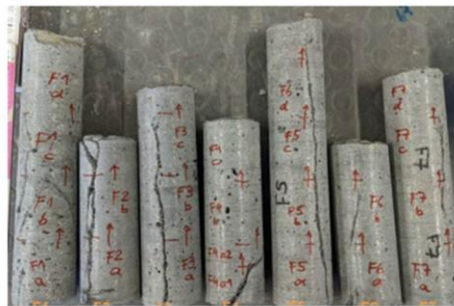
Figure 17: Drilled UHPFRC cores extracted from the tunnel lining

Targeted investigations were therefore carried out in collaboration with the Swiss Federal Laboratories for Materials Science and Technology (EMPA). Using X-ray computed tomography, the three-dimensional fibre distribution within drilled cores was analysed, revealing preferential fibre orientations related to casting and flow conditions. These investigations demonstrated that fibre orientation and local heterogeneity have a significant influence on crack initiation and propagation in UHPFRC linings. Building on these findings, a further research programme is planned for 2026 and 2027, including controlled prototype tests and casting trials. The investigations will focus on key parameters such as pumping method, mix design, formwork configuration and lining thickness, with the aim of improving fibre distribution and crack control.

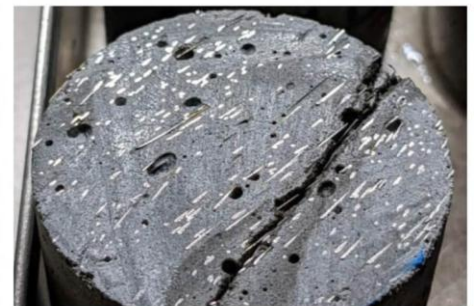
Figure 18: UHPFRC core with through-thickness crack and fibre distribution

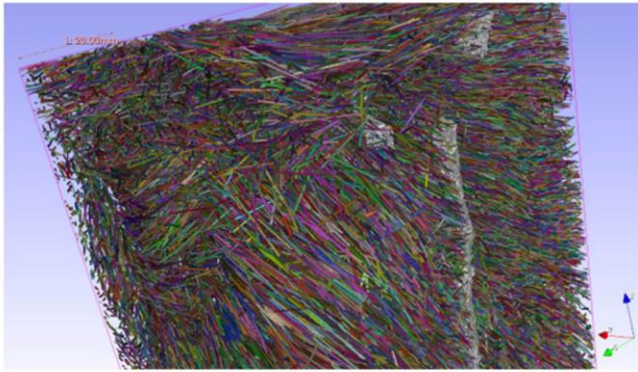
Figure 19: 3D rendering of fibres and a crack in a core sample. Individual fibres are randomly colour-coded, while the segmented crack is shown in grey

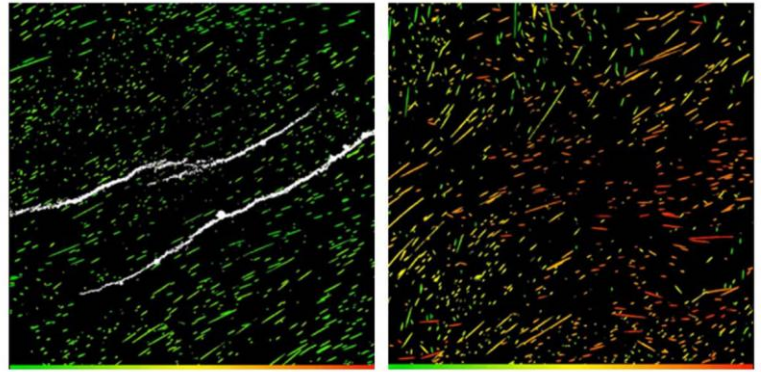
Figure 20: Fibre orientation in UHPFRC cores derived from X-ray CT analysis. Left: Core with a through-going crack, showing fibres predominantly oriented parallel to the crack plane (green), which is unfavourable for crack bridging. Right: Core without crack, exhibiting a heterogeneous colour distribution (green to orange/red) indicative of a largely random fibre orientation.

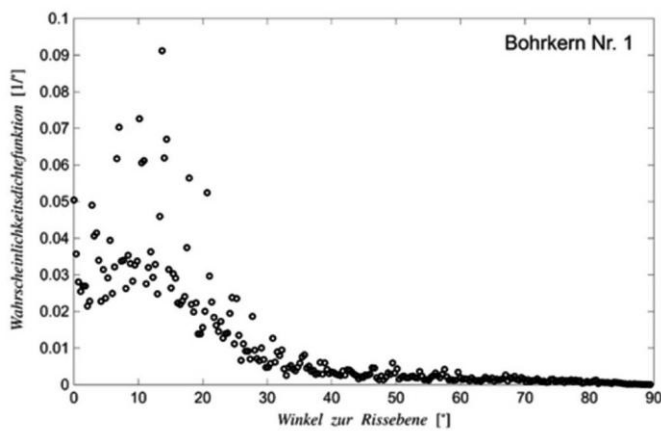
Figure 20: Probability density function as a function of the fibre orientation angle α relative to the crack plane for core 1 with a through-going crack

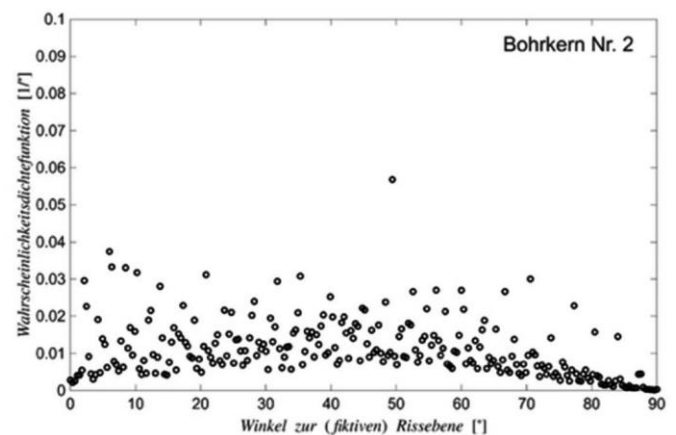
Figure 21: Probability density function as a function of the fibre orientation angle α relative to the crack plane for core 2 without crack

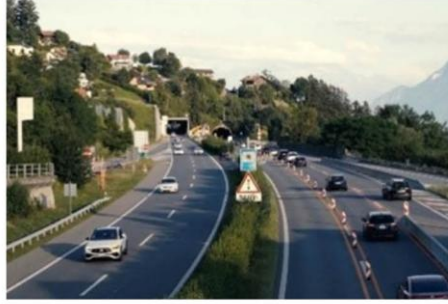
Figure 23: Traffic management layout on the A9 motorway during renovation works

The execution sequence followed the same high-level steps as the T3 methodology. Works were organised to ensure daily reopening, with the tube under intervention closed at night and the parallel tube operated with bidirectional traffic.

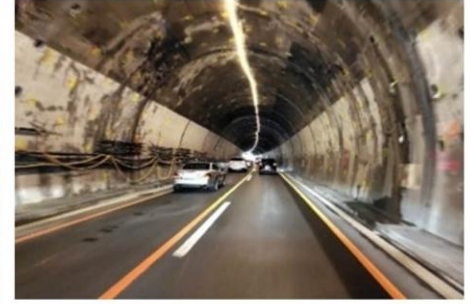
Figure 24: Tunnel prior to renovation, showing waterproofing defects

The renovation of the Criblette and Chauderon tunnels was carried out on the A9 motorway, one of Switzerland's most heavily trafficked road corridors. In both tunnels, the main deterioration concerned the existing waterproofing system, which exhibited cracking associated with localised water ingress.

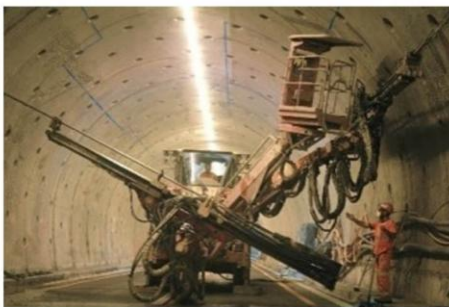
Figure 25: Drilling works inside the tunnel during night-time closures

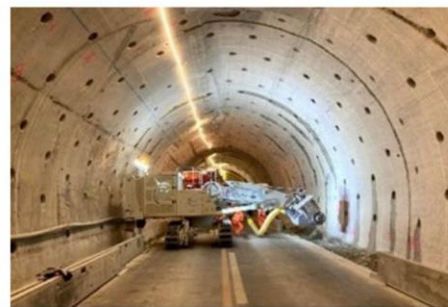
Figure 26: Controlled removal of the existing lining

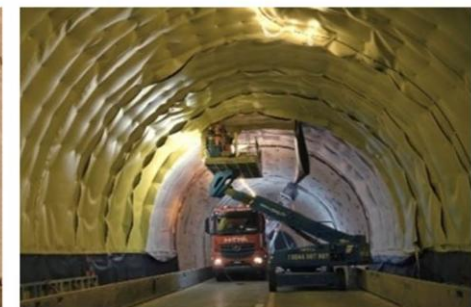
Figure 27: Installation of waterproofing system

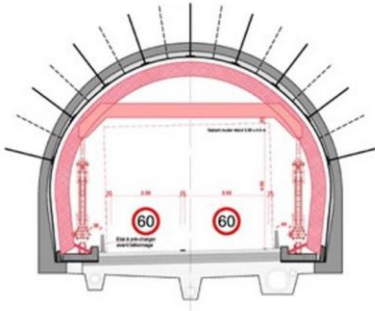
Figure 28: Cross-section showing the formwork system and its fixing concept (anchor lengths shown schematically)

A key operational aspect was the formwork installation and fixing concept. The formwork carriage was designed to withstand the horizontal concreting pressure without intermediate struts that would conflict with the traffic clearance. Load transfer was ensured through prefabricated reinforced concrete running strips placed on the pavement, providing a stable load path and avoiding the need for additional temporary props or anchoring systems.

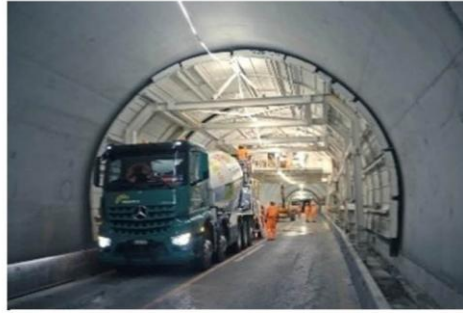
Figure 29: Inner lining casting with mobile curing and formwork units

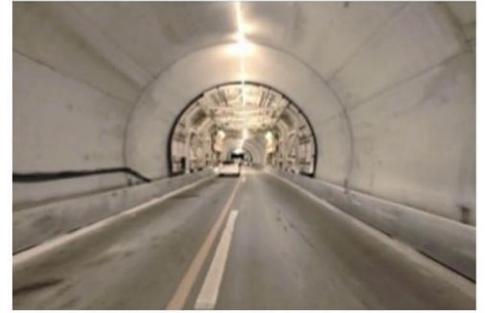
Figure 30: Traffic circulation with formwork in place during renovation works

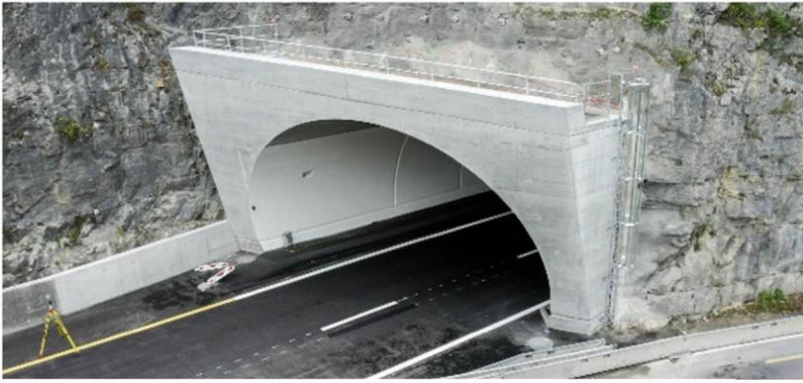
Figure 31: Finished portal of tunnel T3 (©patriceschreyer.com)
