Surveying existing rockfall flexible barriers to create a cartographic database aimed at the maintenance planning process

B. Taboni & G. Umili

L.M. Albertelli & I.D. Tagliaferri

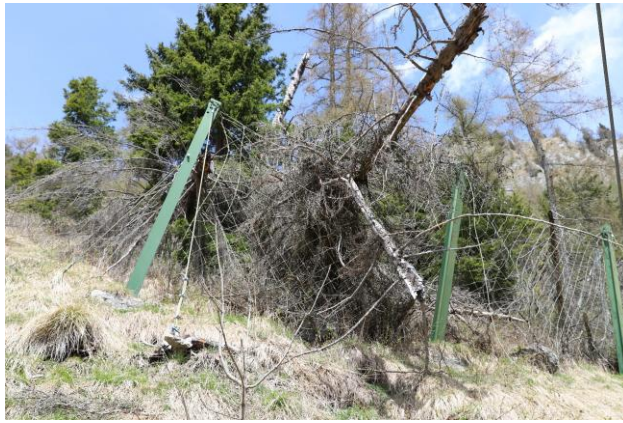
Level of CONCERN	MCE
HIGH	B
% of Defectiveness	
49%

Fig. 2 Photograph of the first surveyed barrier: it appears highly damaged. In some sections, it has been completely torn apart. On the right is the classification in terms of LoC, %D and MCE.

The components of the first barrier feature a main net panel of rhombohedral wire mesh with 8 mm wire and a mesh diameter of 300 mm. The posts are 4 m tall H beams positioned every 6 m, supporting ten net panels for a total length of 60 m; each post is fixed in place thanks to four anchors. Along the structure, only retaining ropes (RR) can be seen, with a 15 mm diameter; on each rope there is a black box containing a braking element. Globally, the main net and the ropes feature localised patches of rust and corrosion, while the posts are almost entirely covered in rust. The foundations of the posts are working as intended and do not seem damaged. The opposite is true for the RR anchors, which are completely non-functioning and can be easily pulled out, even by hand. No information regarding the design energy capacity of this flexible barrier was available. It clearly appears to be older than the European standards imposed by ETAG 027 (EOTA 2008). The portion of the slope surrounding the barrier is characterised by pine trees, a couple of which have fallen on the barrier itself or close to it, as visible in Figure 1, but caused only limited damage. Besides this, no bushes or vines grow on the structure, and the slope beneath it is generally clear of obstacles.

The data gathered on the FBSS allowed us to classify this first barrier (Fig. 2).

The classification highlights that the barrier must be significantly repaired and, at least in some sections, completely replaced, as pointed out by the high Level of Concern; moreover, the structure Defectiveness is very close to 50%, which means that approximately half of the structure cannot carry out its role and, thus, provide protection. The MCE is the barrier itself (B), as the surrounding area does not influence the protective performance of the structure particularly negatively. On the contrary, many elements of the barrier are heavily corroded and rusted, while most rope anchors do not work correctly.

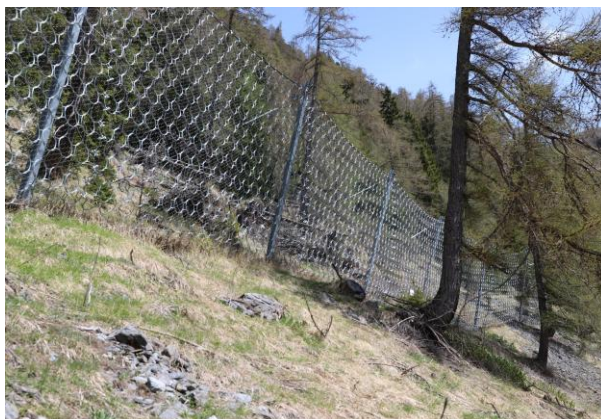
Level of CONCERN	MCE
LOW	/
% of Defectiveness	
8%

Fig. 3 Photograph of the second surveyed barrier: it appears in very good conditions, although pine trees grow very close to the structure. On the right is the classification in terms of LoC, %D and MCE.

The components of the second barrier (Fig. 3) feature a main net panel of interlocking rings with 14 mm wire and a ring diameter of 350 mm; a secondary wire mesh net supplements the main one. The posts are 6 m tall H beams positioned every 10 m, supporting seven net panels for a total length of 70 m; each post is fixed in place through four anchors and two ropes. The structure features retaining ropes (RR) and longitudinal ropes (LR), both with a 22 mm diameter; each rope is equipped with a brake. Globally, very scarce and limited patches of corrosion or rust have been identified on the ropes and posts. The foundations of the posts and the rope anchors are in perfect condition and working as intended. Along the structure, a few of the net panels have gaps beneath them, which would allow small blocks to pass through them. The main issue with this second barrier lies in the fact that four large pine trees have grown very close to the barrier itself. Additionally, close to the end of the barriers, just below one of the panels, a couple of large boulders can be found. These, alongside the trees, would significantly limit the proper functioning of the structure in the event of a rock hitting those portions of the barrier. Besides this, the portion of the slope surrounding the barrier is clear of vegetation, although bushes and vines have started colonizing the ropes and their anchors. This barrier conforms to European standards and, thus, is more recent than ETAG 027 (EOTA 2008). The data gathered on the FBSS allowed us to classify this second barrier (Fig. 3).

The classification highlights that the barrier needs only marginal maintenance, as pointed out by the low Level of Concern; the structure Defectiveness is lower than 10%, as the structure has only marginal issues related to trees and boulders too close to the barrier. No MCE is defined, as no L3 check has been identified.
