Investigating the Relationship Between Grouting Response Curves and Stress Measurements at Fornebu Metro Line

M.H. Haugsand, A. Neby, O. Woldmo

*Oslo Municipality Fornebu Metro Line, Norway
martin.haugsand@fob.oslo.kommune.no*

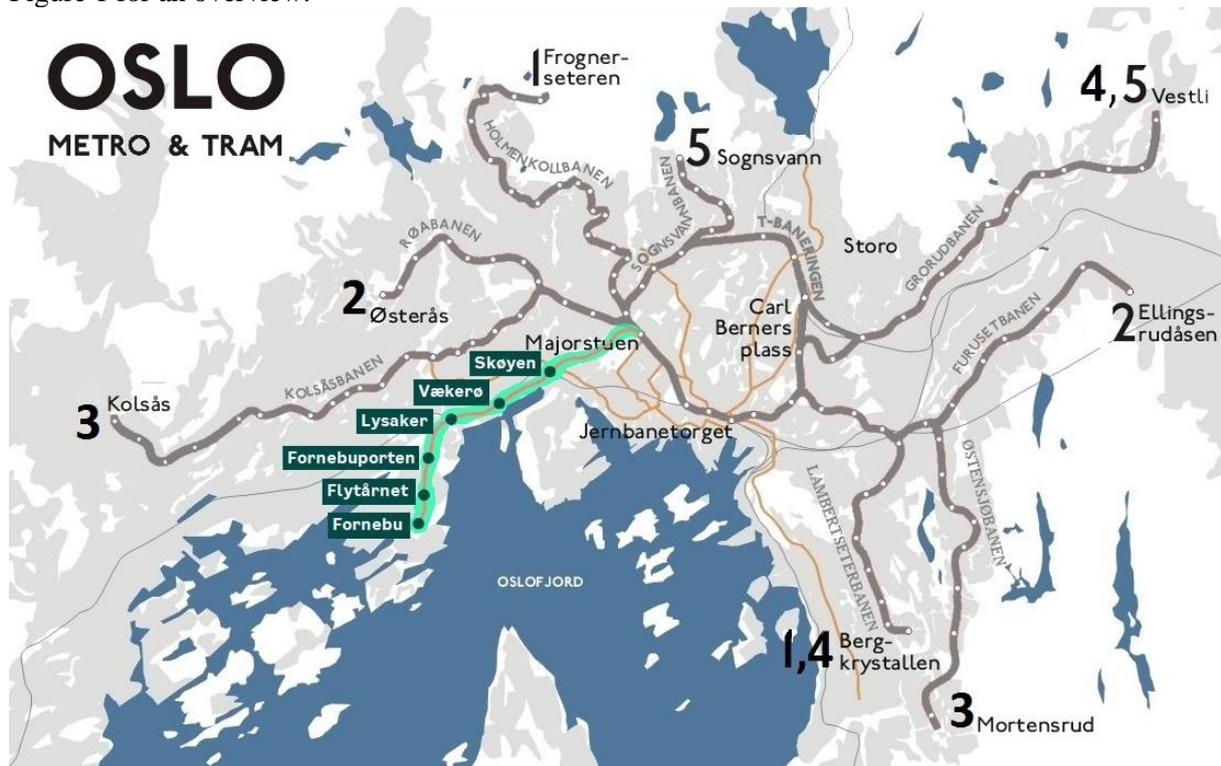
Figure 1 Oslo Metro overview with the new Fornebu Metro Line extension

The Fornebu Metro Line project is an extension of the Oslo Metro Line System, linking the Fornebu peninsula to Oslo. The project consists of approximately 8 km of tunnels with 6 new stations, see Figure 1 for an overview.

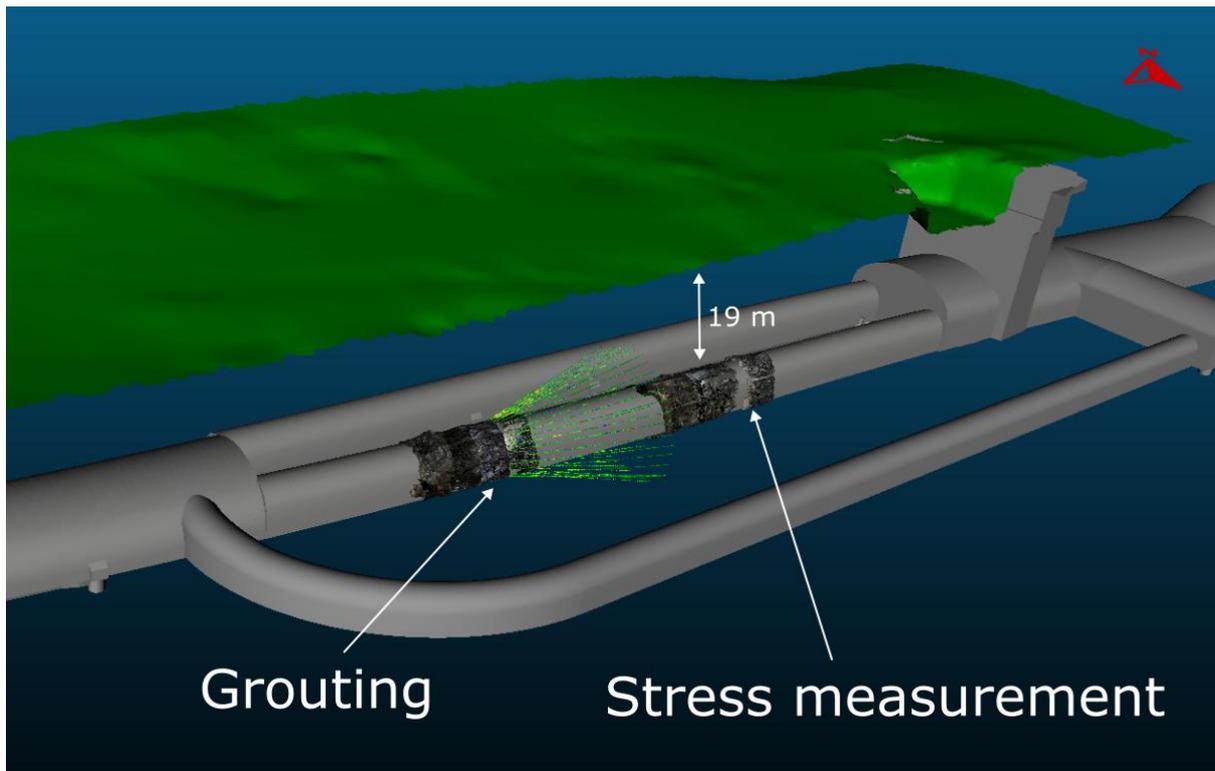
Figure 2 Detailed look of locations of the stress measurement and grout screen with observed shut-in pressures. The green plane represents the top of the rock mass.

The rock stress measurements at Fornebu Metro Line were conducted by SINTEF and presented to the project in the form of a report. Several measurements along the tunnel axis have been performed but this study focuses on the stress measurement carried out about 100 meters before Våkerø Station, see Figure 2.

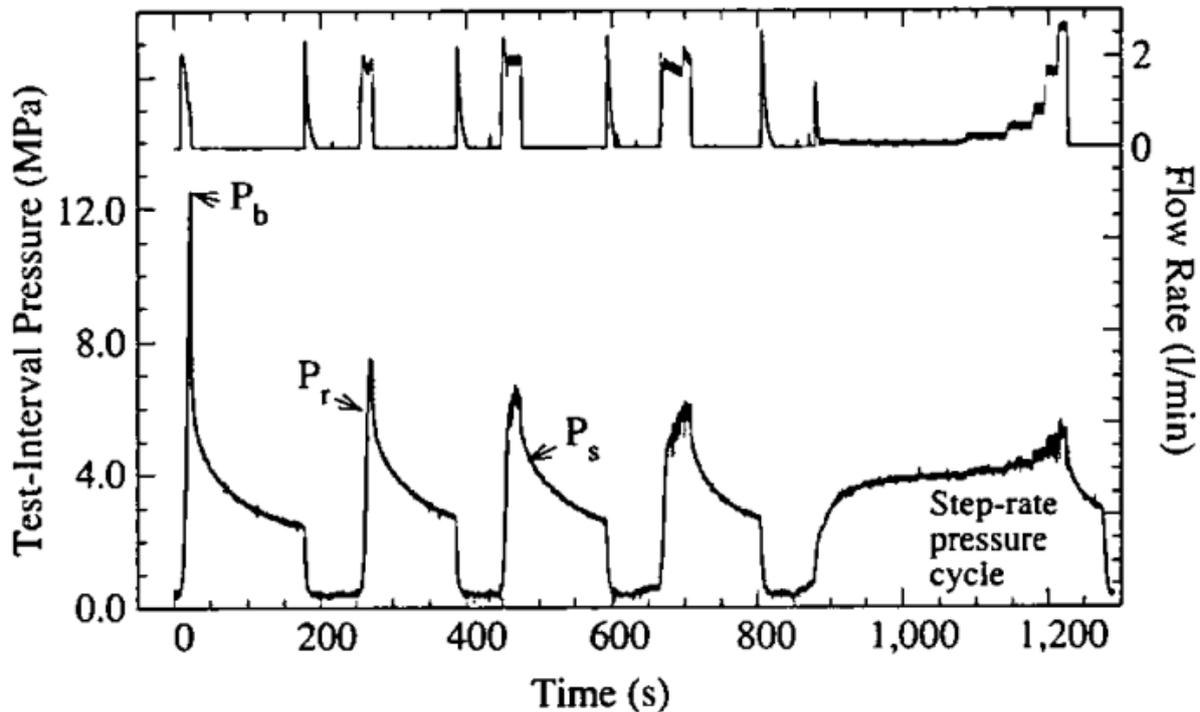
Figure 3 Cycles of measuring the shut-in pressure. Taken from (International Society for Rock Mechanics, 2007).

Hydraulic fracturing test (International Society for Rock Mechanics, 2007) is another method for determining rock stress. The method works by creating or reopen fractures using a pumped liquid. When a fracture is opened, the pump is shut off and the pressure response is measured at the pump. The stop causes the pressure to drop “instantly” before tapering out. The measured pressure where it starts to taper is interpreted as the *shut-in* pressure. This pressure represents the force acting on the fracture by the rock mass itself, i.e. rock stress. An example of a hydro fracturing test is shown in Figure 3.

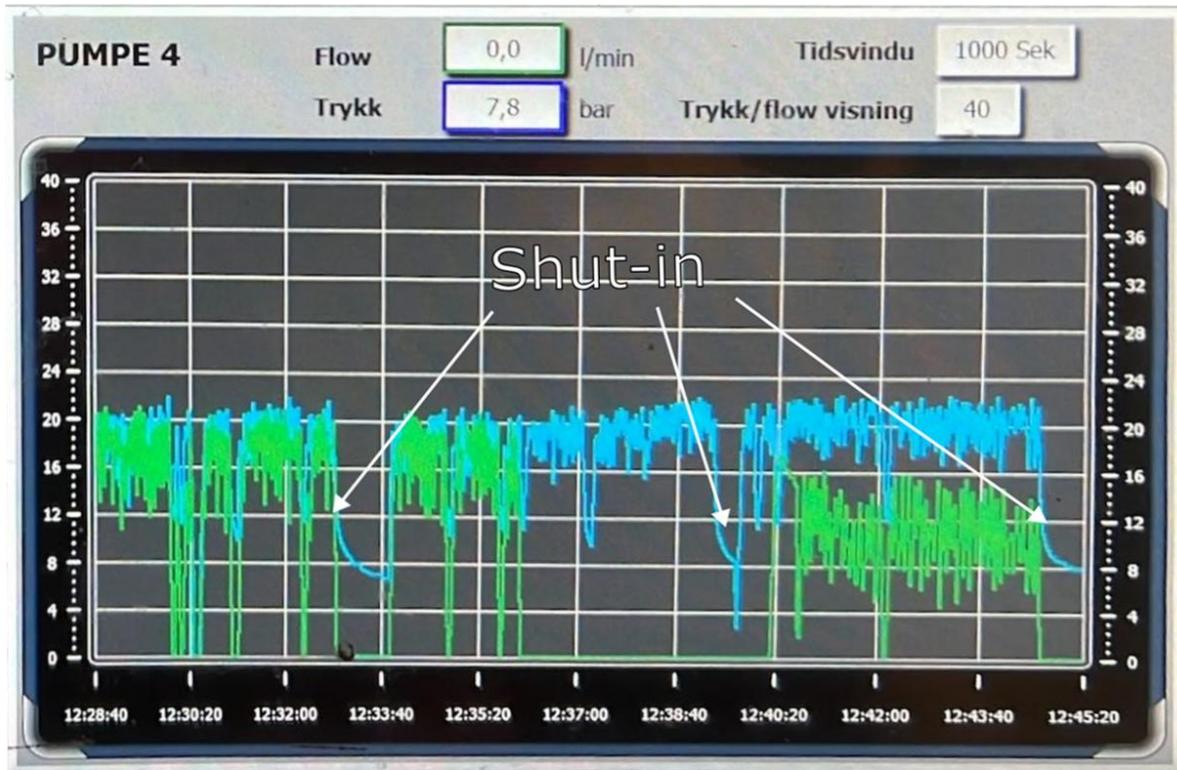
Figure 4. Pressure response curves during grouting when the pump is stopped without venting the pressure

During grouting, hydraulic jacking was suspected when the pressure and flow remained stable, or if the pressure was decreasing with stable or increasing flow. In these holes the pump was stopped without venting the pressure. The pressure response from the rock mass could then be observed on the onboard screen. Figure 4 shows three of these pumping stops with an interpreted shut-in pressure.

A total of 15 pumping stops were performed in 8 different grout holes. The grout holes were placed in the invert and at the tunnel face itself. The shut-in pressure was observed to be between 11-13 bars and 16-18 bars.

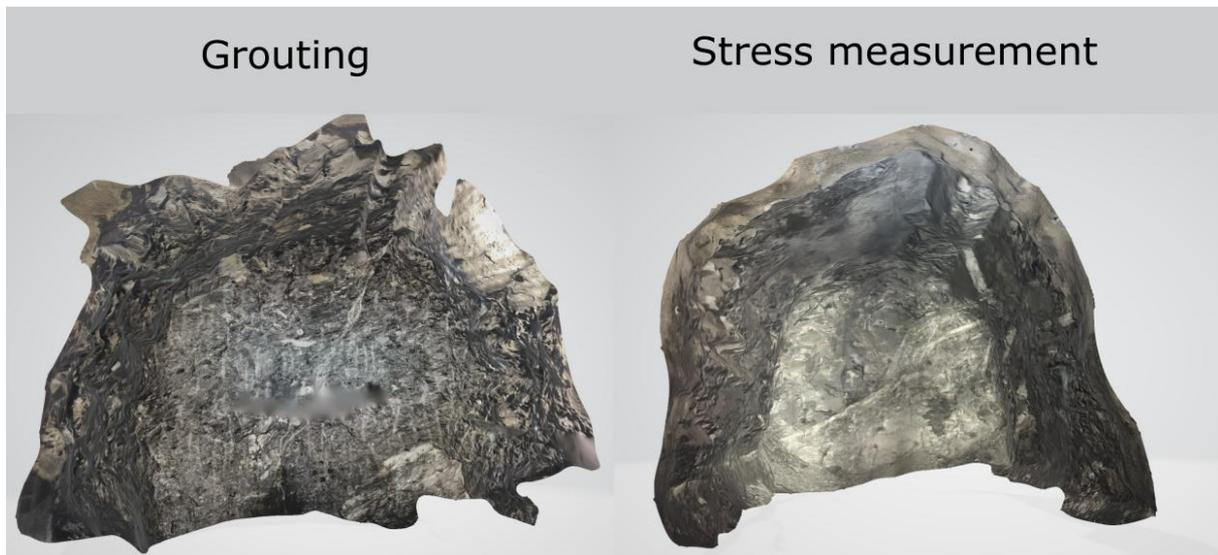
Figure 5 Rockfaces at the location of the grouting and the stress measurement

The tunnel face at chainage 6025, one blast round advance from the grouting face, was mapped with extra attention to fractures with grout filling. Figure 5 show 3D scans of the rockfaces at the grouting and stress measurement location. The rock mass type at both chainages is similar, both consisting of shale. The crown runs along the bedding at both locations, and the right wall runs along a steeply dipping larger fracture. The fracture orientation looks similar, both visually and measured, for both faces. The rock mass was however somewhat weaker at the grouting face with more signs of deformation and less lime content.

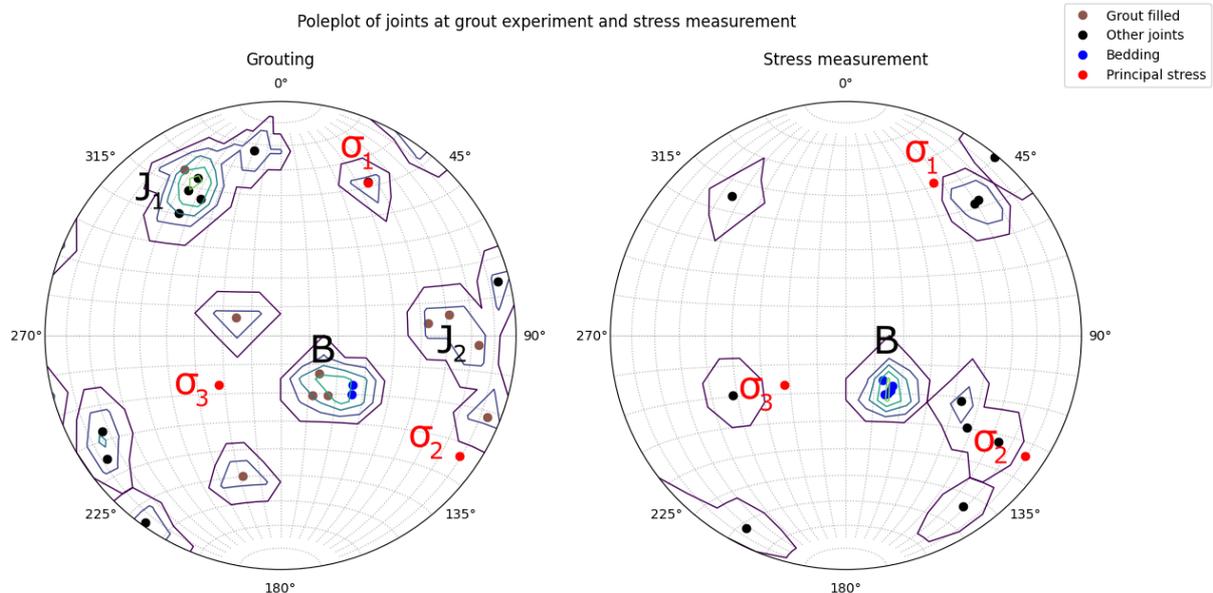
Figure 6 Pole plot of mapped fractures and principal stresses. J = joint set, B = bedding, σ = principal stresses

The fracture orientations of grout-filled joints, other joints and the bedding can be seen in the pole plot in Figure 6. The plot also contains the orientation of the principal stresses.
