# Condition Assessment and Maintenance Strategies for South-West NSW Bridges

Muhammad Khattak, Structural Engineer (Bridges), Transport for NSW

In the Southwest region of NSW, which borders Victoria, this paper focuses on two key border bridges which span over the Murray River: Heywood Bridge (B07331) in Wodonga and Mulwala Bridge (B05819) in Mulwala.

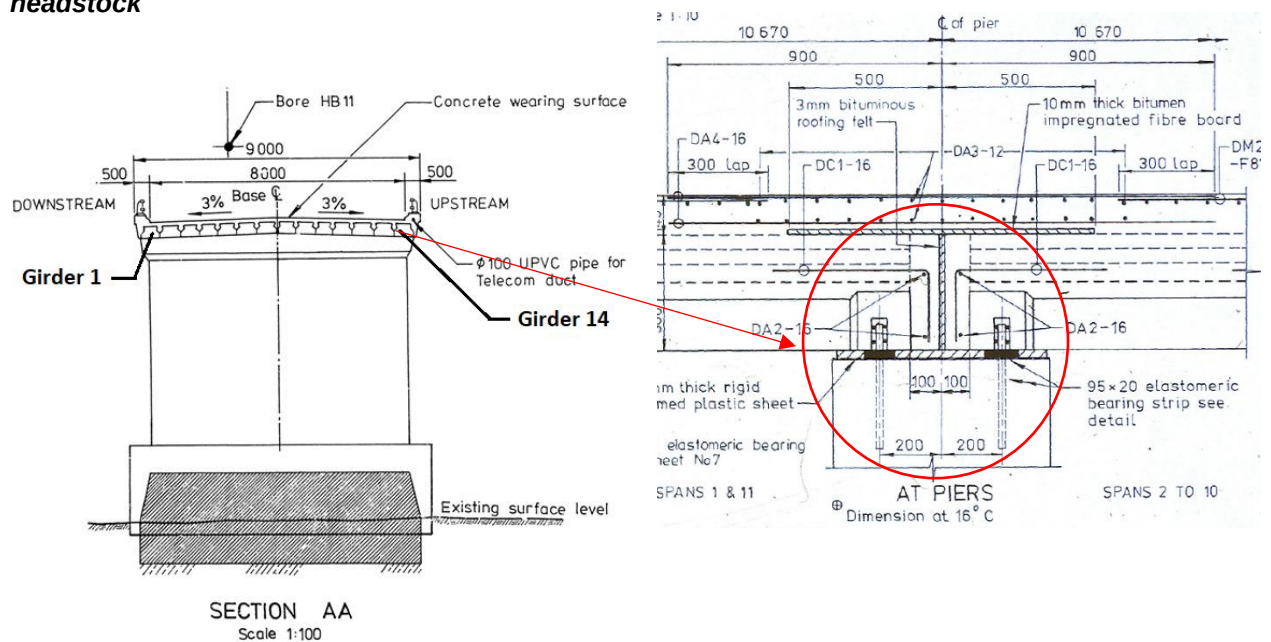
**Figure 3 Elevation of the Pier and details planks(girders) seating arrangement at pier's headstock**

The beam shown in Figure 3 are supported at the headstock at each end in respective spans. A dowel bar is extended from the headstock to these beams to restrain the movement of the planks/girders.

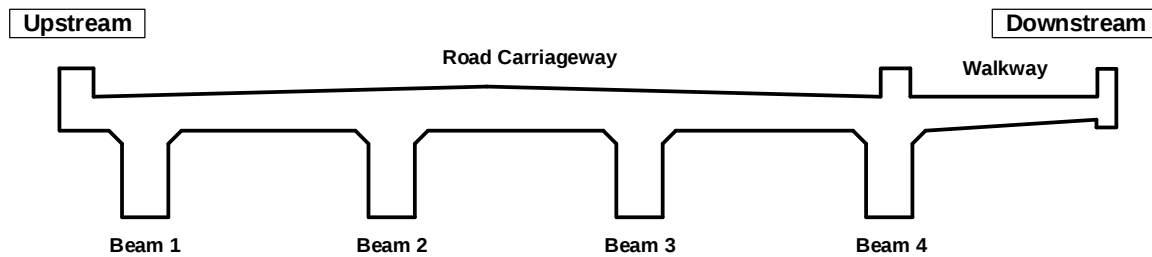
**Figure 12 Concrete Beam Spans 1 to 5 and Spans 9 to 32 (simply supported) Layout**

The beams shown in Figure 12 are supported at the headstock at each end of their respective spans. A dowel bar extends from the headstock to these beams to restrain the movement of the bridge.

The Level 3 structural inspection, carried out in 2018, found deterioration at the ends of the beams (Figure 12 shows the beam configuration) in the simply supported concrete beam spans (Spans 1 to 5 and 9 to 31). The deterioration manifested as cracking (up to ~1-2 mm) and spalling on the side faces of the beams over the seated areas (as shown in Figure 13). At the most severely affected locations, cracks extended from the beams into the headstock, accompanied by spalling of the headstock.

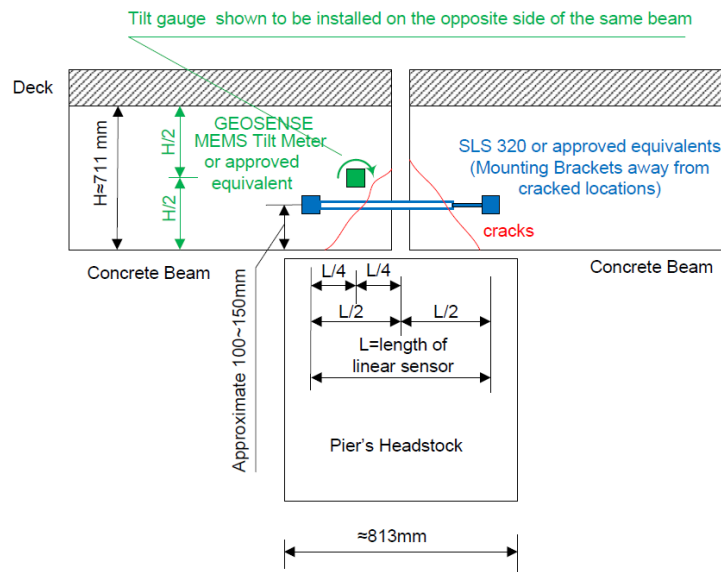
**Figure 15 Proposed installation of sensors at respective piers and beam ends locations**

TfNSW managed the design and implementation of the bridge monitoring system to ensure effective approach to bridge maintenance. A detailed monitoring plan was developed. The monitoring instruments, including tilt meters and linear displacement sensors, were recommended for installation at locations in poor to very poor condition. Below (as shown in Figure 17) is the layout of the installed monitoring system, including condition ratings for all beam ends. As shown in Figures 15 and 16, a linear displacement sensor (in blue) was installed at two beam ends to measure displacement movement, while a tilt meter (in green) was installed at the end of each beam to monitor tilt.
