AUSTROADS
BRIDGE
CONFERENCE 2025
Brisbane | 25-27 June 2025

Normanby Overpass, Bridge Strike: Assessment, Management and Rehabilitation

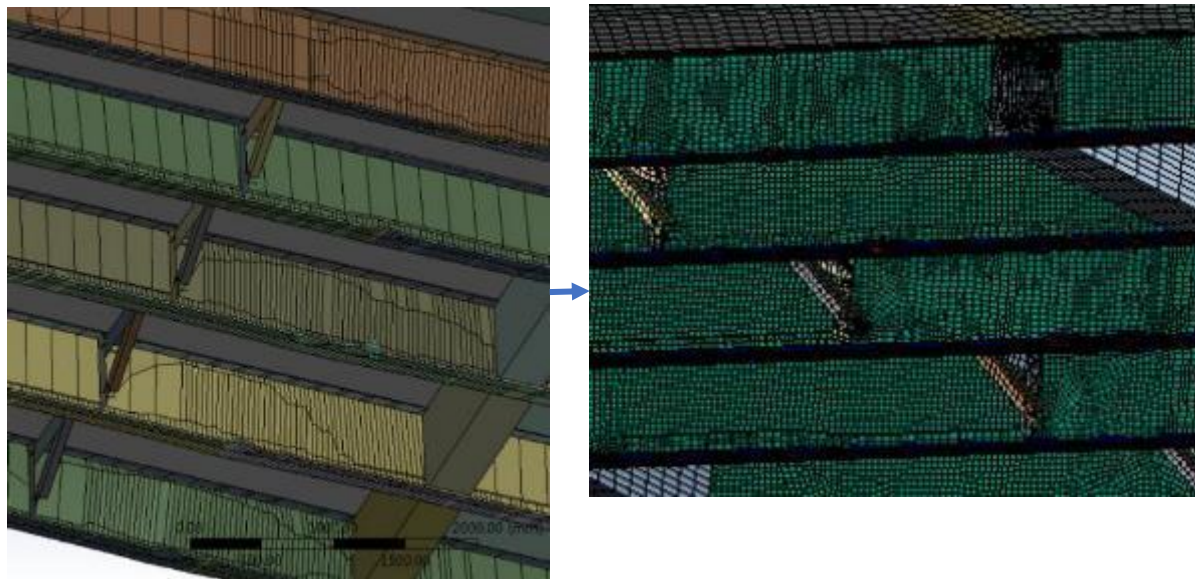
Figure 7 3D laser scan data converted to geometric surfaces, and then to finite element mesh

3D laser scans of the superstructure produced a cloud of points, which were then converted into geometric surfaces. Ansys⁶, an engineering software, was then used to create a finite element model of the girders, including damage, distortions and cracks. Figure 7 shows the geometric surfaces and finite element mesh of the damaged superstructure.

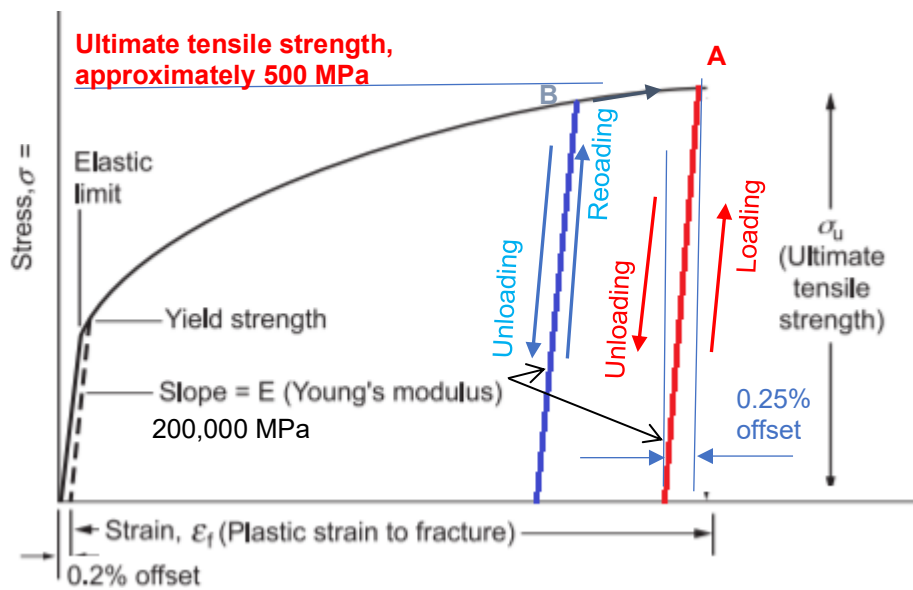
Figure 8 Strain to failure in undamaged and damaged steel with plastic yield

Sections of the damaged flanges had undergone plastic deformation due to vehicle impacts. In ductile strain hardening materials, such as the steel in the girder flanges and the doubler plates, this will lead to an increase in yield strength but could also lead to a reduction in subsequent strain to failure. For example, if the steel in the 610UB125 flange was plastically strained due to damage to Point B in the stress-strain curve (refer to Figure 8), and if load was then removed and re-applied, stress would travel linearly along the slope having a gradient corresponding to the Young's Modulus, E , shown by the blue arrows and would then flow along the original stress-strain curve until failure due to rupture. If, however, the plastic strain due to the impacts caused the steel to nearly reach the point of rupture (refer to Point A in Figure 8), then reloading would cause strain to increase linearly with a slope equivalent to E until the ultimate tensile strength (UTS) of approximately 500 MPa was reached, but could then rupture soon after since it was already close to the failure limit on the stress-strain curve. It is difficult to determine the residual plastic strain in the flanges (see note in Figure 8). The conservative assumption would be to assume straining due to impact up to Point A. A conservative measure of rupture strain would then be 0.25% (UTS of approximately 500 MPa divided by elastic modulus of 200,000 MPa). This criterion was applied to the average of the strain across the flange section at the high strain location, when determining the residual capacity of the damaged sections of the girders. The criterion is conservative since monotonic loading was assumed with yield occurring at yield strength rather than at an increased value due to strain hardening.

Note: A nonlinear analysis was carried out to replicate the deformed shape of the damaged flange. The quasi-static analysis did not converge to the fully deformed value but predicted a plastic strain of 17% at about 85% of the deformation. Therefore, residual strains of the order of 20% or more could potentially exist in the damaged girders.
