# SA Water OCUs Performance Assessments

**Presenters: Paul Sproules<sup>1</sup>, Heath Georgeff<sup>2</sup>**

## OCUs Performance Assessments

Prepare report with collated data, observations and finding with recommendations for improvements ensuring optimal performance

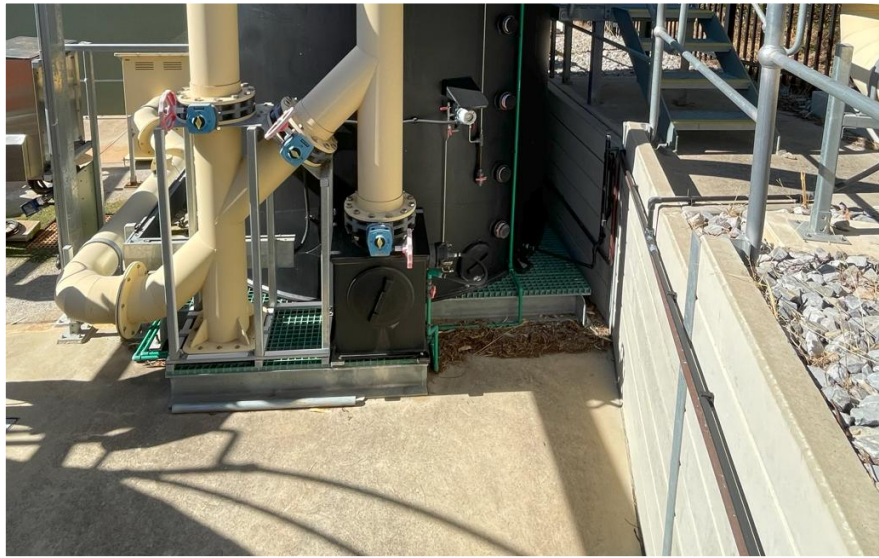
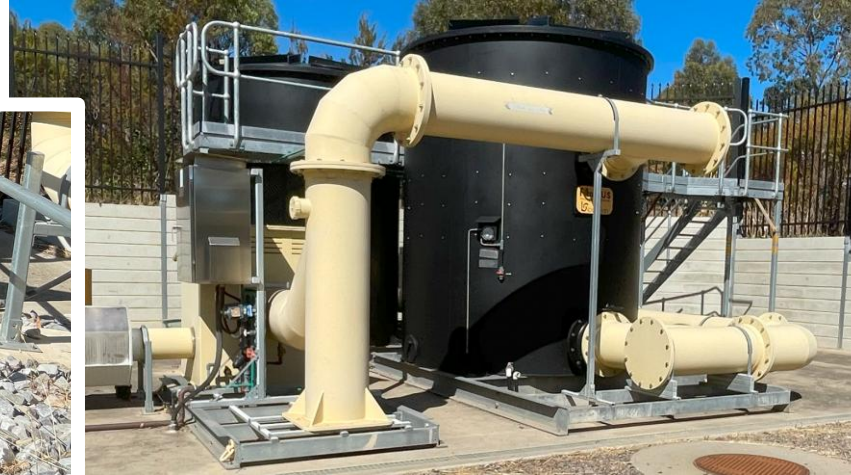
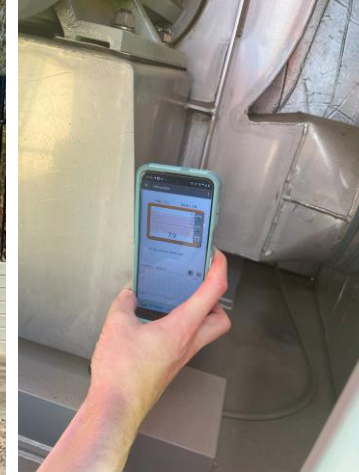
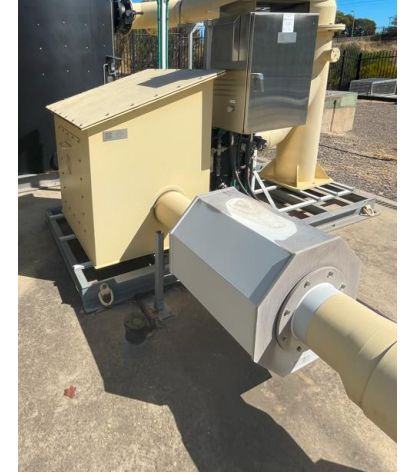
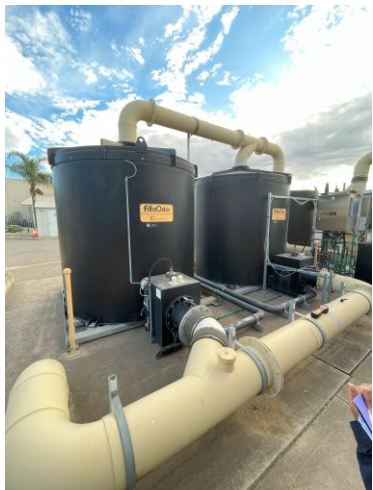
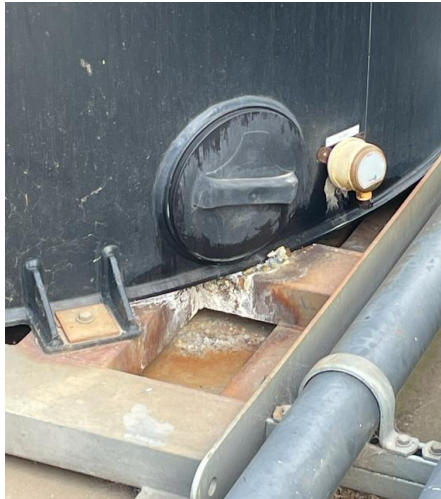
# Condition Assessments

| Condition | Performance |
| GOOD | GOOD |

- H<sub>2</sub>S inlet: 6 ppm.
- Inlet volatile organic compounds (VOC): 1.5 ppm.
- H<sub>2</sub>S after biofilters: 0.48 ppm (92% removal) via spot sample measurements.
- H<sub>2</sub>S after carbon: 385 ppb

- Consideration of network ventilation and possible rectification of restricted airflow through collecting pump station manhole
- Renewal of blocked drains

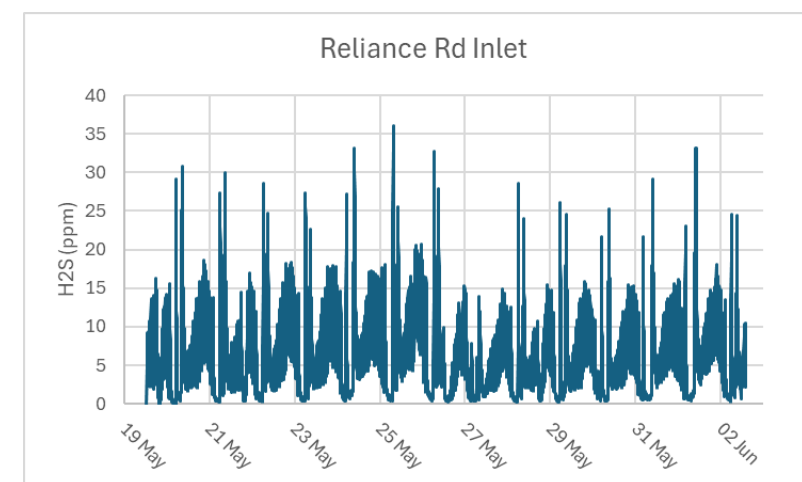
# WWPS282 OCU, Capella Avenue, Hallett Cove

- Inlet H<sub>2</sub>S: 9.7 ppm
- Inlet VOCs: 1.5 ppm
- Outlet H<sub>2</sub>S (post biofilter): 0.3 ppm (97% removal)
- Outlet H<sub>2</sub>S (post carbon): 570 ppb

| Condition | Performance |
| FAIR | GOOD |

- Investigate sump pump performance issue leading to flooding of sump.
- Fix blocked duct drain after the biofilter.
- Monitor carbon bed odour breakthrough and replace when required.

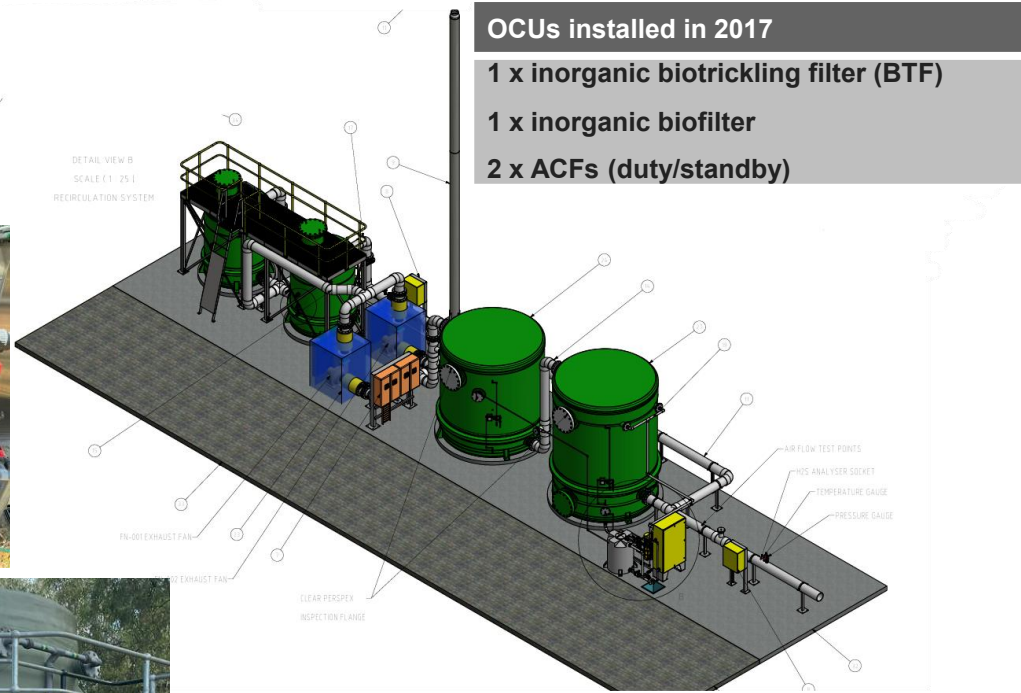
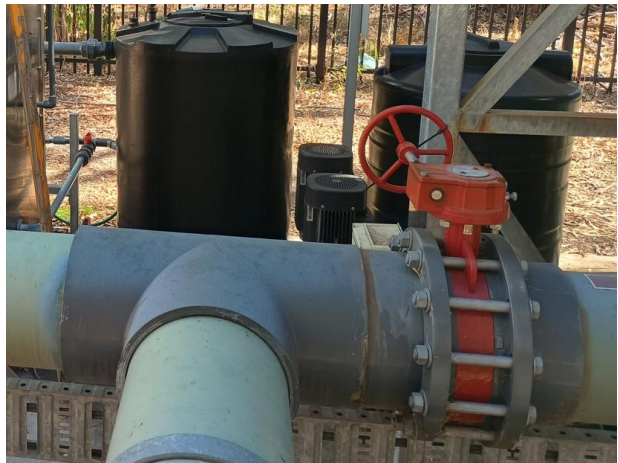
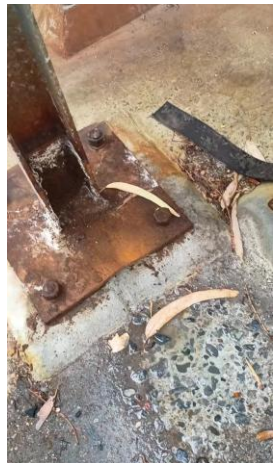
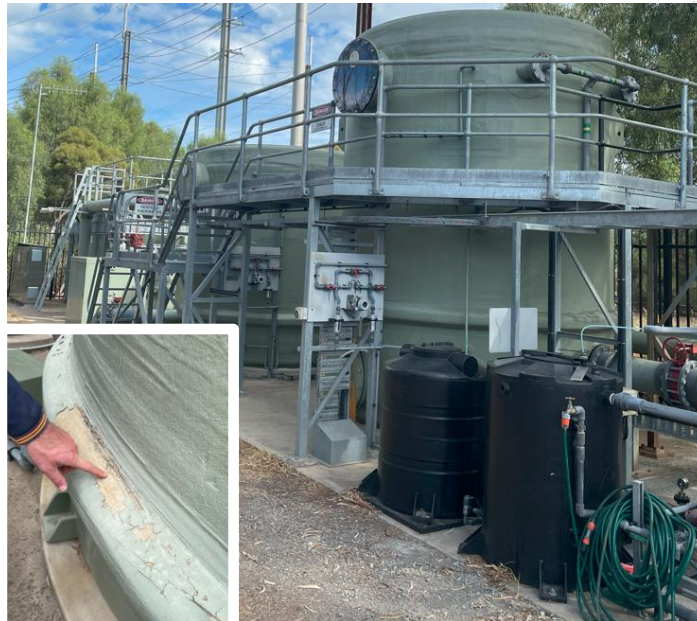
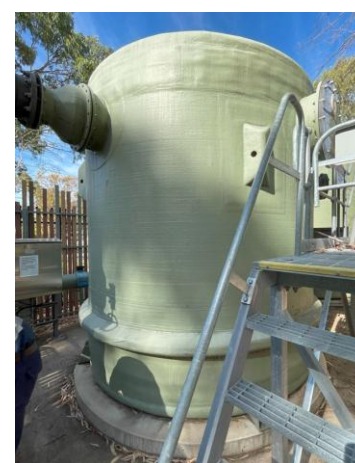
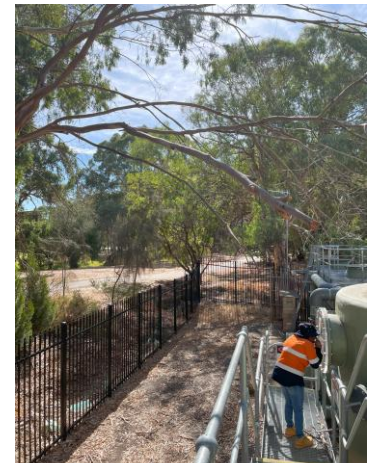
# OCU1, Teasdale Crescent, Parafield Gardens

| Condition | Performance |
| FAIR | FAIR |

- Renewal of:
  - leaking sampling ports
  - pressure indicators
  - dosing pump mounting and corroded cable tray
- Removal of an intrusive tree branch at top platform.
- Calibration of the Dräger Polytrons
- Consideration of sewer corrosion. High septicity is recommended to be addressed to prolong sewer life
- Although H<sub>2</sub>S removal is good, further assessment of possible BTF media compaction will determine if DP continues to rise leading to potential biomass degradation putting performance pressures on the system
