RECONSTRUCTION OF THE DOLNOLUČANY TUNNEL, FROM INITIAL IDEAS FOR SOLVING LEAKS TO THE CONSTRUCTION OF A NEW TUNNEL

L. Mařík

SAGASTA s.r.o., Prague, Czech Republic

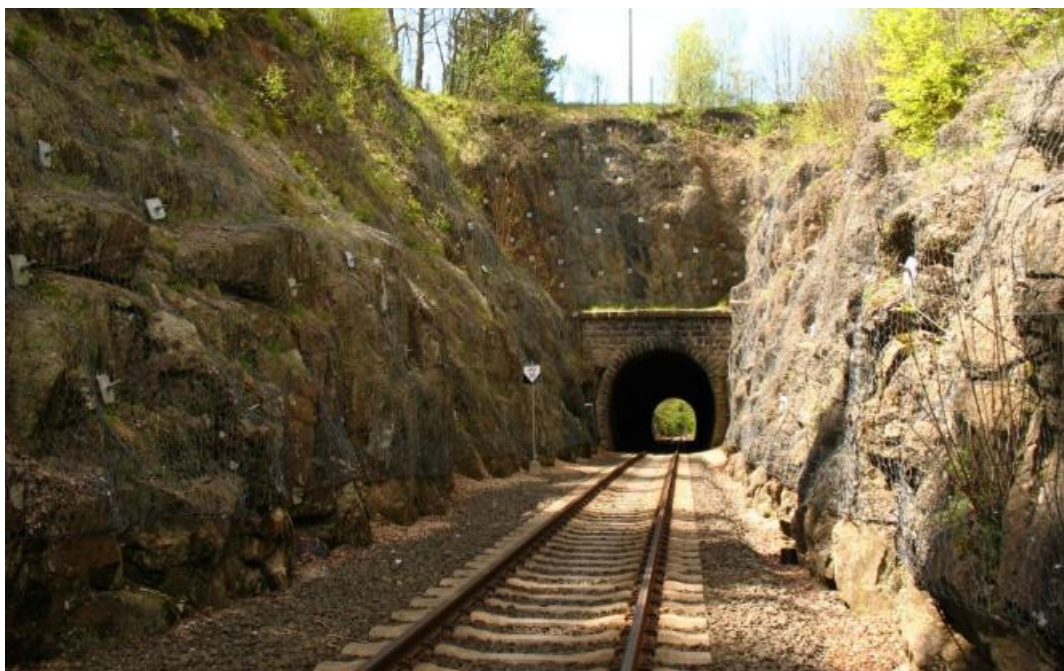
Fig. 13 Rock cut walls in front of the portal

In agreement with the client, it was proposed to extend the tunnel from the original 82.5 m to 100 m as part of the reconstruction. By moving the portals away from the steep and unstable portal slopes (which currently require reinforcement with anchors and steel mesh), the risk of rockfall onto the track will be significantly reduced. The typical conditions at both portals are illustrated in Figure 13.

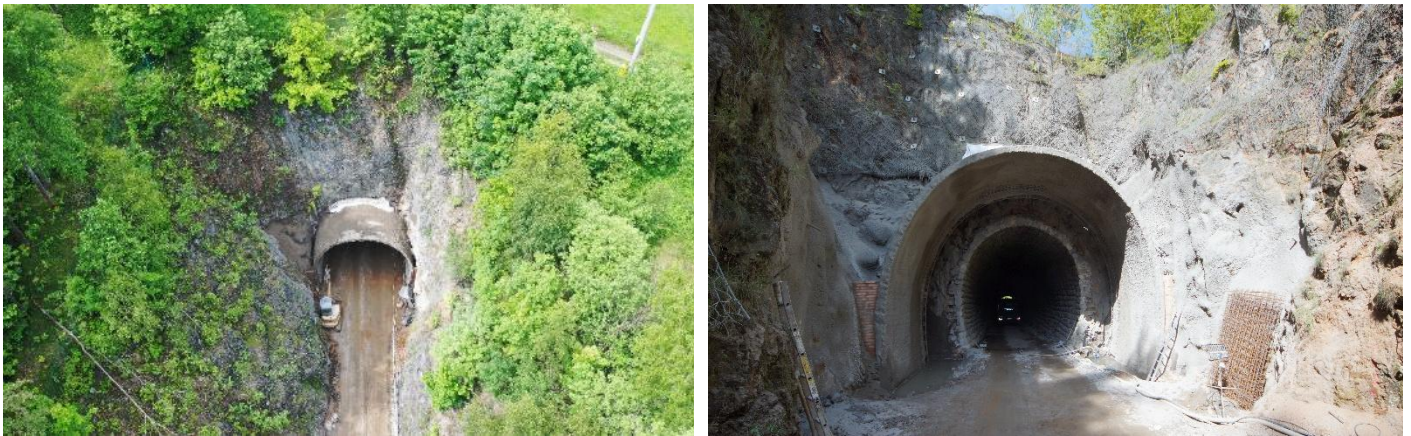
Fig. 16 Cramped space conditions at the tunnel portal in a deep rock cut

Since the railway superstructure in this section had been renovated only 10 years prior, the client requested the reuse of both the ballast bed and the track panels following the works. The contractor, SUBTERRA, had to manage difficult site access and extremely cramped conditions at the portals—which are situated in deep rock cuts—while operating within the constraints of a single-track tunnel (see Figure 16).
