GEOTECHNICAL MONITORING DURING THE CONSTRUCTION OF BARRIER-FREE ACCESS TO THE JIŘÍHO Z PODEBRAD METRO STATION

M. Čermák, B. Pavelková, R. Morávek
INSET s.r.o., Prague, Czech Republic

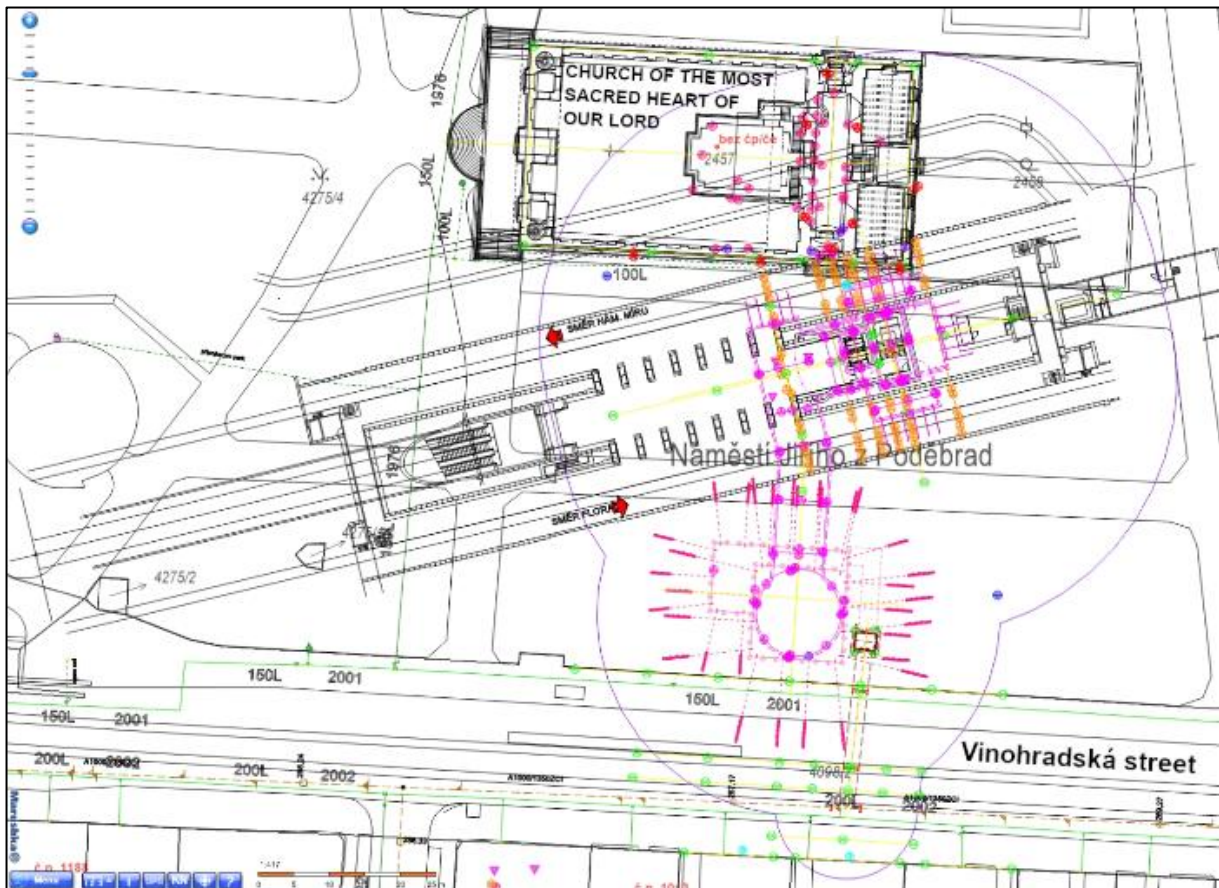
Figure 1: Distribution of measuring points from different methodologies and the zone of influence from the project documentation (see also the situation in (ČERMÁK, M., PAVELKOVÁ, B., MORÁVEK, R., 2014))

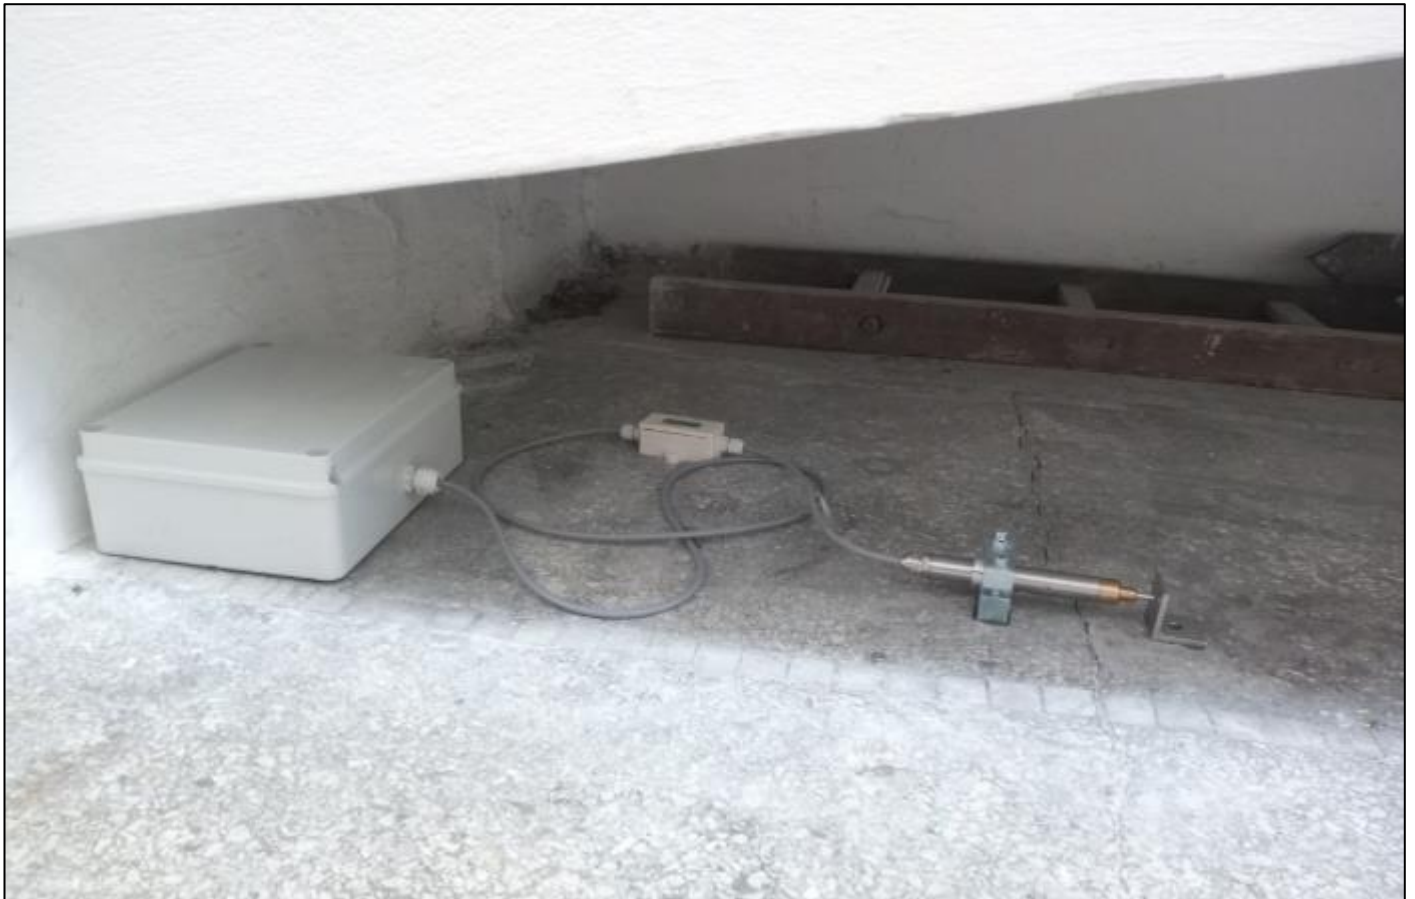
The measured changes in crack widths from automatic measuring devices in the church were not significantly affected by temperature. At the same time, no significant correlation with construction activity was measured. The measured values were well below warning levels – see Figure 6 and Table 1. Simultaneously with the measurement of crack width changes, the temperatures of the measured structure were also measured at these locations. Figure 6 shows how the church tower is significantly affected by temperature changes, and the maximum and minimum temperatures were measured at the same time at a point in the tower (shown in red in the graph).

Figure 5: Automatic crack width measurement device with electronics for sending measured data to the geotechnical monitoring office (glued to the structure)
