# Beyond the Planting: Keeping WSUD Systems Functional Over Time

Eric Lin – Stantec  
[eric.lin2@stantec.com](mailto:eric.lin2@stantec.com)

FRANC 2025 - Asset Management  
16 October 2025  
11:35 – 11:50 am

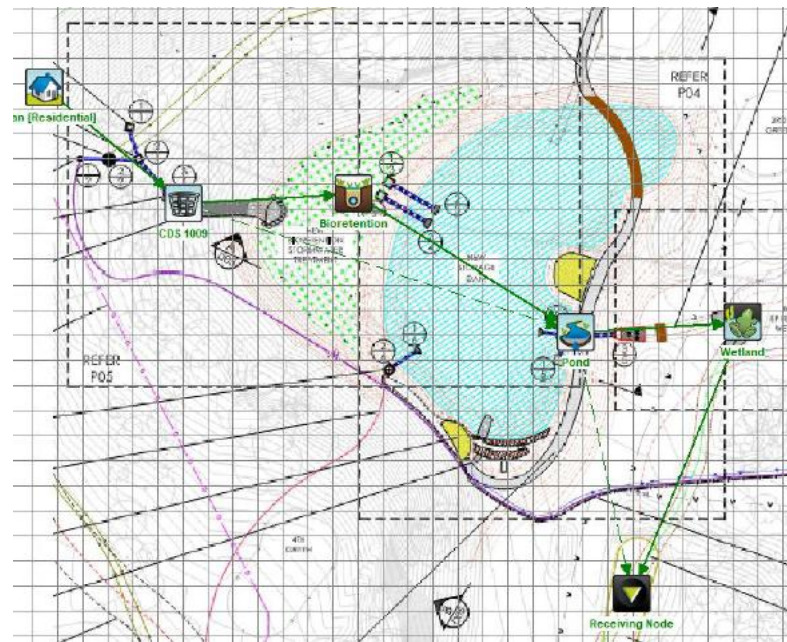
Plan provided by Mallory McLennan - GRC

- Catchment delineation: account for upstream inflows – Precinct Level Infrastructure
- Maintenance access: continuous movement, safe, and reach of maintenance equipment.
- Functional zoning: separate treatment areas from recreation.
- Incremental treatment approach: treatment train reduces end-of-pipe reliance.
- Bypass mechanism is not considered in the modelling.

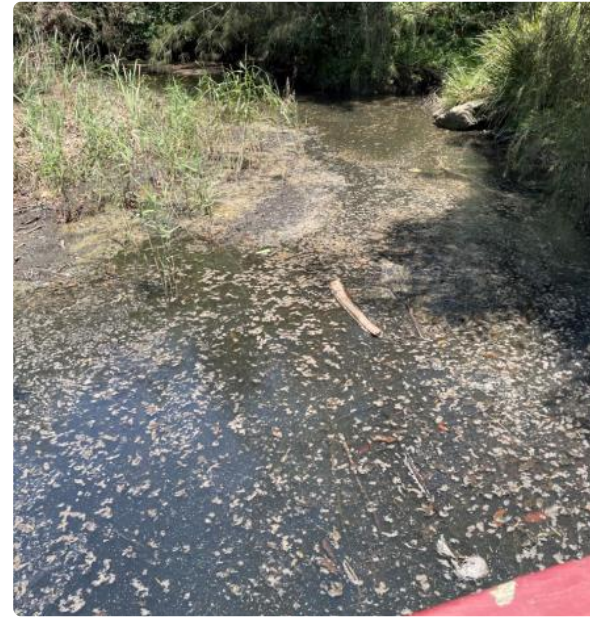
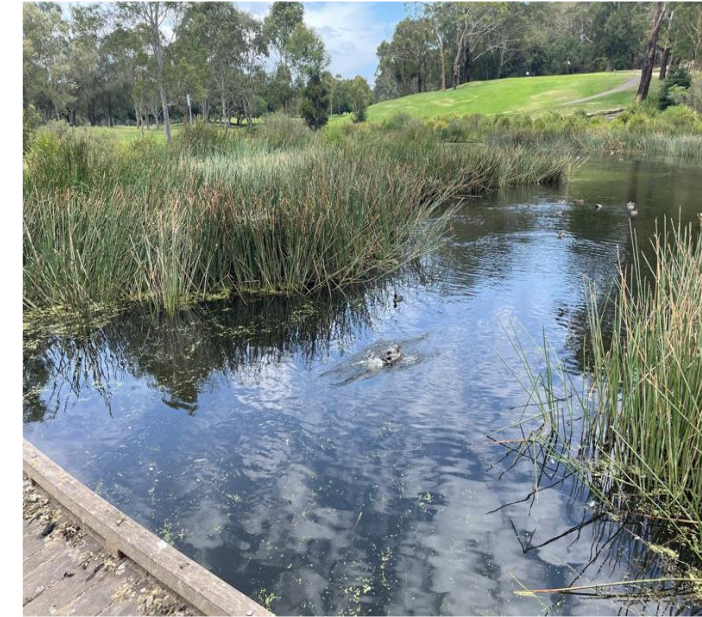
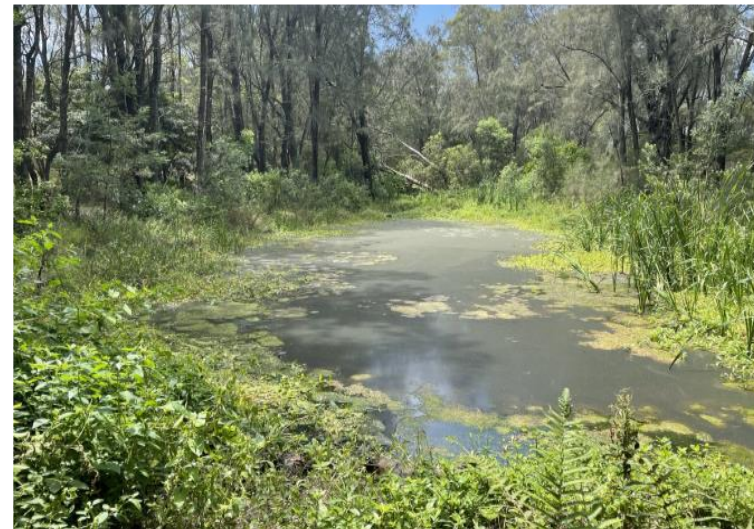
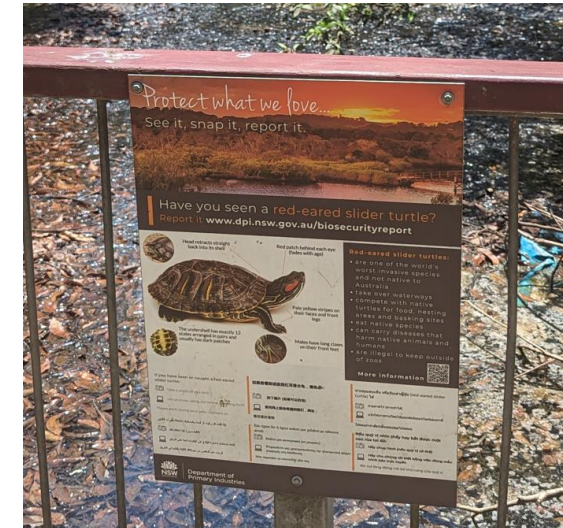
- Reduced treatment efficiency, negative waterway health
- Algal growth or odour from stagnant zones.
- Invasive species dominance.
- Increased rehabilitation costs.
- The challenge with stormwater lies in its ability to transport excess nutrients and pollutants into our waterways, causing significant harm.
- Moreover, the substantial volumes of stormwater flowing into waterways post-rainfall exacerbate erosion along creek beds and banks.
