Clyde Dam and Schist Landscape Field Trip

28 April 2026

Field trip leaders: Don Macfarlane, Romy Ridl

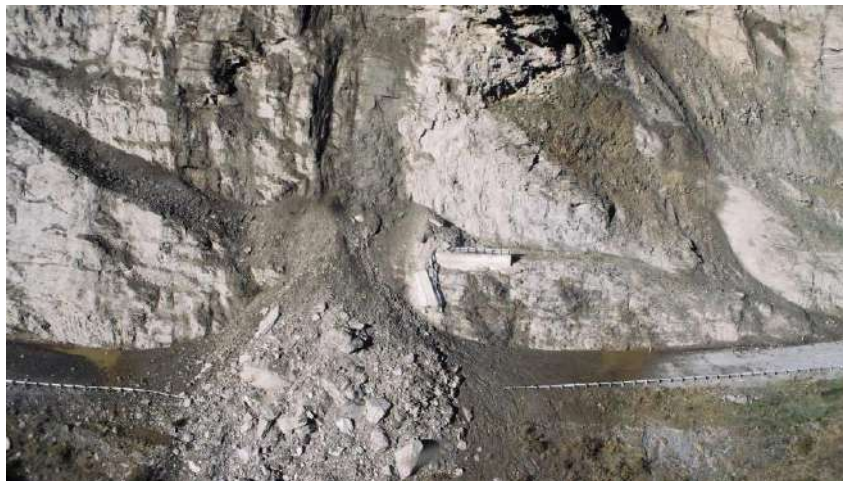
Figure 12. Rockfall closed the SH6 in 2000.

In 1972 the slope was cut back 30 m and steepened to an angle of 75° to widen SH6. A joint controlled slope failure (30,000 m³) blocked the highway for 6 weeks in 1974. Since then, there has been an ongoing history of scaling and stabilisation works, including another slope failure of 10,000 m³ which caused road closure for 5 days in 2000.

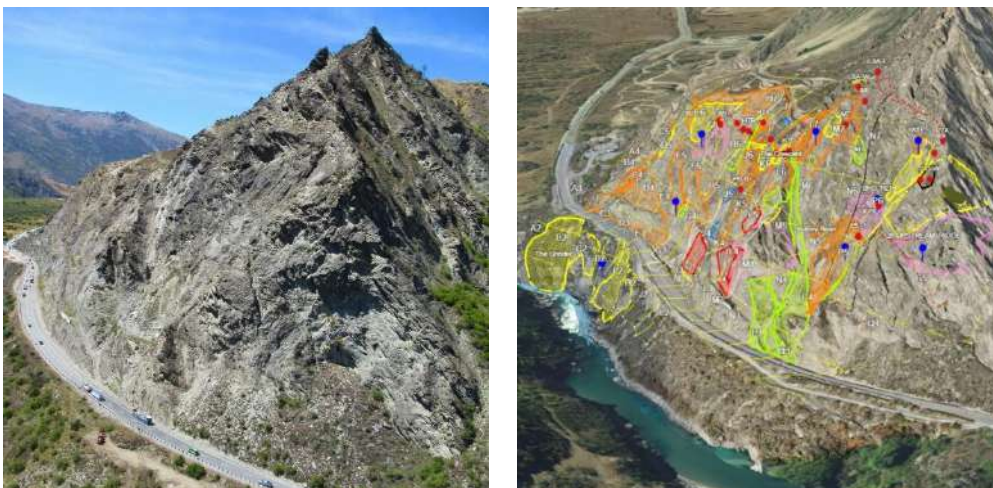
Figure 13. Drone image of Nevis Bluff and the digital twin developed to identify and manage risk (WSP, 2025).

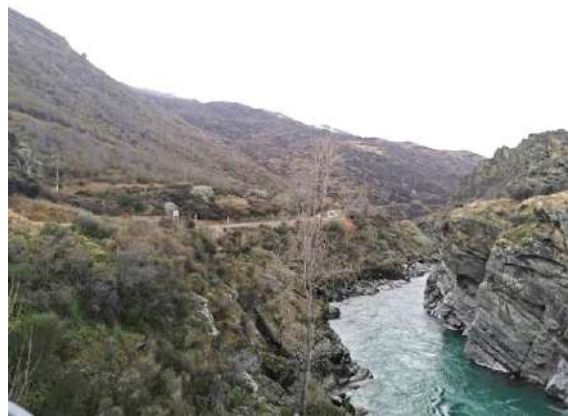
Figure 15. Looking downstream with the K9 landslide on the true left of the Kawarau River.

The K9 landslide is a large dip-slope landslide ($\sim 10^9 \text{ m}^3$) developed in Rakaia Terrane greyschists (psammitic–pelitic quartz–mica schist) with subordinate greenschist (chlorite–epidote schist). It is ~ 9 km long with maximum displacements ~ 100 m and grabens up to ~ 100 m wide. At the scale of the gorge, deformation includes prominent lateral shears and internal scarps. Bell (1976, 1982, 1987 and 1992) documented anomalously steep foliation dips ($60\text{--}70^\circ$) within the lower (compressional) zone of the K9 landslide in the Kawarau Gorge, contrasting with the regional dip-slope fabric on the SW-facing antiform limb where foliation typically dips $\sim 25\text{--}30^\circ$ to the southwest. This identification of toe buckling/foliation oversteepening and buried megablocks beneath chaotic debris provided a key conceptual analogue for Central Otago large slope evolution and was used to inform interpretation of the Cromwell Gorge geological model during the Clyde Power Project.

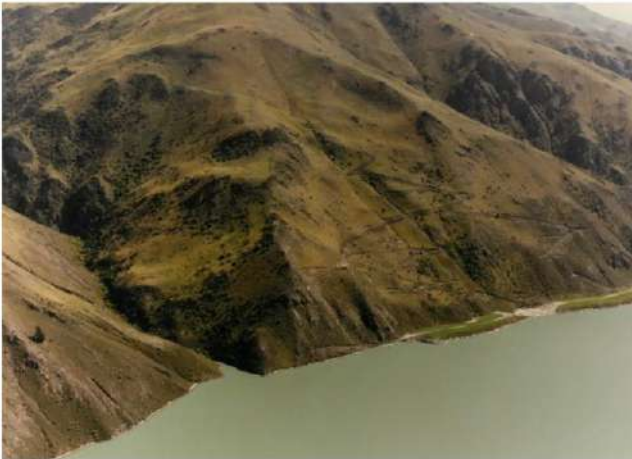
Figure 22a. Overview of Jackson Creek Slide (Contact Energy Ltd).

Jackson Creek slide (Figure 22) is located on the opposite side of Lake Dunstan. The mechanism of failure is wedge failure. Stability analysis indicated that a substantial (25%) reduction in stability would occur as a result of lake filling and toe inundation. Remedial works comprise a 1.2M m³ toe buttress, 450m of drainage drive and 8000m of drainage drilling plus surface treatment of tension cracks.

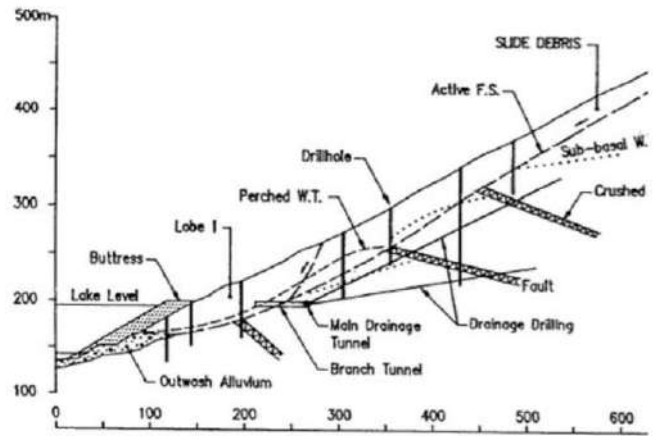
Figure 22b. Cross section of Jackson Creek Slide (NZGS, 2021).

The lower slopes were reactivated by stripping for the 60 m high toe buttress, with significantly increased movement rates during construction. The buttress had an immediate beneficial effect on the toe lobes but the upper slope took several years to stop moving. The slide is currently dormant.

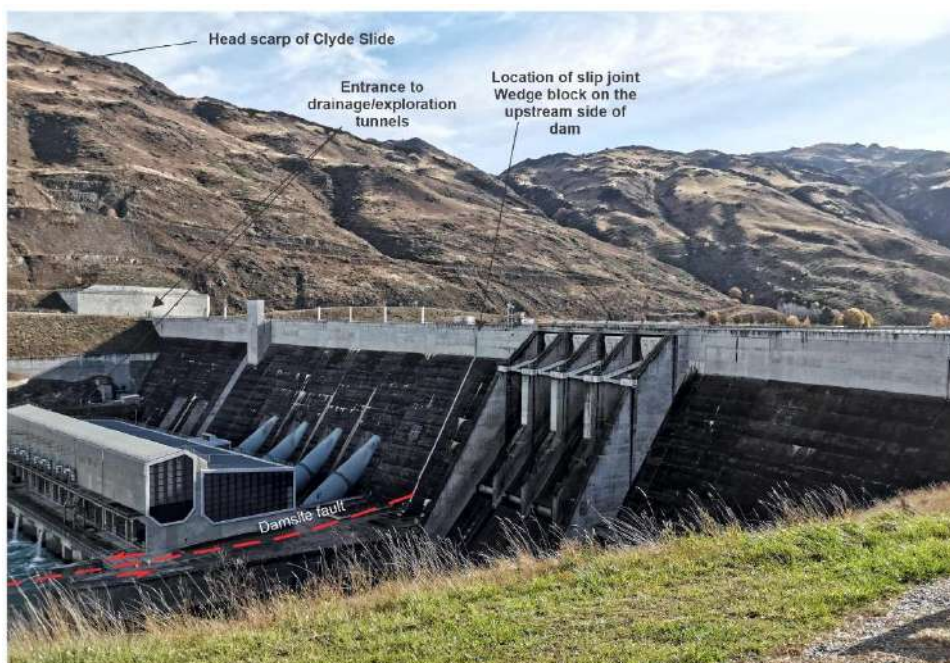
Figure 24. Clyde Dam with the Clyde Slide in the background. Photograph taken in May 2019.

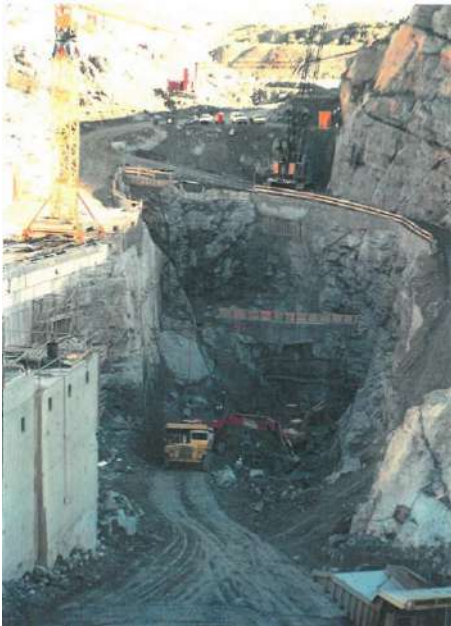
Figure 26. Looking upstream along the River Channel Fault, the orange colour excavator is located close to the River Channel Fault cut-off shaft (Thomson, 1993).

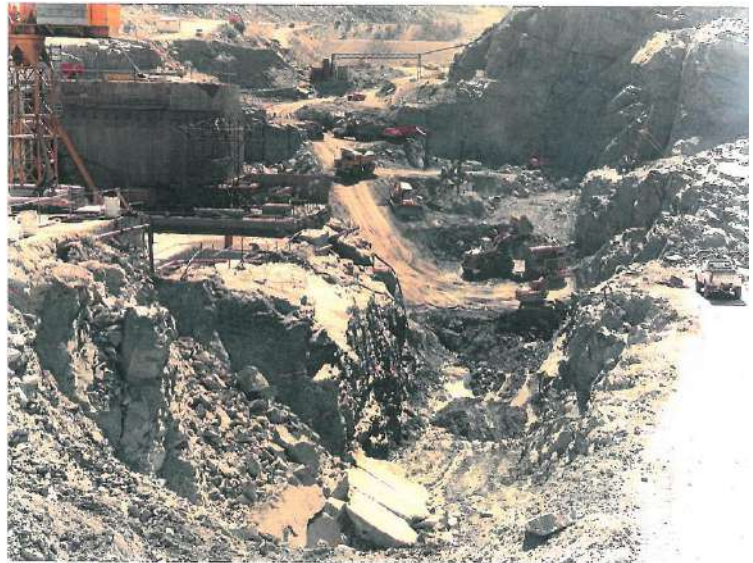
Figure 27. Looking upstream along the River Channel Fault remedial excavation (Thomson, 1993).

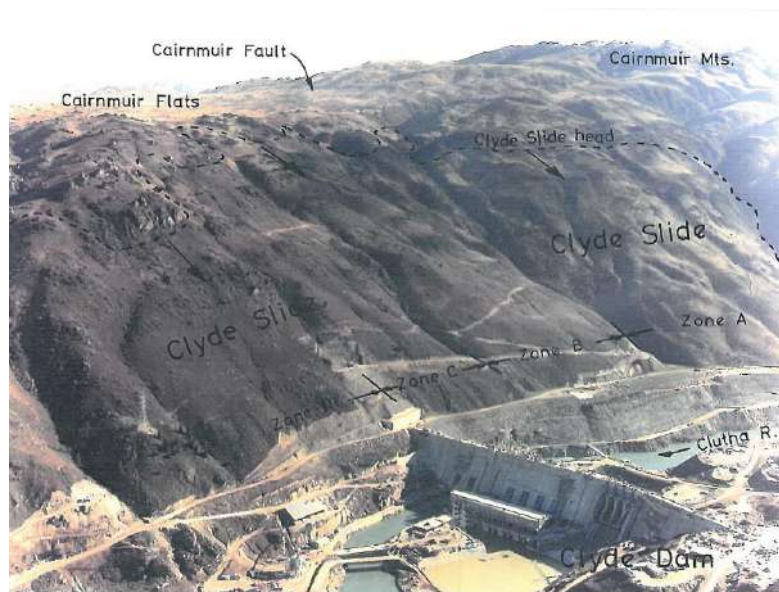
Figure 28. Clyde Slide taken during construction phase in 1989 (Thomson, 1993).

The Clyde Slide is located on the true right of the Clyde Dam spanning ~2 km of moderate–steep slope and extending from ~RL 190± at the toe up to RL 550± at the head. The slide base developed along foliation shears dipping obliquely downstream and towards the valley and stepping across joints and upslope-trending minor faults. The slide mass comprises chaotic debris with large, displaced blocks (Thomson, 1993) with four distinct zones recognised. In Zone C the slide base is above the dam crest level. This constrained the location of the right abutment.

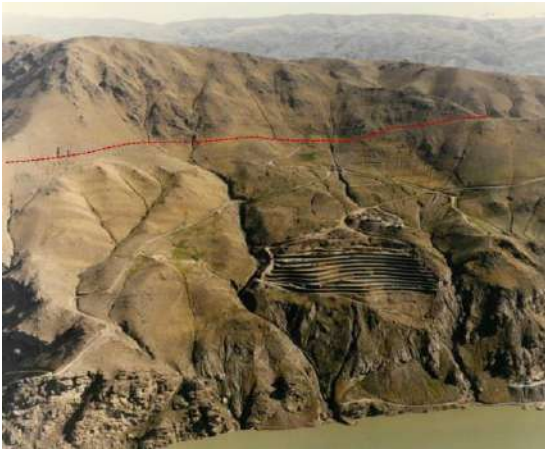
Figure 30. Overview of Cairnmuir Slide. The red line is the inferred geological terrane boundary fault (Contact Energy Ltd).

Cairnmuir Slide, perched about 60m above the lake on the true right of the lake, has formed along foliation drag-folded by movement along the terrane boundary fault. It was the most active landslide in the gorge prior to remedial works with total movement of over 600m and was very sensitive to rainfall. Remedial works consisting of surface protection, drainage tunnels and extensive drainage drilling to intercept infiltrating rainfall have reduced the original movement rate by over 95 % (NZGS, 2021).

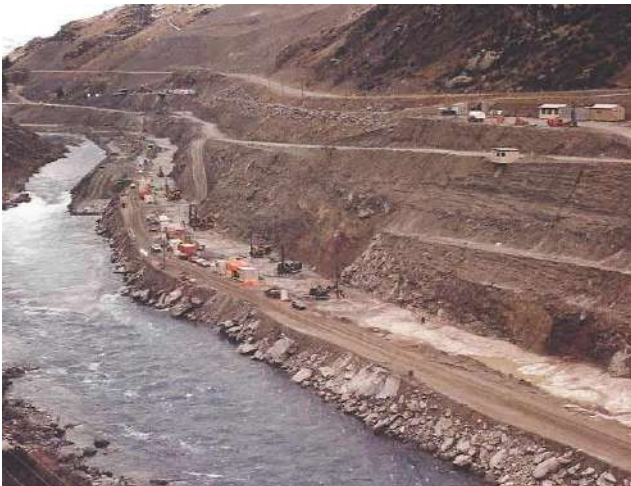
Figure 34. Grout curtain under construction at Brewery Creek (Clyde Power Project, unpublished).

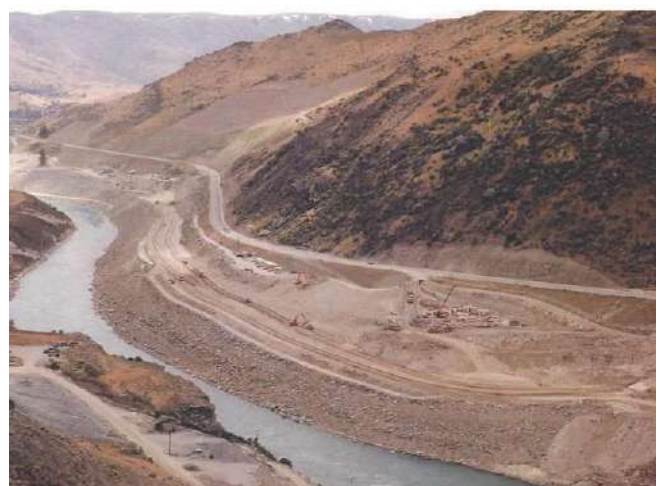
Figure 35. Constructing toe buttress, Brewery Creek slide (Clyde Power Project, unpublished).

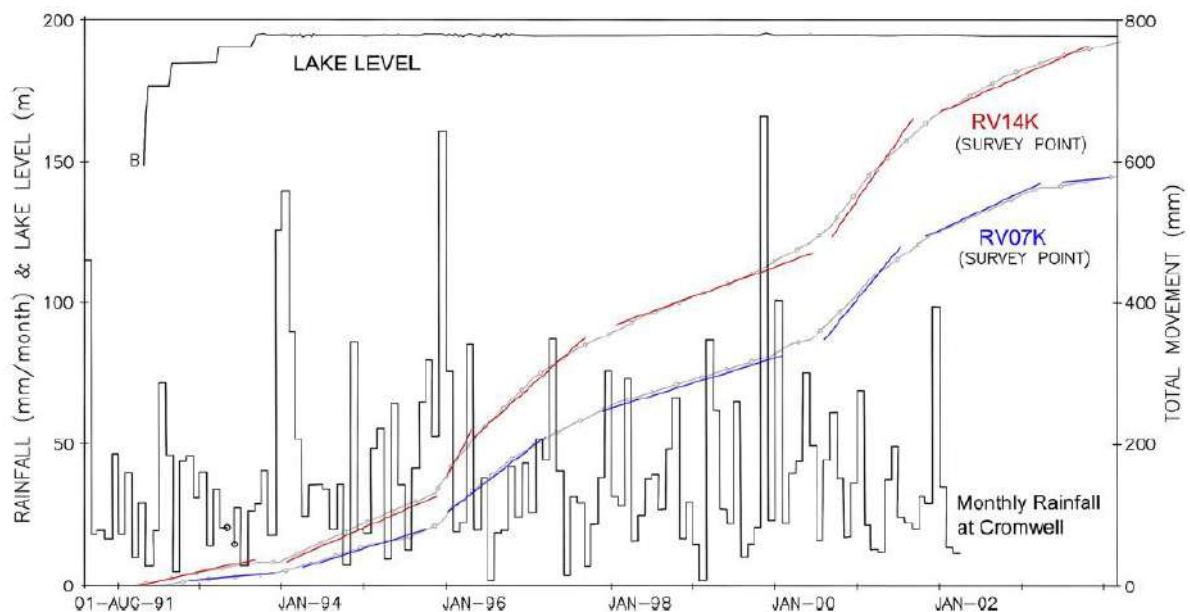
Figure 38. Survey displacement rates at Zone A of Ripponvale Slide and total rainfall for Cromwell (Macfarlane, 2009).

Review of the survey data from Zone A of Ripponvale indicated that the landslide shows that accumulative rainfall of > 300 mm over a period of 3 – 4 months results in landslide acceleration that progressively reduces over a period of 1 – 2 years (Macfarlane, 2009).
