# TRANSVERSE ZIGZAG DAMAGE MODE AND STITCH CRACKING IN ANTISYMMETRIC ANGLE-PLY LAMINATES

Jeffrey T. Chambers<sup>1</sup>

<sup>1</sup> Aurora Flight Sciences, A Boeing Company, Manassas, VA, USA, chambers.jeffrey@aurora.aero

**Keywords:** Transverse zigzag, Mode interaction, Lengthscales

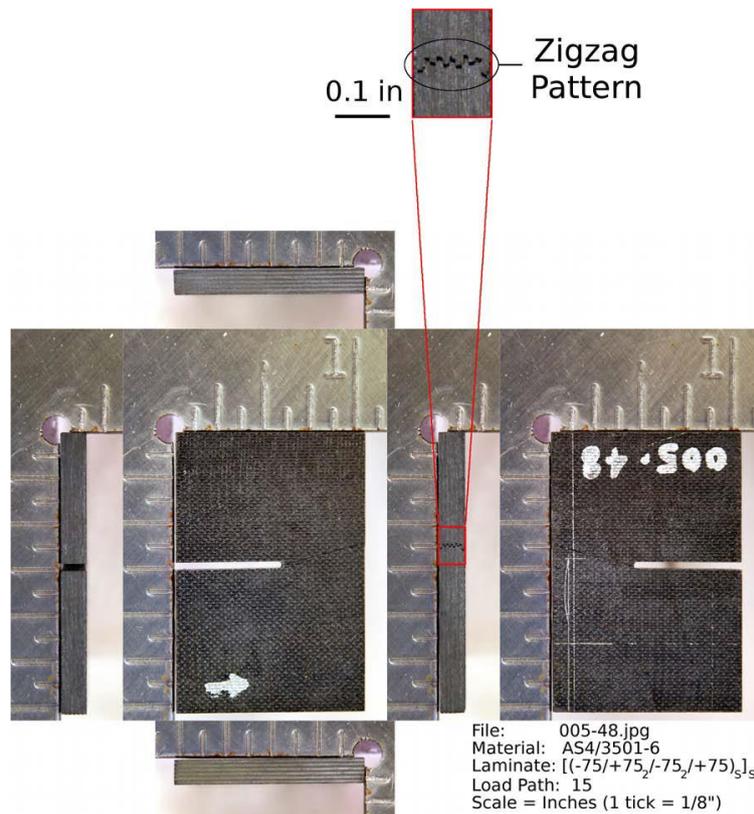
Figure 1: Documentation photograph layer of a single-edge-notched specimen (005-48) with transverse zigzag damage, with an enlarged view of a section of the right face where the zigzag path intercepts the edge.

The lengthscales [7, 8] involved with the interactions of damage modes involved in the transverse zigzag damage type include the laminate thickness, the normalized ply mismatch length,  $L$ , and the lengthscales associated with matrix cracking. In addition, new lengthscales are introduced from transverse zigzag: the “width” of the zig-zag pattern (i.e., in-plane length), the angle relative to loading, and the length of the propagation of the damage type. The results from the computed microtomography scans reveal that the transverse zigzag damage type propagates along fiber angles, maintaining the same zigzag shape, as shown in Fig. 1, along the entire propagation path.

quantitatively, and allow lengthscale effects to be better investigated across the levels of composite testing. The damage documentation procedure is detailed in depth in Section 5 of [1]. The procedure begins by documenting the specimen faces with an optical photograph layer (e.g., Fig. 1), followed by quantifying the damage extent using a damage grid layer, and finally creation of damage sketch layer to capture the type(s) and orientation of damage. At the time of this study, each step was completed manually by the investigator, a very labor intensive and subjective process. As computer vision and artificial intelligence methods have advanced, it is highly recommended to automate the procedures. This would save a tremendous amount of time processing each specimen and enable an objective classification procedure. The base documentation photographs of this work can be made available to researchers developing such capabilities. While all specimens are documented following this procedure, select specimens were chosen to be investigated via X-ray micro-focus computed tomography ( $\mu$ CT). The  $\mu$ CT inspection technique demonstrates a leap in observable lengthscale, enabling damage to be investigated throughout the volume of a specimen at resolutions of a few microns. Also, the resulting digital volume enables artificial intelligence methods to be developed in order to process the postmortem damage characteristics [e.g., 12].

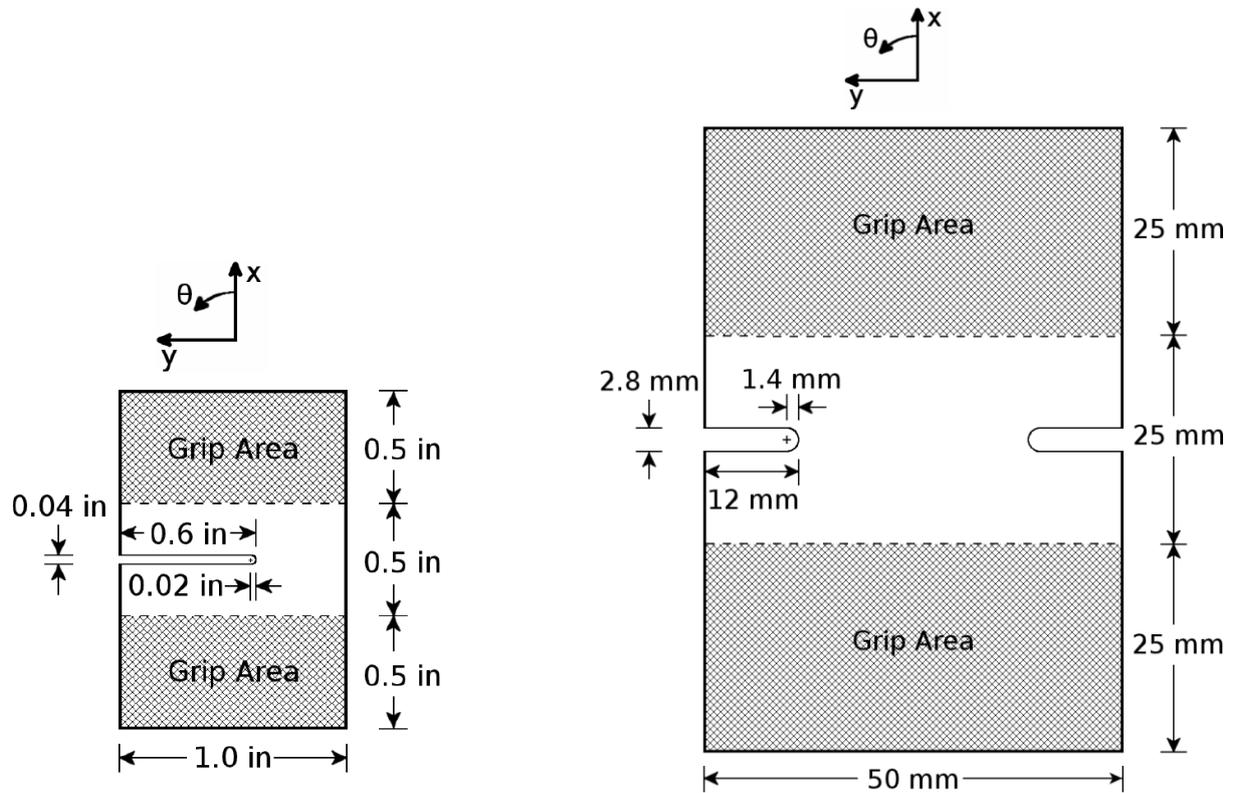
Figure 2. Planar illustration of the (left) single-edge-notched specimen and the (right) double-edge-notched specimen.

For the transverse zigzag damage mode, which is the topic of this paper, only five open hole specimen were observed with this damage mode and no ply drop-off specimens exhibited the mode. Thus, these two specimen types are not discussed herein. The geometric dimensions and structural detail of the single-edge-notched specimen and double-edge-notched specimen are shown in Fig. 2, respectively, with the specifics of the specimens further described in sections 4.1 and 4.2 of [1]. Dimensions listed in are nominal and are given in the system in which they were manufactured. The single-edge-notched specimens were manufactured for a previous study using English units. The double-edge-notched specimens were manufactured using SI (International System) units.

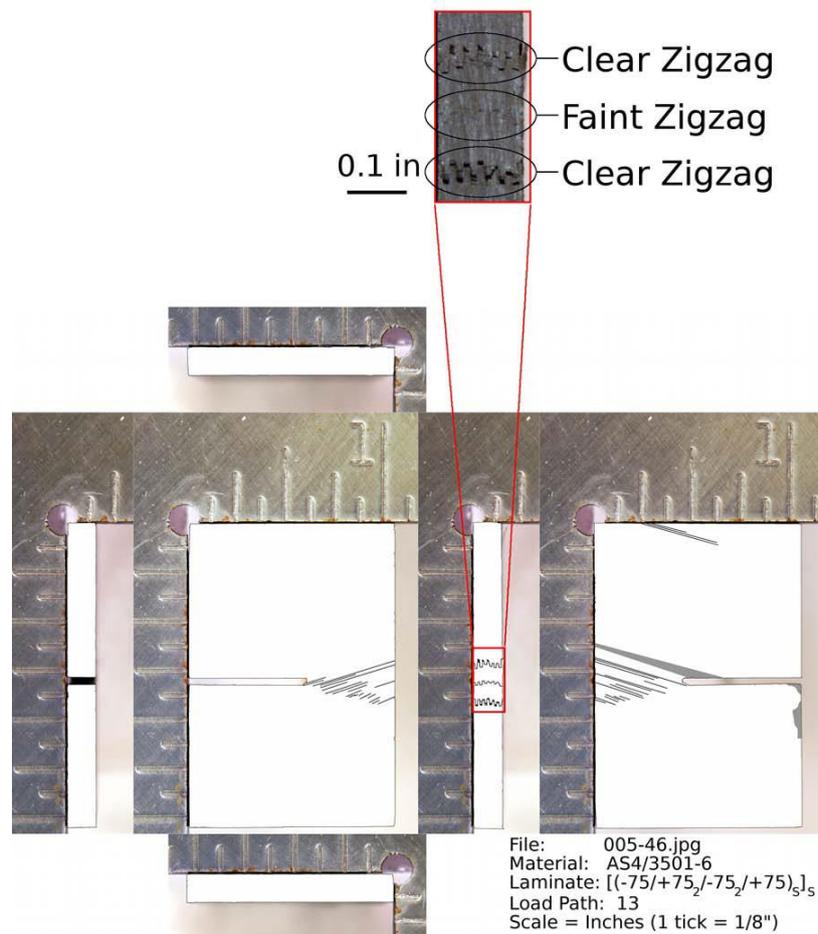
Figure 3. Example damage sketch layer of a single-edge-notched specimen (005-46) with multiple transverse zigzag damages, with an enlarged view of a section of the right face where the transverse zigzag paths intercept the edge.

This transverse zigzag pattern is observed in 52 of the single-edge-notched specimens, with the damage initiating at the tip of the strain riser and progressing along the fiber angles to a side surface. Almost half (24 specimens) of the specimens exhibiting this transverse zigzag pattern have a fiber angle of  $75^\circ$ , 10 specimens have a fiber angle of  $60^\circ$ , 11 specimens have a fiber angle of  $30^\circ$ , and the remaining 7 have a fiber angle of  $15^\circ$ . The surface to which the transverse zigzag propagates depends on the fiber angle of the laminate, as the propagation path starts at the tip of the strain riser and follows the fiber angle to the intercepting edge. Of those specimens exhibiting transverse zigzag, 10 specimens have multiple transverse zigzags present, while the other 42 specimens have only a single transverse zigzag. The damage paths in specimens with multiple transverse zigzags are always symmetric about the strain riser (i.e. the  $y$ - $z$  plane). The example shown in Fig. 3 has a transverse zigzag damage that is symmetric about the strain riser. In the enlarged portion of the figure, two distinct transverse zigzags are present (labeled as “clear zigzag”), and upon closer inspection, a faint third transverse zigzag can be found (labeled as “faint zigzag”).

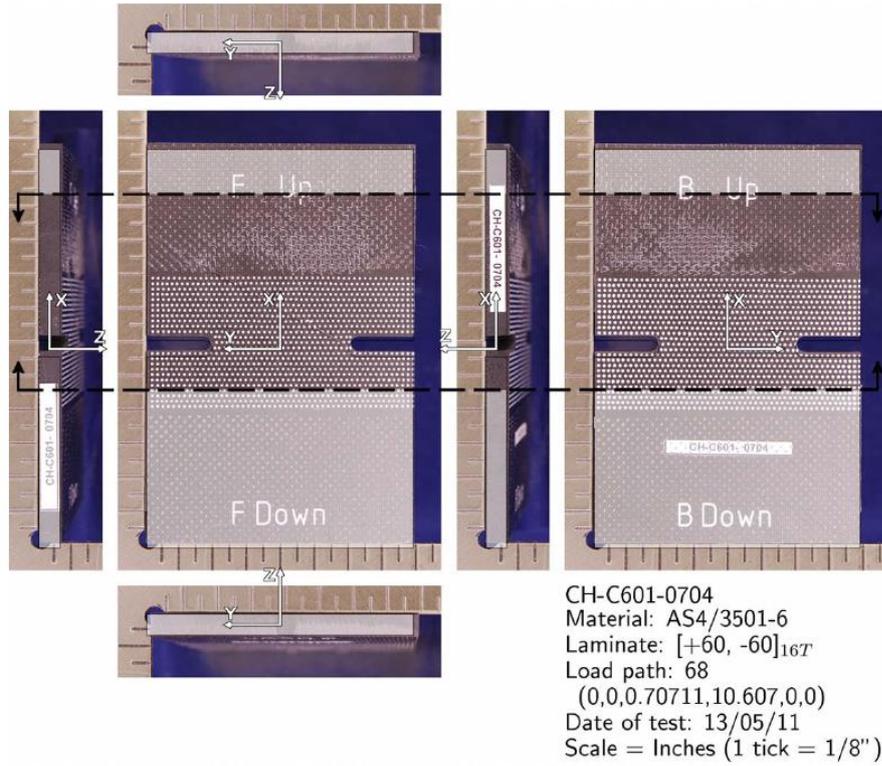
Figure 4. Optical documentation photographs of a double-edge-notched specimen (CH-C601-0704).  
 (Note: Region between dashed lines represents material volume scanned with  $\mu$ CT)

Transverse zigzag damage similar to that seen in the single-edge-notched specimens is observed in the double-edge-notched specimens. A single transverse zigzag damage is observed in 171 of the specimens, while only 2 specimens exhibit a double transverse zigzag damage. The initiation point for transverse zigzag damage is always at the tip of one of the notches, with the damage progressing along the fiber angle until intercepting a specimen edge. Unlike in the single-edge-notched specimens, one of the two double transverse zigzag damage paths is not symmetric about the notch direction. The one specimen with unsymmetric (about the  $y$ - $z$  plane) transverse zigzag damage has a single zigzag initiating from each notch tip. The photograph and damage sketch layers of this specimen are shown in Figs. 4 and 5. The two damage paths progress along the fiber angles and cross at the centerline of the specimen. Minimal interaction between the two damage paths is apparent from the visual damage. Both paths appear to be unaffected by the other path, continuing along their original direction while crossing. Further investigation of the damage paths of this specimen was conducted using computed microtomography. Virtual section cuts taken near the mid-plane of each ply are shown in Fig. 6, illustrating the unaltered paths when the two zigzag paths cross. The other specimen with a double zigzag had both transverse zigzag damage paths originate at the same notch tip, similar to the transverse zigzag damage seen in the single-edge-notched specimens.

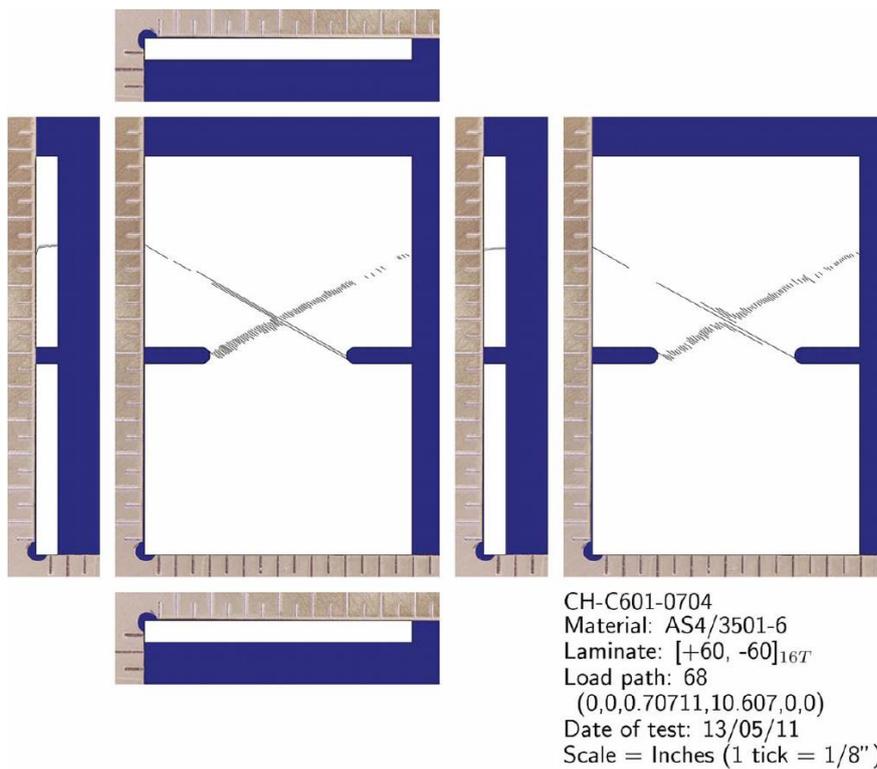
Figure 5. Damage sketch of a double-edge-notched specimen (CH-C601-0704) exhibiting crossing transverse zigzag damage.

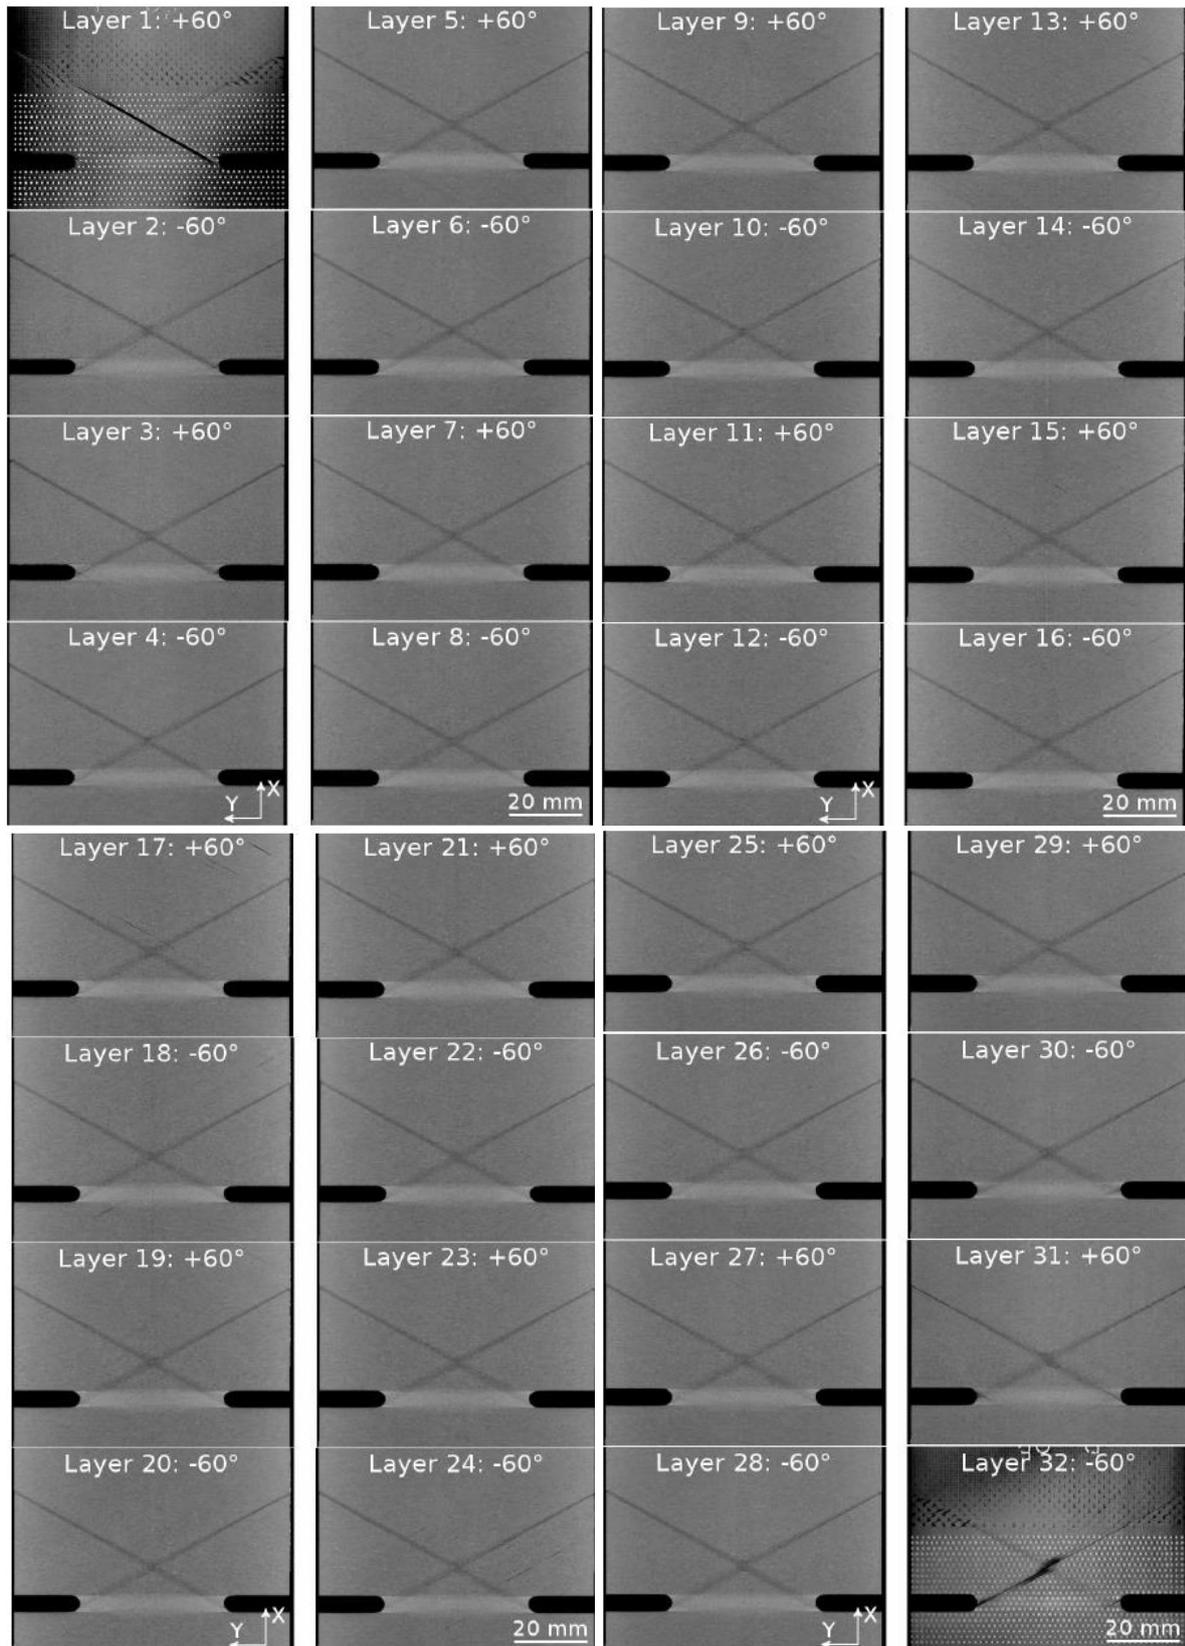
Figure 6. Multiple virtual section cuts of a double-edge-notched specimen (CH-C601-0704), showing 'front' views with virtually removed material (sectioned) from the first ply to the last ply.
