TENSILE PERFORMANCE OF FIBRE-ORIENTED SCARF REPAIR COUPONS FOR WING SKIN MATERIALS

Keywords: Aircraft structures, Adhesive bonding, Tensile strength, Scarf repair, Optimisation

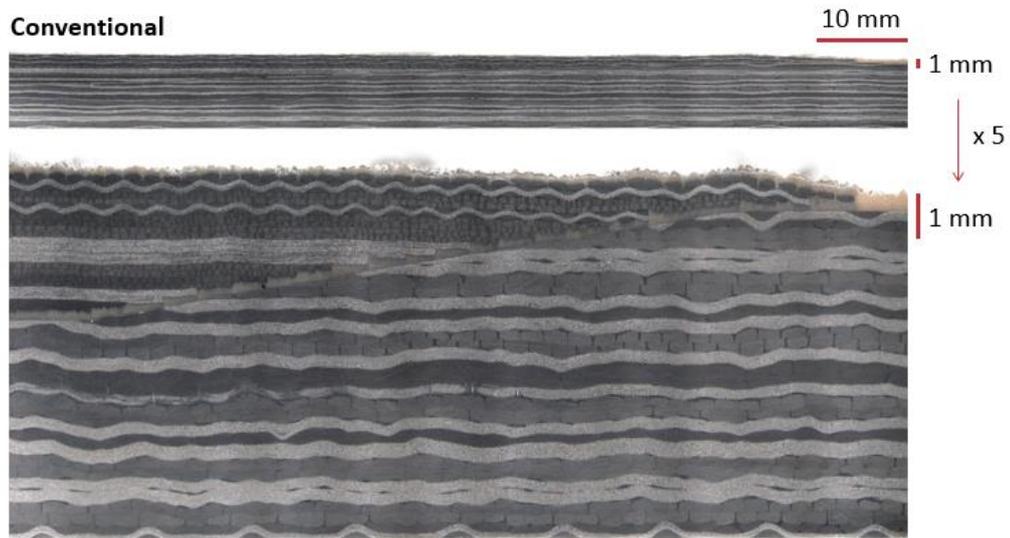
Figure 3: Conventional scarf repair bond-line, including 5x height-stretched visualisation.

The quality of the repaired panels was confirmed by through-transmission ultrasonic scans seen in Figure 2. In the absence of any large bond-line defects, these repairs were classified as of good quality. Bond-line microscopy showed accurate ply stepping and good ply matching, with only a small offset in the thickness direction due to the adhesive film thickness at the bottom of the repair patch. Image analysis also reveals the standard deviation of plies from their nominal spacing to be less than ± 0.5 mm. Detailed stitched images of the conventional, size-optimised, and strength optimized scarf repairs can be seen in Figure 3, Figure 4, and Figure 5 respectively.
