LONG TERM DEEP SEA EXPOSURE EFFECT ON THE MECHANICAL PROPERTIES OF FILAMENT WOUND COMPOSITES

Astrinos Z. Papadakis¹, George K. Konstantinidis² and Nicholas G. Tsouvalis³

Keywords: composite materials, filament winding, housing, underwater, testing

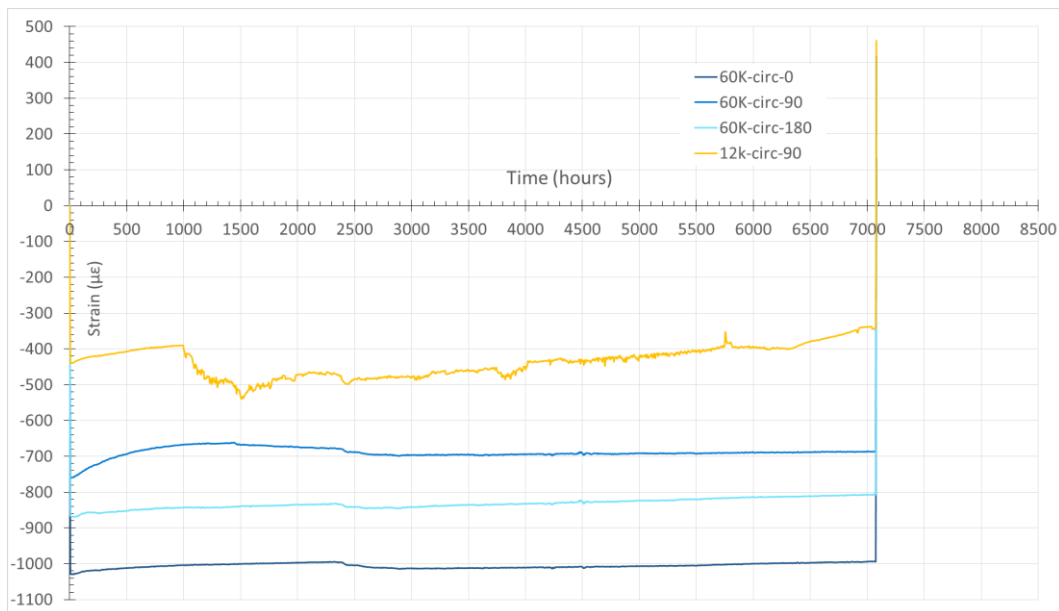
Finally, in figures 6 and 7, the readings obtained by the strain measurements during the housings' stay in the deep sea are presented. Specifically, figure 6 presents strain measurements during the first period of exposure, whereas figure 7 presents the respective results of the second period.

Figure 6. Circumferential strains during the first period of deep sea exposure

Concerning the pressure housings response, figures 6 and 7 show that, in general, the strain level measured from all sensors remained almost stable during the whole period of exposure in the sea and in both immersion periods. More specifically, figure 6 indicates that the three sensors installed on the 60K carbon fiber housing measured strains from 700-1000 µε, depending on the position on the

housing. On the other side, the sensor used for the 12K housing measured strains between 400 and 500 $\mu\epsilon$. The noise observed in this last sensor doesn't exhibit a specific trend and cannot be explained by the other results, however, it is not attributed to a housing's failure. In addition, it is observed that the general strain level of the 60K cylinder is higher than the respective level of the 12K. This fact can be explained by the real thickness of the housings. Specifically, in the case of the 60K one, thickness was measured equal to 5 mm in contrast to the 6 mm respective dimension of the 12K housing. As far as the second period of exposure is concerned (figure 7), the constant strain level recorded by all sensors is again presented. In this case, the strains in the 60K housing were measured by two sensors since a failure occurred in the third one. The aforementioned general observations exclude the possibility of the development of creep effects, depicting that the studied filament wound composite structures are extremely resistant to deep sea environment conditions and thus, highly recommended for several underwater applications.
