## ***IN-SITU* INVESTIGATION OF DAMAGE MODE PROGRESSION IN OPEN-HOLE QUASI-ISOTROPIC LAMINATES**

### **Abstract**

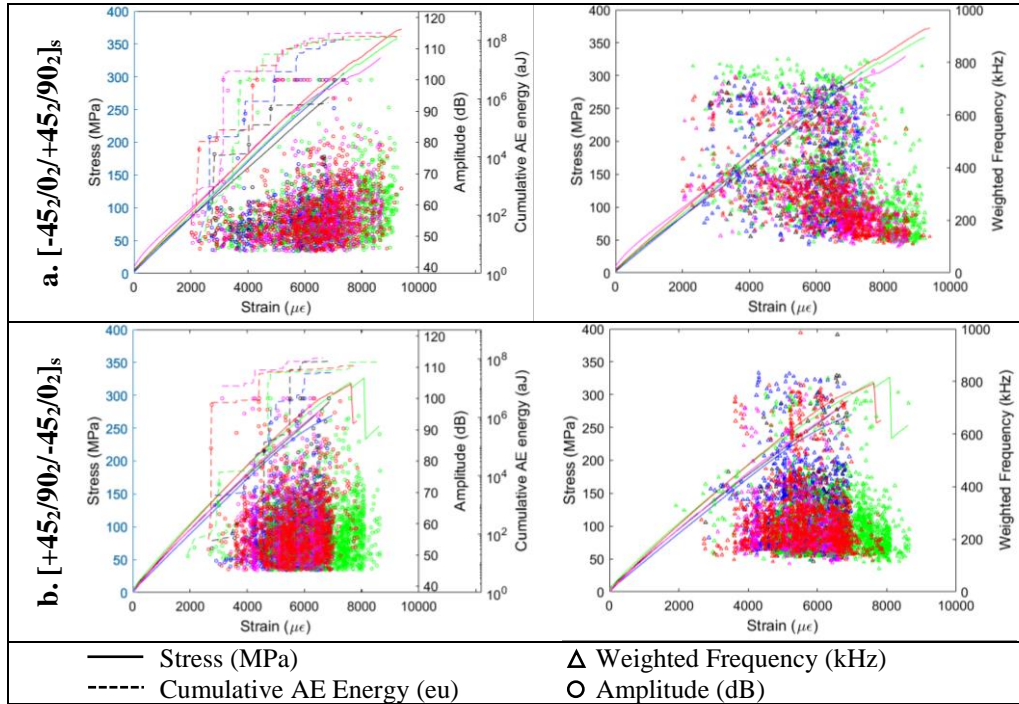
Five tension tests are performed for each laminate type. Figure 1 presents test results for both laminates, combining in one graph stress-strain curve and parameters of the AE events: Amplitude with cumulative AE energy and weighted frequency. Different colours represent different tests. Figure 1 shows that not only stress-strain response, but also the AE results change considerably with the change in lay-up sequence. The maximum stress levels in Figure 1 do not correspond to the ultimate strengths of the specimens, but rather the stress levels that particular tests are stopped.

**Figure 1.** Stress-strain curves and AE results for test laminates.

Figure 1.a shows that amplitude and energy levels of registered AE events increase with increasing strain throughout the tests of  $[-45_2/0_2/+45_2/90_2]_s$  laminate. At the same time, high weighted frequency events are registered at low strain levels whereas, low weighted frequency events are mostly registered at higher strain levels. Figure 1.b shows that the number of registered AE events reduces considerably after stiffness degradation due to the macro delaminations in  $[+45_2/90_2/-45_2/0_2]_s$  laminate at  $\pm 45/90$  and  $-45/0$  interfaces.

Second laminate type is [+45<sub>2</sub>/90<sub>2</sub>/-45<sub>2</sub>/0<sub>2</sub>]<sub>s</sub>. It is seen (Figure 1.b) that the number of registered events reduce considerably after large load drops due to the macro delaminations at +45/90 and -45/0 interfaces around 7500  $\mu\epsilon$  and 8100  $\mu\epsilon$  strain levels. Figure 5 shows that damage initiates at 4600  $\mu\epsilon$ . High number of AE events with low-amplitude/high-frequency characteristics (CL3) are registered after 4700  $\mu\epsilon$  in Figure 5. They are initially localized between 15 – 21 mm in Figure 5.(a-3). They propagate to the hole region after 5100  $\mu\epsilon$ , then to the further regions (through 30 mm away from the AE sensor) after 7000  $\mu\epsilon$ . High-amplitude events (CL1) are localized around the hole region until 7000  $\mu\epsilon$  and propagate to the further regions after 7000  $\mu\epsilon$ . Distance of the central hole to the AE sensor is between 23-25.5 mm but location graph for edge observation region is plotted for 21-29 mm in Figure 5.(a-3) because of the quickly propagating long delaminations.
