Numerical Modelling of Uniaxial Compressive Tests on Sille Bimrock

Abstract

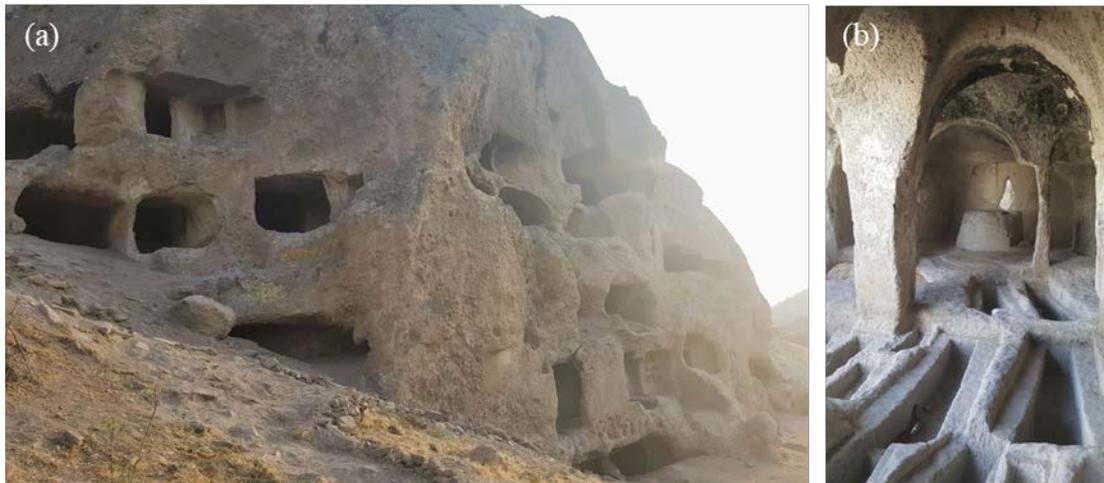
Fig. 1 Some views from (a) Sekili Cave and (b) Koimesis Tes Panagias Church and rock-cut tombs.

Two historical structures within a hill settlement, known as “Sekili Cave” and “Koimesis Tes Panagias Church”, dating back to approximately A.D. 500, were carved into an agglomerate rock mass medium in Sille (Konya, Türkiye) (Fig 1). This ancient hill settlement preserves archaeological heritage from the early Christian era, such as rock tombs and valuable wall paintings. Most of these structures are exposed to atmospheric conditions and, as a result, are particularly susceptible to physical weathering due to climatic factors. Some instability problems such as discontinuity-controlled failures, wedge failures

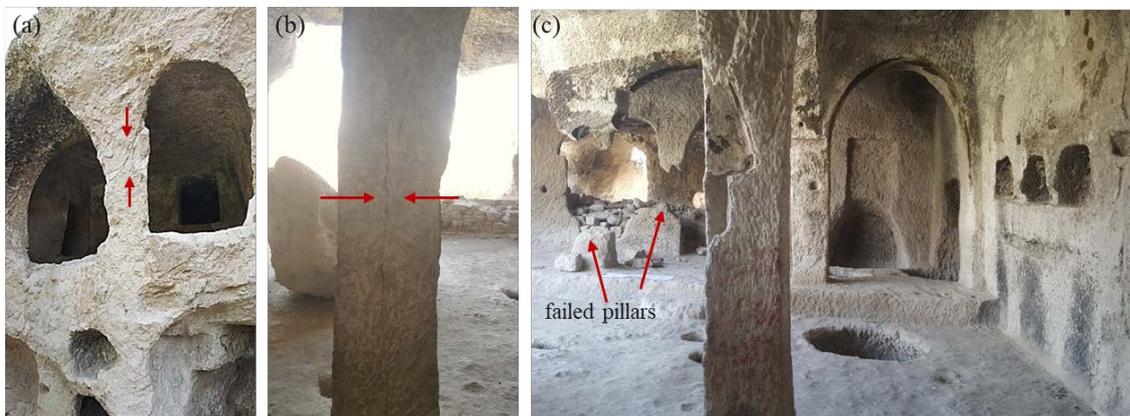
Fig. 2 Instabilities caused by unconfined compressive stress.

from the ceiling, shear failures at the pillars, and roof collapses caused by excessive weathering and long-term loading have been observed in the hill settlement (Fig 2).

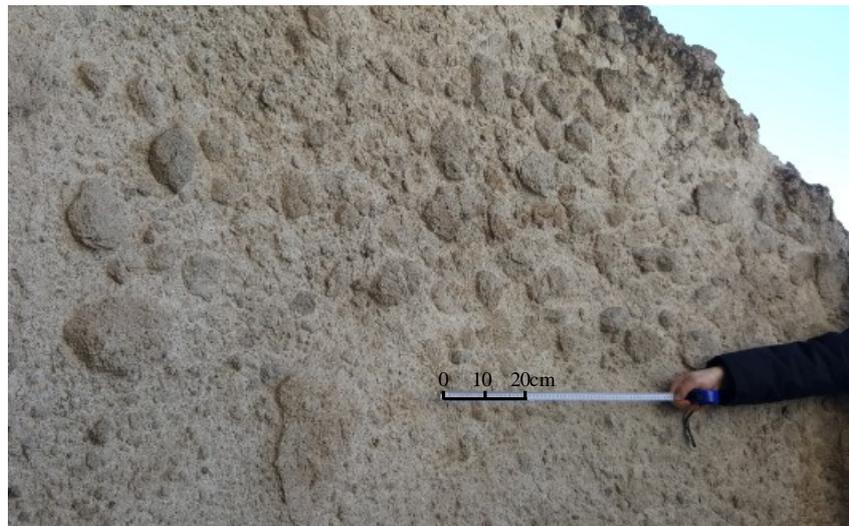
Fig. 3 A view from side wall of Koimesis Tes Panagias Church presenting various size of andesite blocks welding in a fine-grained matrix.

This study investigates a pyroclastic rock mass outcropping in the historical Sille settlement in Türkiye, which formed in a terrestrial environment during eruptions associated with Late Miocene-Early Pliocene volcanism (Özkan 2017). The K–Ar ages of the rocks range from 11.95 to 3.35 Ma (Keller et al. 1977). Based on in-situ surveying, Avşar (2020) stated that Sille agglomerate is comprised of rock blocks of various sizes in a relatively low strength tuff-like matrix with an evident welding (Fig. 3). The optical microscopy examinations indicated that the blocks are andesite with porphyritic texture and contain plagioclase, biotite, quartzite phenocrysts, and opaque minerals. Additionally, based on the observation of different outcrops, no preferential orientation in the distribution of the blocks was detected (Avşar 2020 and Avşar 2021). While some large blocks have clear angularity, smaller blocks are mostly rounded or semi rounded.

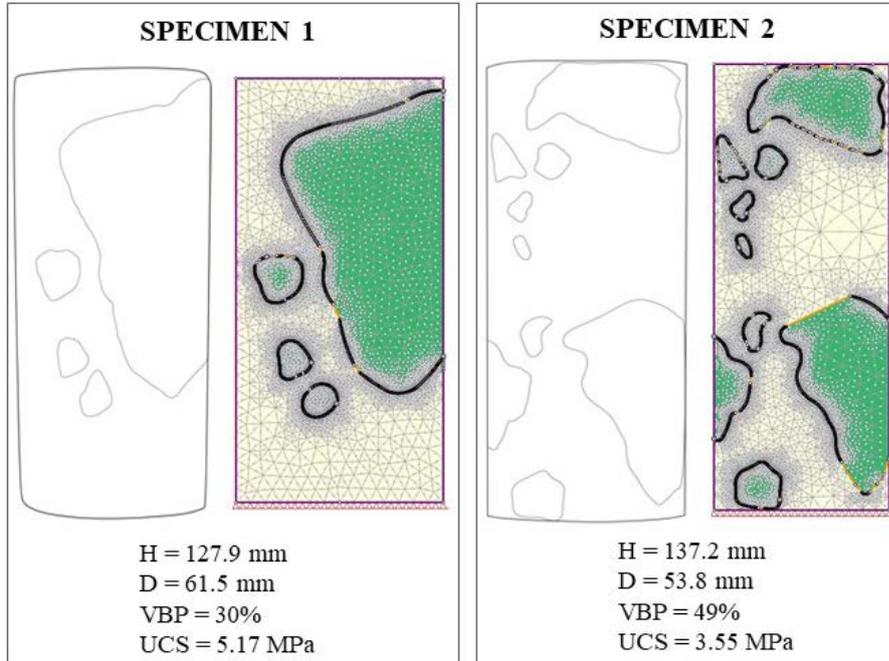
Fig. 4 - Front views of the two agglomerate specimens analyzed numerically, mesh characteristics and boundary conditions applied.

cores. To more reliably model the heterogeneous rock samples, the block-matrix contacts were considered and simulated by introducing interface elements (i.e. “joints”) in the RS2 software. Six-node triangular elements were chosen to mesh the bimrock models. A non-uniform mesh size, with higher density around the blocks, was used, and local mesh refinements were adopted to guarantee a high-quality meshing. The bottom model boundary featured fully restrained boundary conditions, while free boundary conditions were applied to the other external boundaries (Fig. 4).

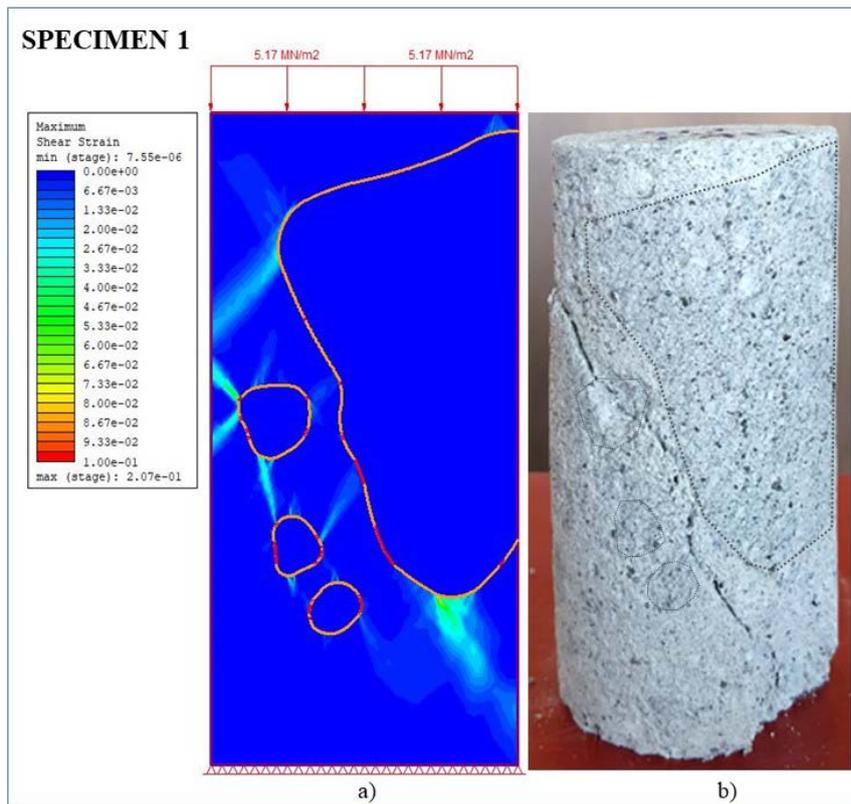
Fig. 5 Specimen 1: a) maximum shear strains of and plasticized interface joints (in red); (b) specimen after the UCS test, with block outlines drawn in the illustration and failure surface developing close to block boundaries.

Although the limitation of the 2D analyses (i.e. plain-strain conditions), the concentration of the maximum shear strains obtained from the numerical analyses accurately reproduced the actual failure mode detected in the laboratory. A comparison between the actual specimen and the numerical analysis result is shown in Figure 5 for specimen 1 and in Figure 6 for specimen 2. From these figures, the fundamental role of the stronger rock blocks is evident. Specifically, it can be seen that the maximum shear strains are localized close to the stronger rock blocks, where stresses concentrate, and that a plasticization of the joint elements (i.e. block-matrix interfaces) occurs close to the failure surface. Moreover, the specimen with the highest VBP (i.e. specimen 2) experiences a shear band that connects the different rock blocks, while a more irregular distribution of the maximum shear strains is shown in the specimen with the lowest block content (i.e. specimen 1). With reference to this low-VBP specimen, it is worth noting that the actual failure surface (Fig. 5b) crosses one of the rock inclusions and that this behaviour was not reproduced in the numerical analysis. The reason for such a difference can be attributed to some defects (i.e. cracks) that the rock block may have experienced during the sample preparation, as well as to three-dimensional effects, that a 2D analysis cannot catch.

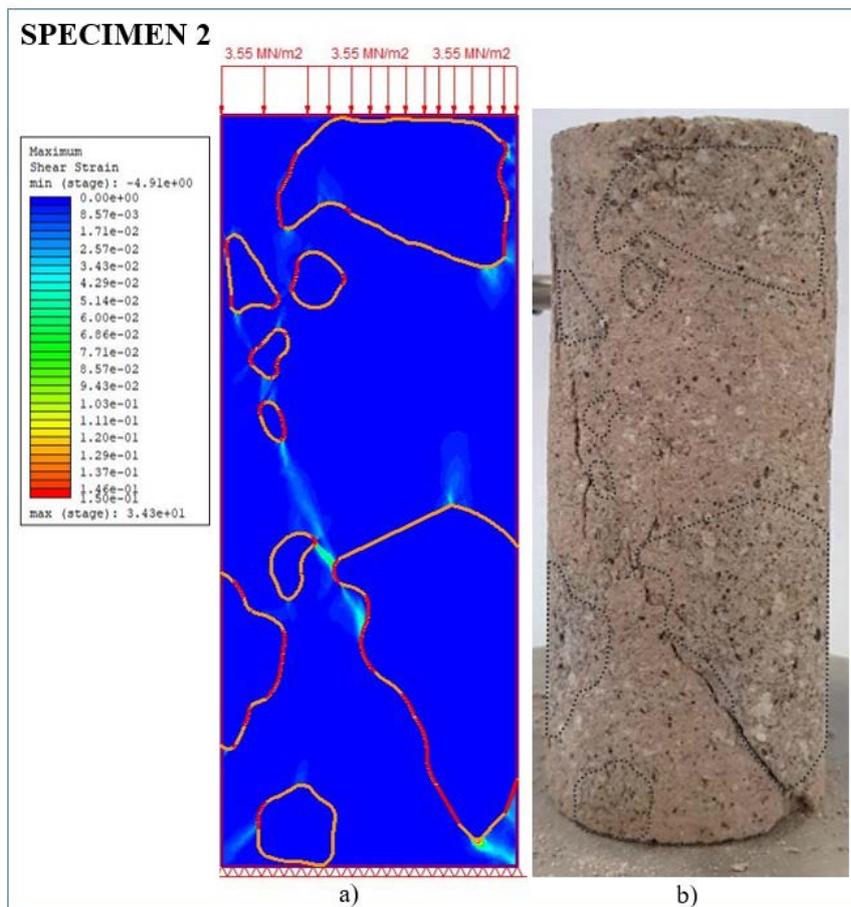
Fig. 6 Specimen 2: a) maximum shear strains of and plasticized interface joints (in red); (b) specimen after the UCS test, with block outlines drawn in the illustration and tortuous failure surfaces developing along block boundaries.

In the framework of the experimental research on the Sille agglomerate carried out by Avşar (2020), the tortuosity of the failure surfaces of the specimens tested in uniaxial compression was readily observable on the outer surface of the core specimens. The path across the core specimen's surface (whether along boundaries, blocks, or matrix) was analyzed through visual inspection at the end of each UCS test. It was additionally noted that the tortuosity of failure surfaces augmented as the roughness of block surfaces (that quantified by fractal dimension analysis) increased. Another notable finding is that the failure planes predominantly traverse the boundaries between the blocks and the matrix, indicating that block-matrix contacts are the weakest component of the agglomerate-bimrock. Our numerical models have successfully captured the overall mechanical behaviour observed in the laboratory tests, particularly in terms of the distribution of maximum shear strains and the localization of plasticization zones, which largely validate the failure modes identified experimentally. However, certain discrepancies should be further examined: In laboratory tests, natural flaws within the rock blocks and stress accumulations due to sample preparation can influence the failure path. Since these pre-existing defects cannot explicitly be incorporated into the numerical model, some deviations between the predicted and observed failure surfaces are inevitable. The 2D modelling approach may not fully capture critical three-dimensional mechanisms involved in the failure process. Specifically, in the laboratory specimens, the failure surface was observed to cut through one of the rock inclusions, a behaviour that was not reproduced in the numerical simulation, likely due to the inherent limitations of 2D modelling.
